Home Inspection Report

Property Address:
198 Dream Home Blvd
Louisville KY 40245

ABI Home Inspection Service, LLC

Date: 3/10/2016	Time:	Report ID:
Property: 198 Dream Home Blvd Louisville KY 40245	Customer: Joe Smith	Real Estate Professional:

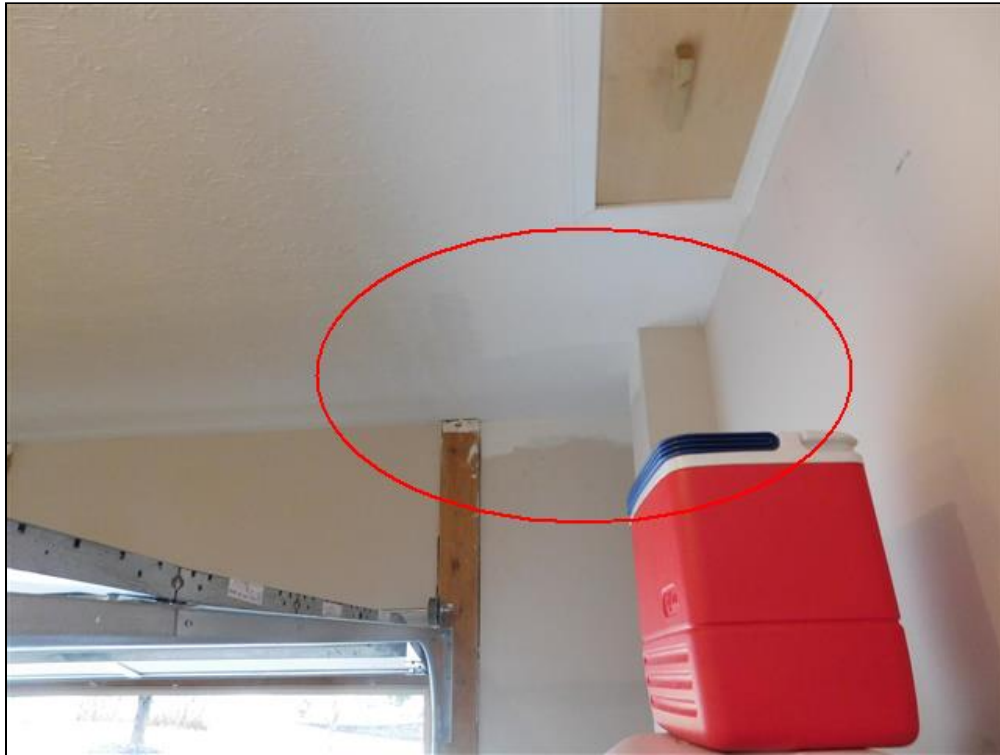
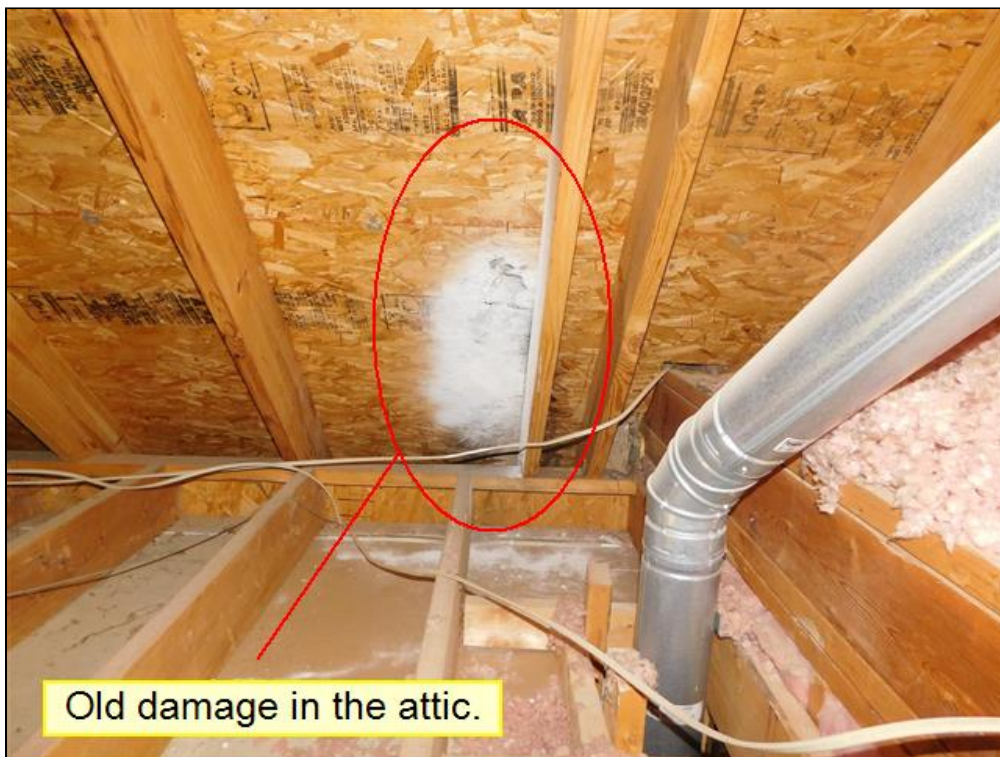
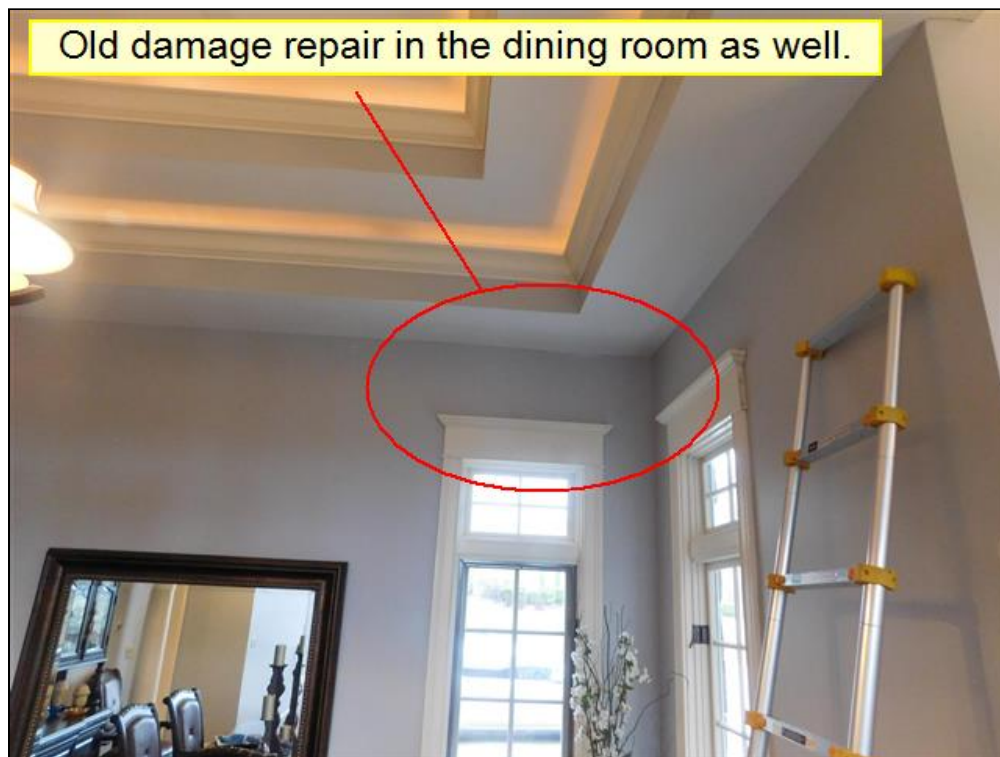
3.1 There is old damage in the garage attic at the corner where it meets the house. It looks like the flashing failed and the roof sheathing got wet. Check with the owners about when this happened, but it looks like old damage to me. Nothing was wet today in the attic.

4. There is old damage in the garage attic at the corner where it meets the house. It looks like the flashing failed and the roof sheathing got wet. Check with the owners about when this happened, but it looks like old damage to me. Nothing was wet today in the attic.

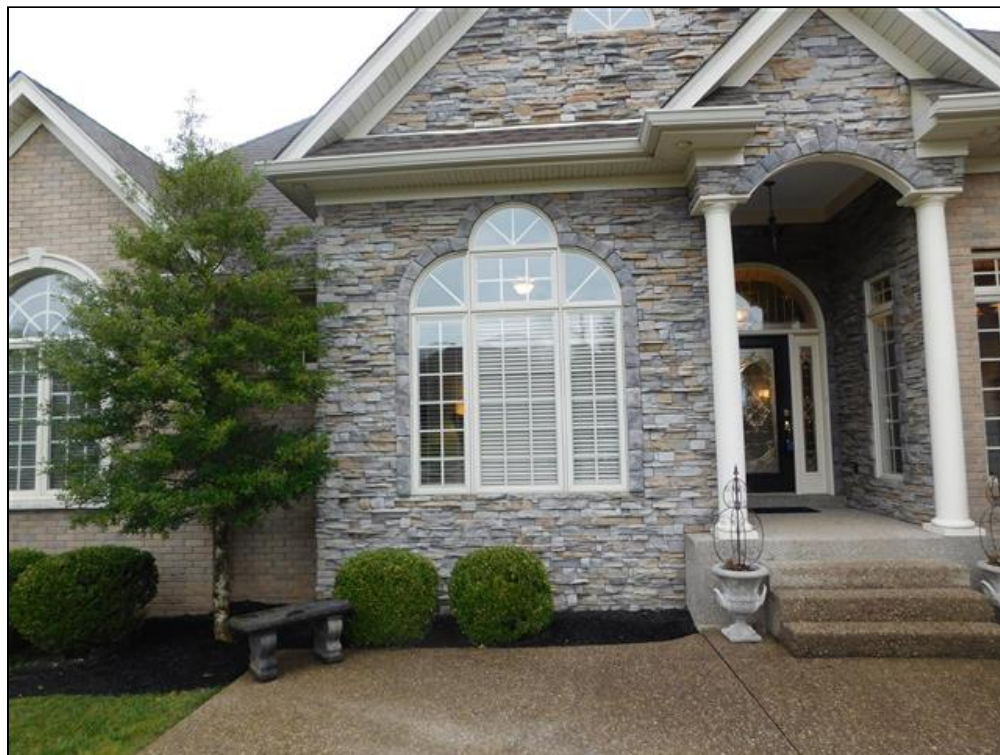
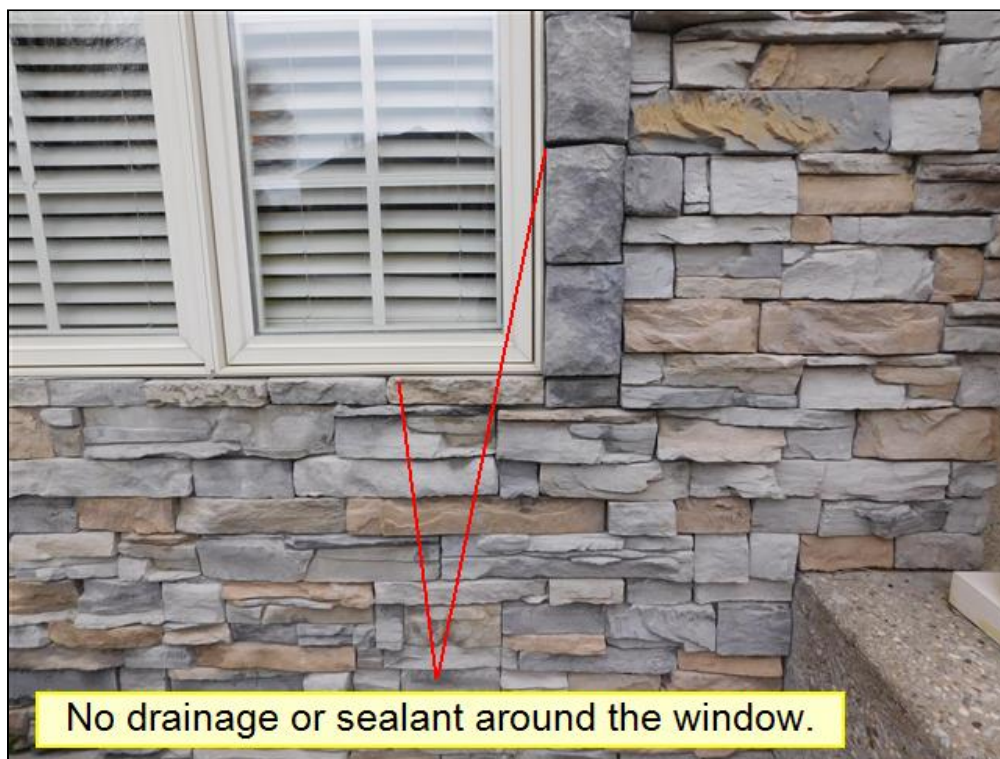
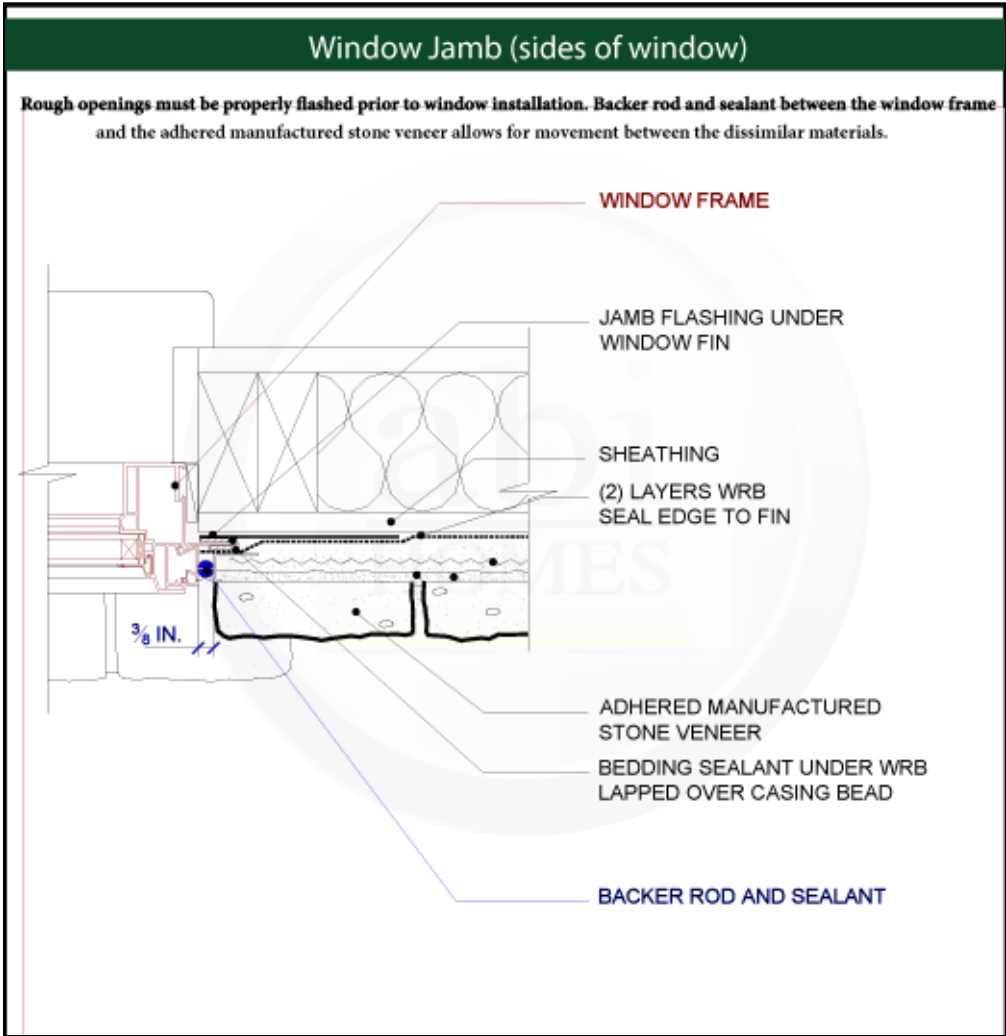
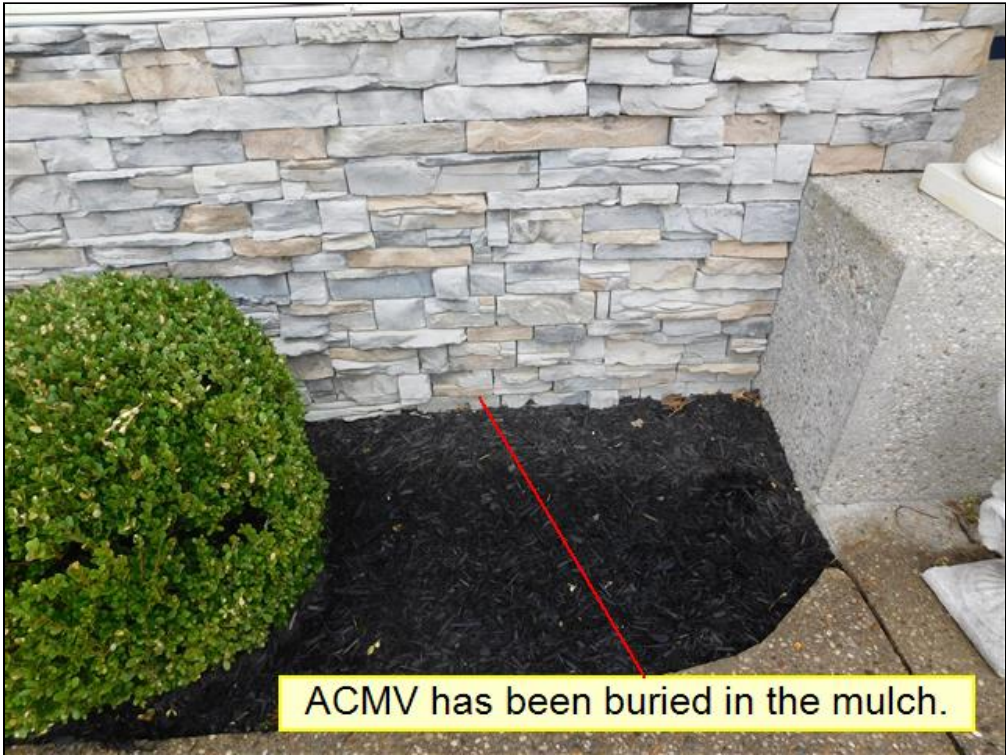
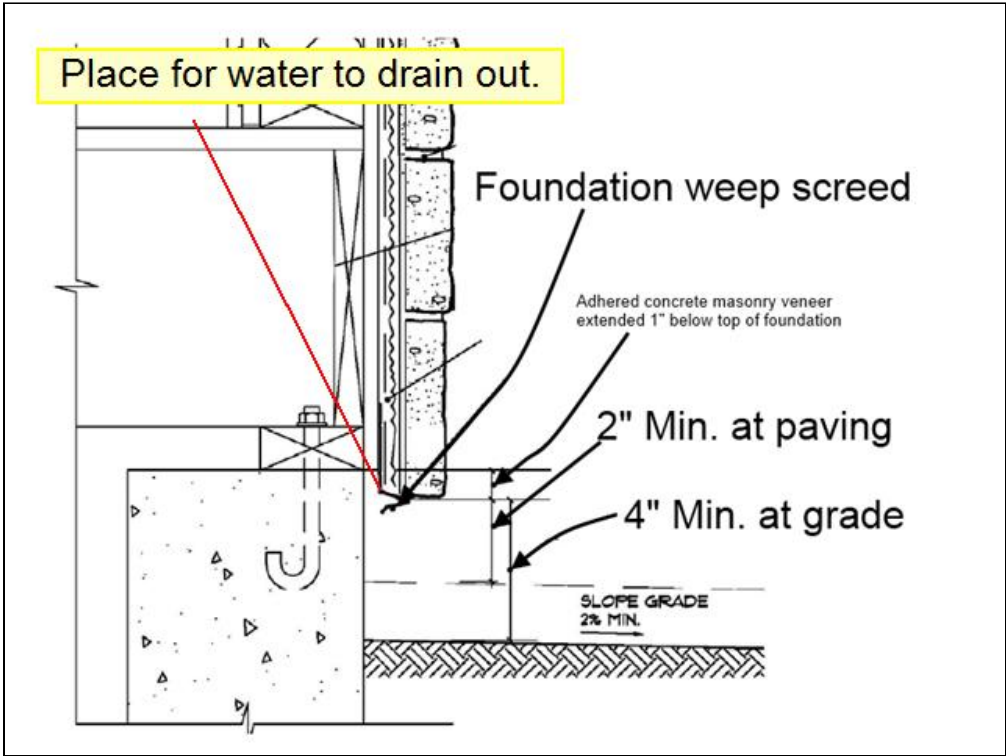
There are several issues with this installation that could potentially cause moisture problems within the walls of the home. Unfortunately, there is no way of knowing for sure without moisture testing inside the wall cavity. Deep wall moisture sampling in these areas could reveal a potential major problem. However keep in mind this sampling in NOT fool proof, and could miss damaged areas all together. There is no substitution for opening up the wall and visually looking at the framing and sheathing, but that is just not a realistic option during the transfer of property. Even after all the testing, you still need to understand the veneer was installed incorrectly, is missing several important details, and could start to leak at any time. It would also be a very good idea to get a few bids on repairing the install based on the install guide I've included with this report. At least then you can know some worst case scenario numbers to work with.

5. There are several issues with this installation that could potentially cause moisture problems within the walls of the home. Unfortunately, there is no way of knowing for sure without moisture testing inside the wall cavity. Deep wall moisture sampling in these areas could reveal a potential major problem. However keep in mind this sampling in NOT fool proof, and could miss damaged areas all together. There is no substitution for opening up the wall and visually looking at the framing and sheathing, but that is just not a realistic option during the transfer of property. Even after all the testing, you still need to understand the veneer was installed incorrectly, is missing several important details, and could start to leak at any time. It would also be a very good idea to get a few bids on

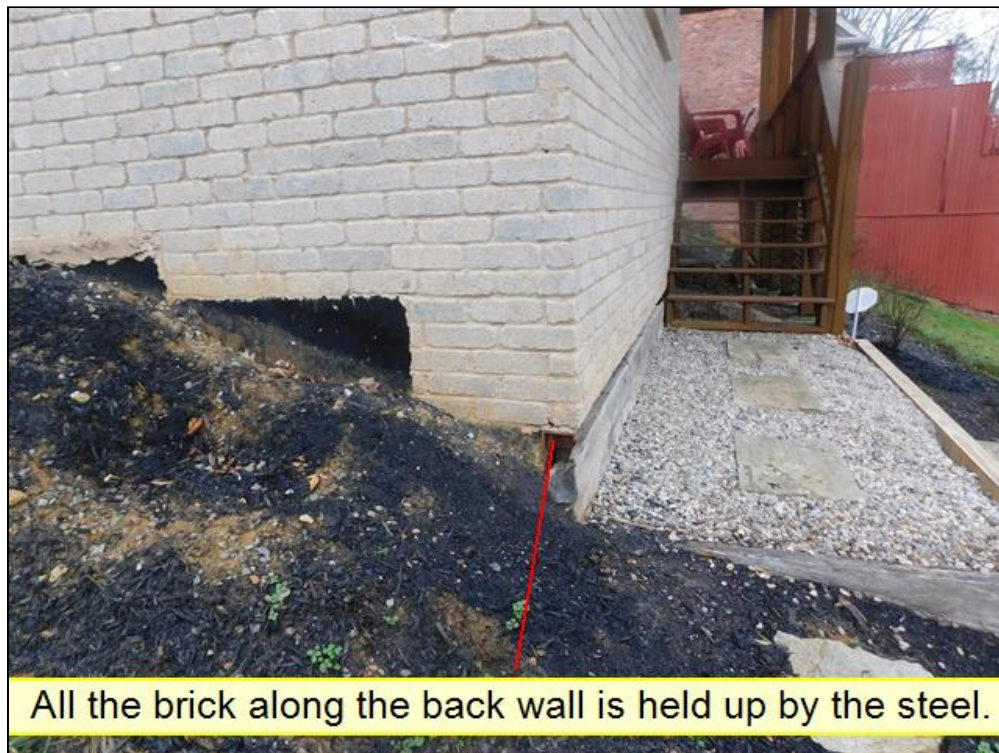
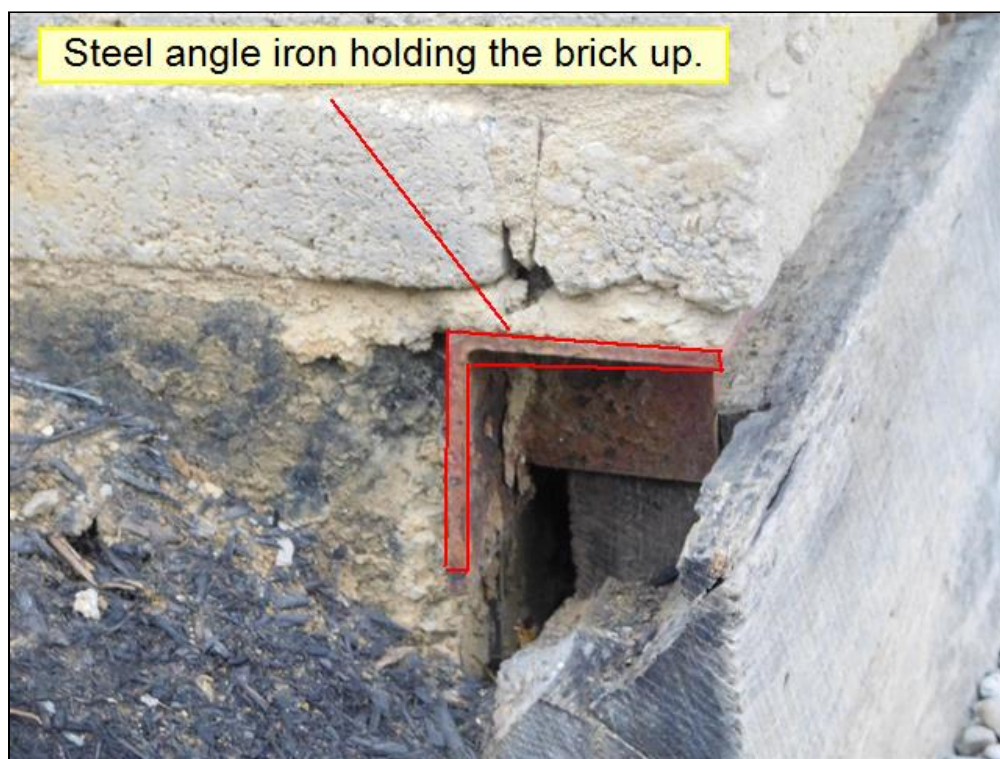
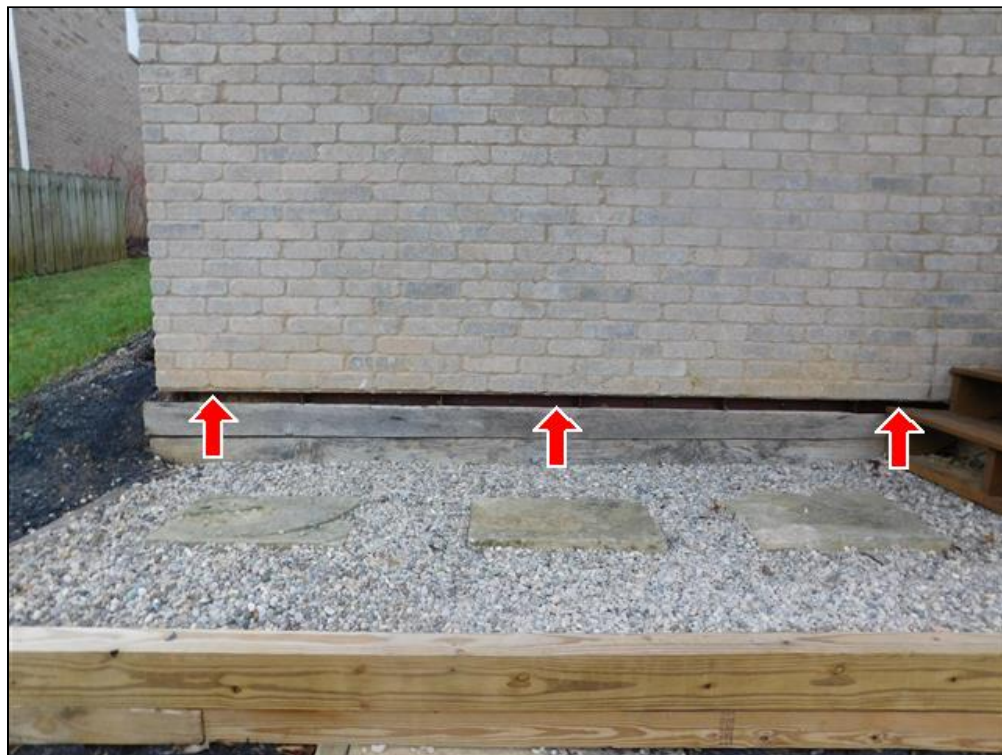
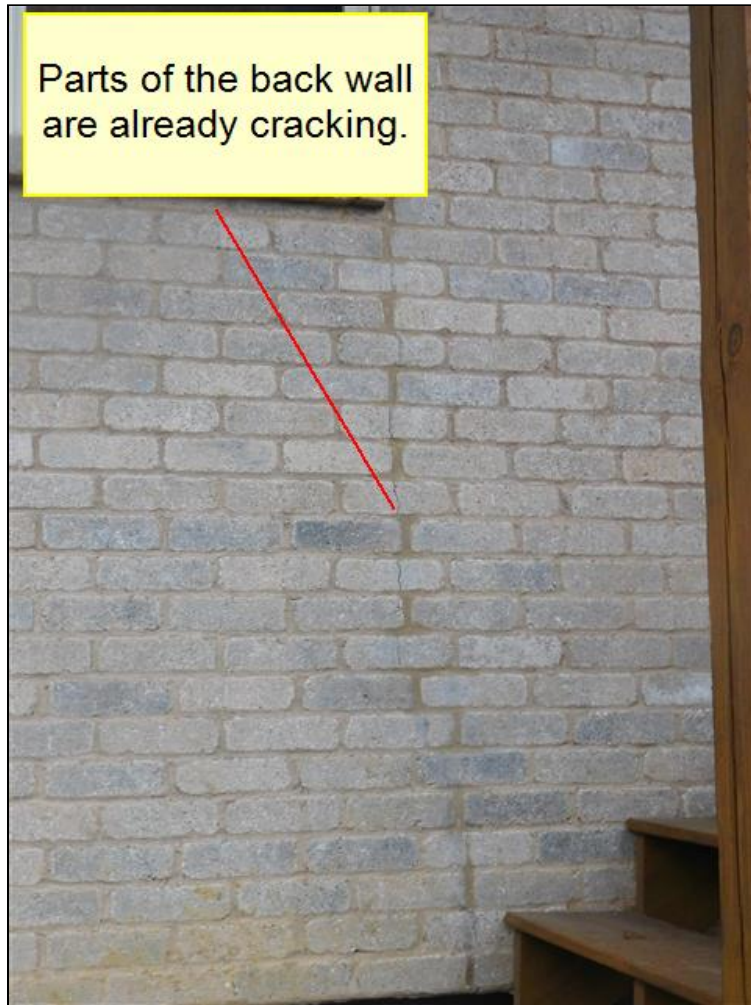
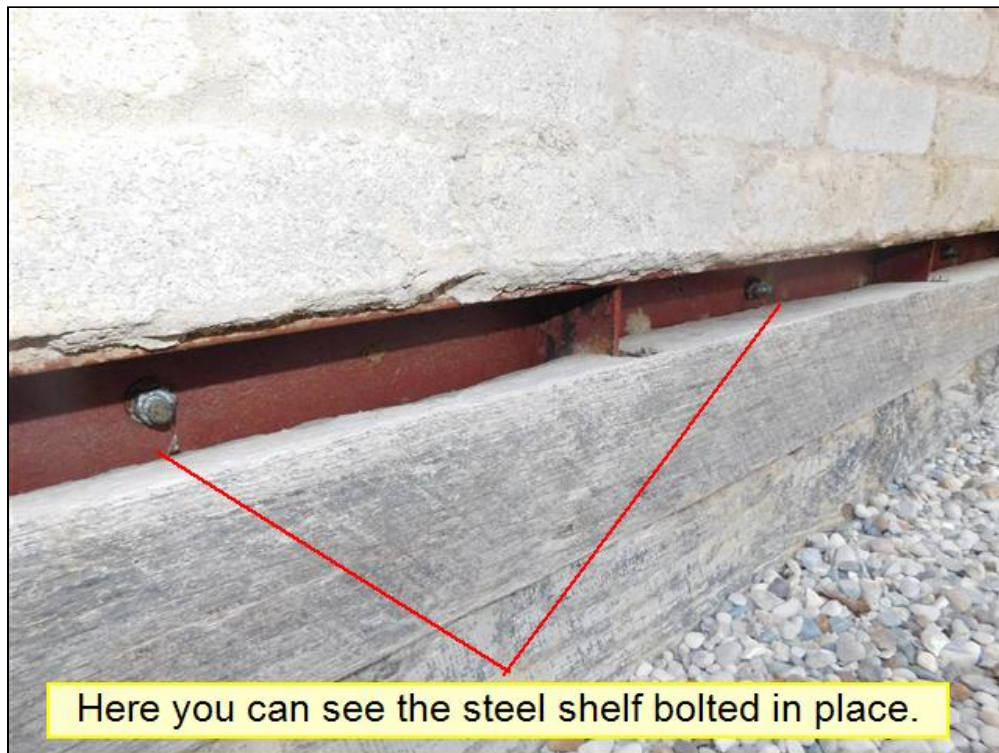
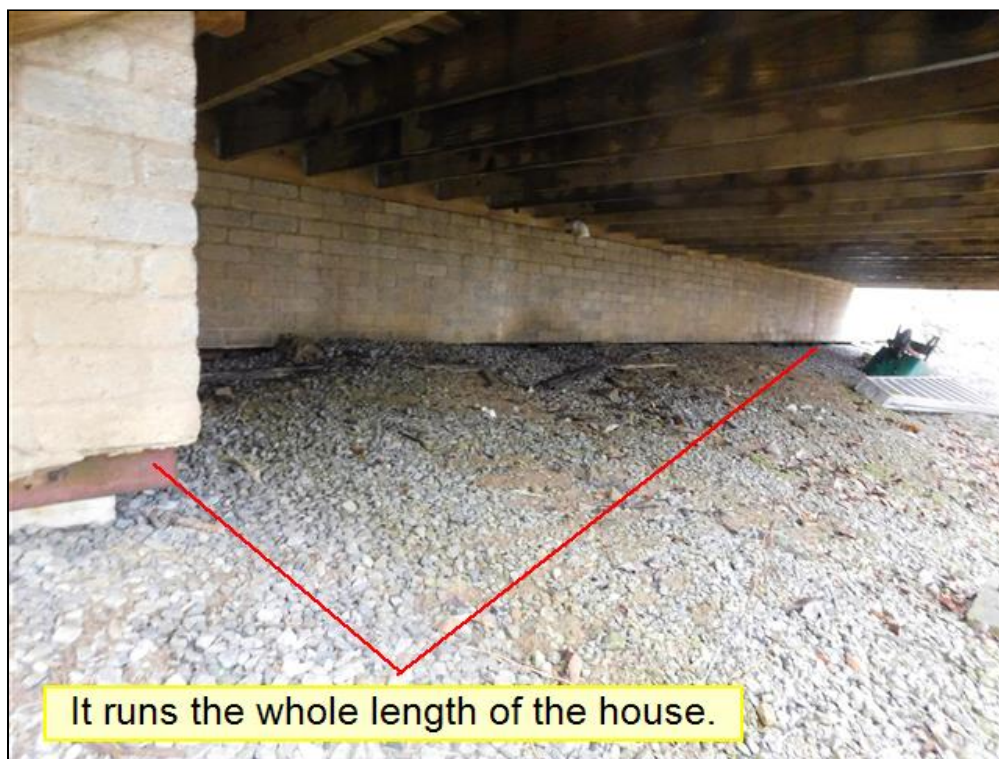
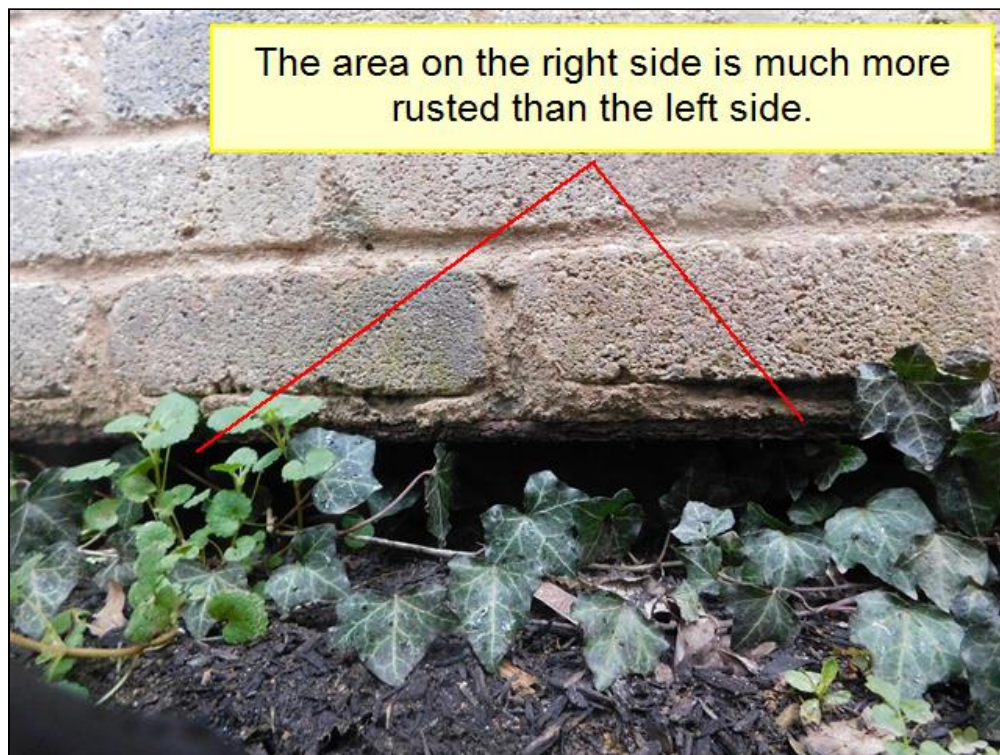
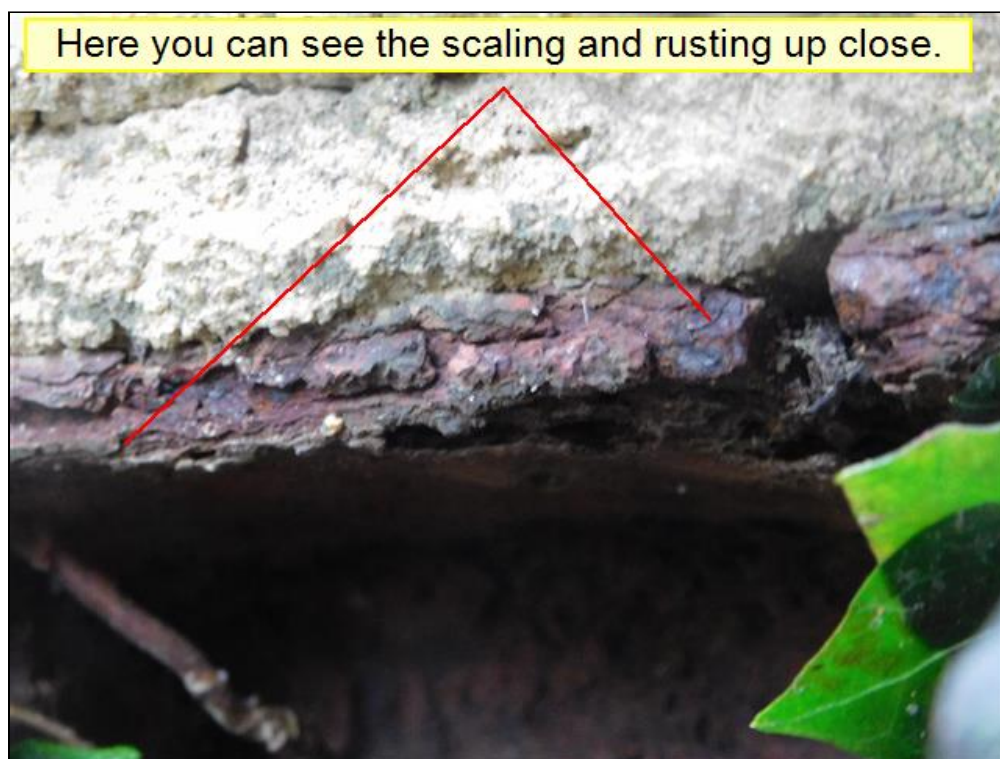
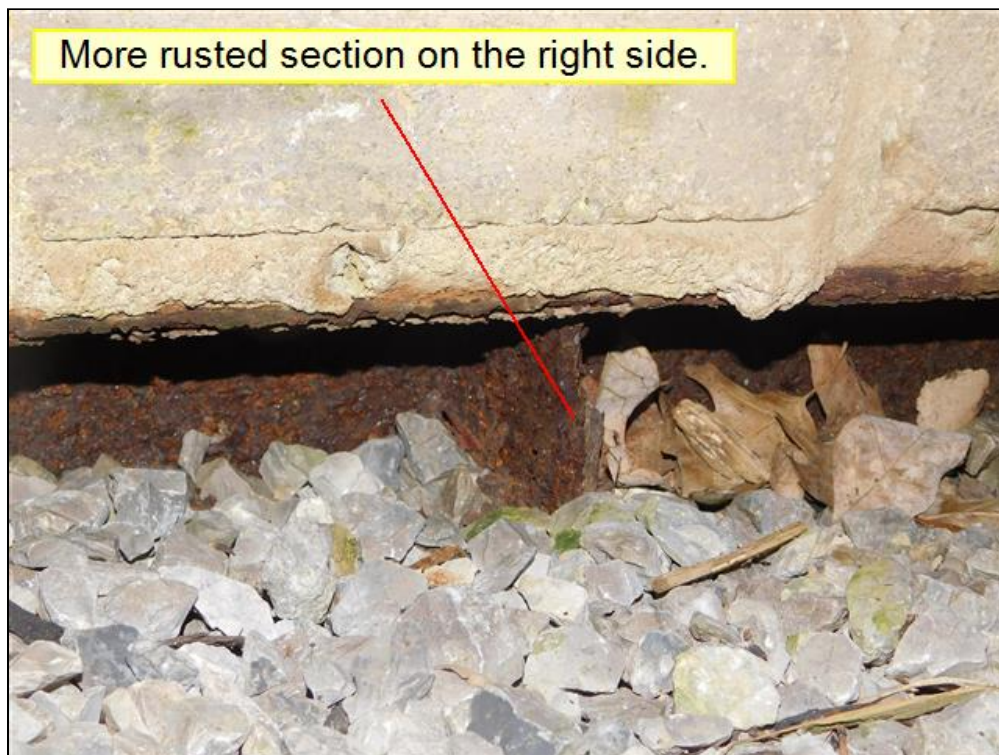
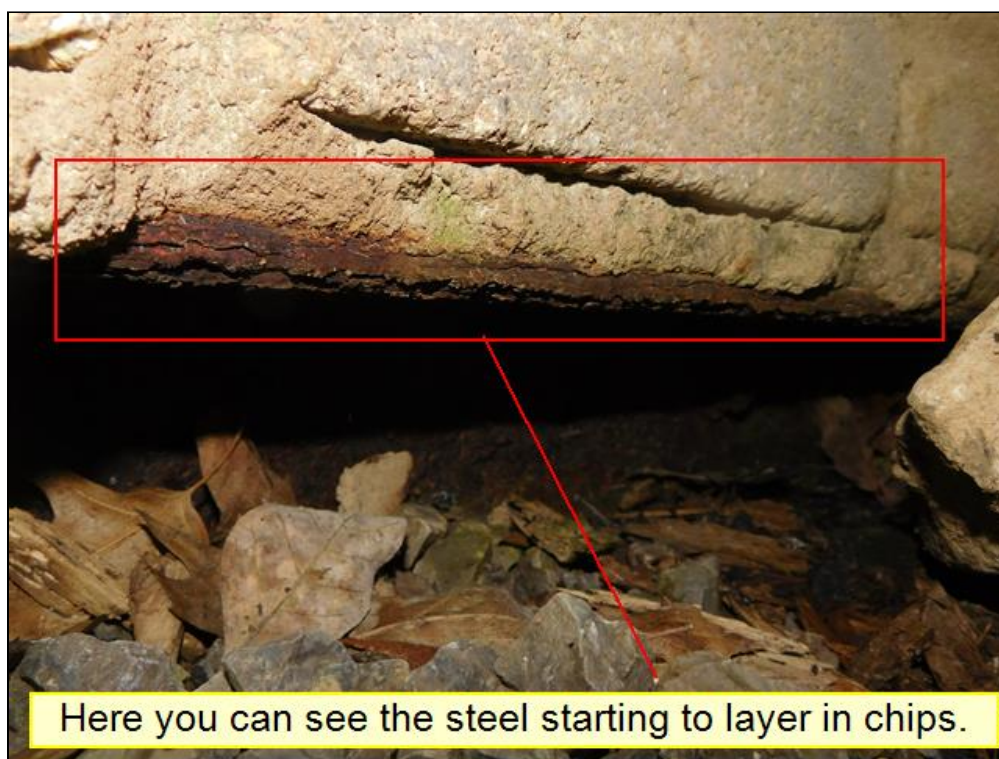
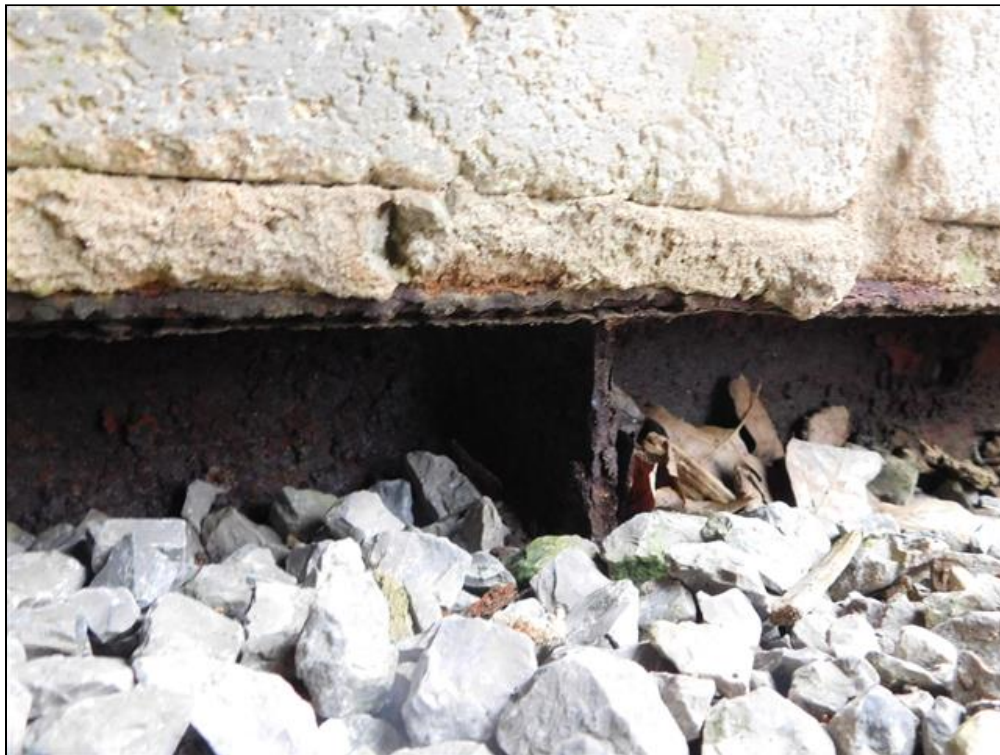
4.0 (2) The brick along the back of the house is not resting on the foundation like it should be. Instead it is sitting on top of a steel lintel that is bolted to the face of the concrete foundation. This means the whole wall of bricks are relying on the strength of the bolts to hold everything up. The other problem is all of this steel is rusting. In several spots it is heavily rusted. Over time this will get worse, and may cause the brick to crack and fail. I can't say for sure if things will ever get that bad, but with the rusting that we can see now after only 15 years, I don't see how its not going to get worse. I recommend you reach out to qualified brick mason and structural engineer to help design a repair and get their opinion on the situation at hand.

6. (2) The brick along the back of the house is not resting on the foundation like it should be. Instead it is sitting on top of a steel lintel that is bolted to the face of the concrete foundation. This means the whole wall of bricks are relying on the strength of the bolts to hold everything up. The other problem is all of this steel is rusting. In several spots it is heavily rusted. Over time this will get worse, and may cause the brick to crack and fail. I can't say for sure if things will ever get that bad, but with the rusting that we can see now after only 15 years, I don't see how its not going to get worse. I recommend you reach out to qualified brick mason and structural engineer to help design a repair and get their opinion on the situation at hand.

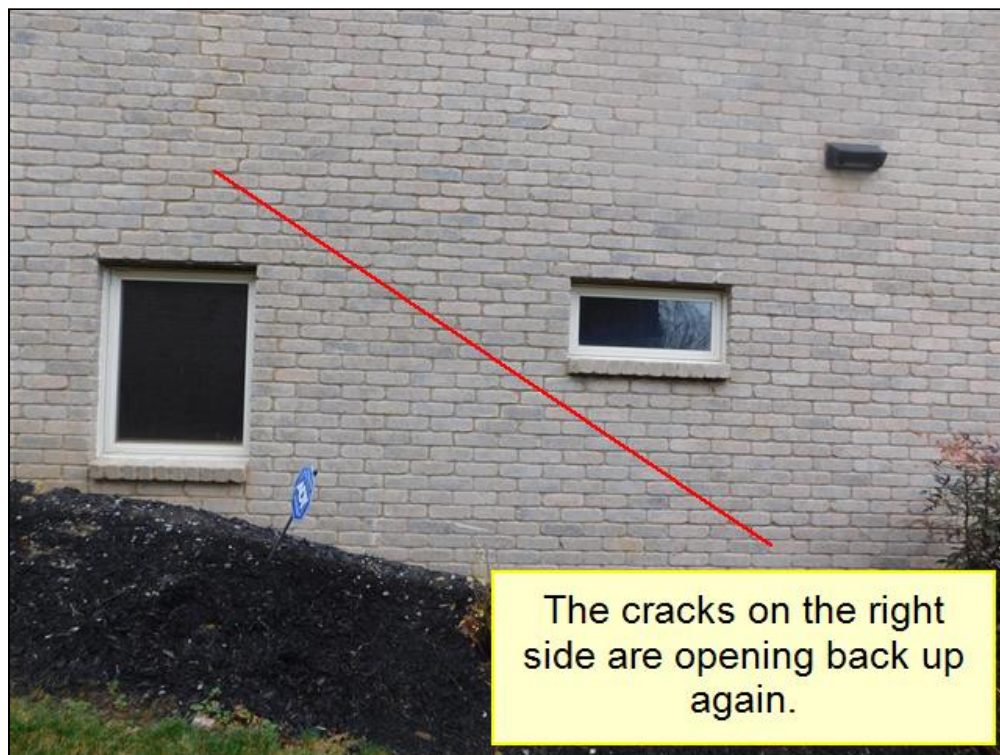
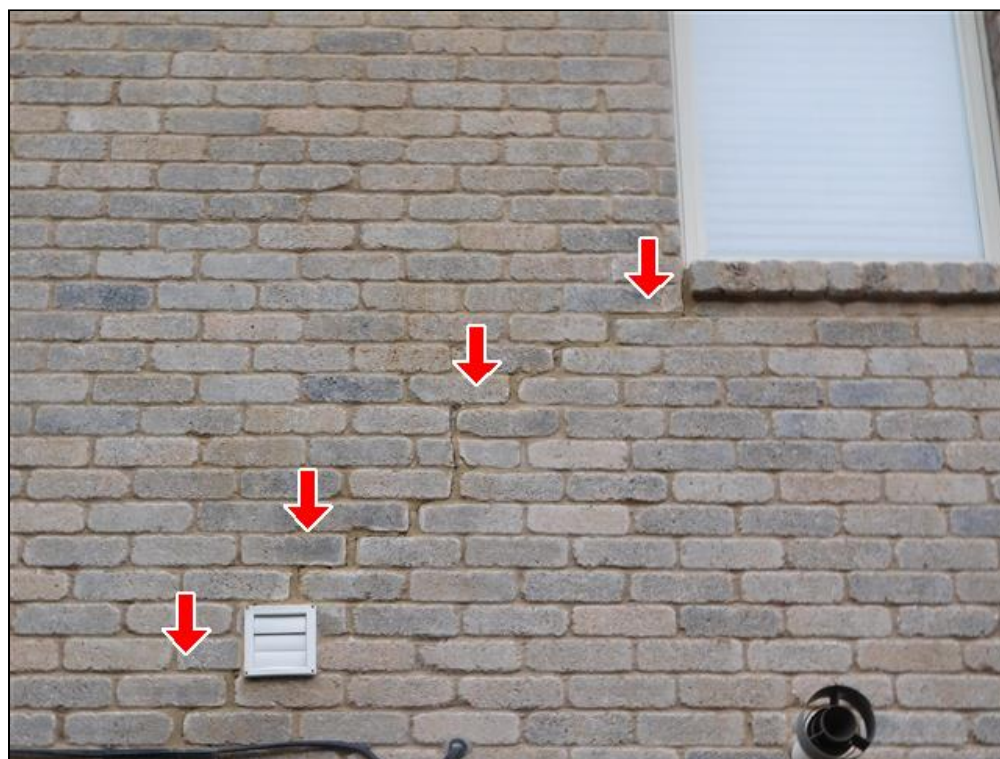
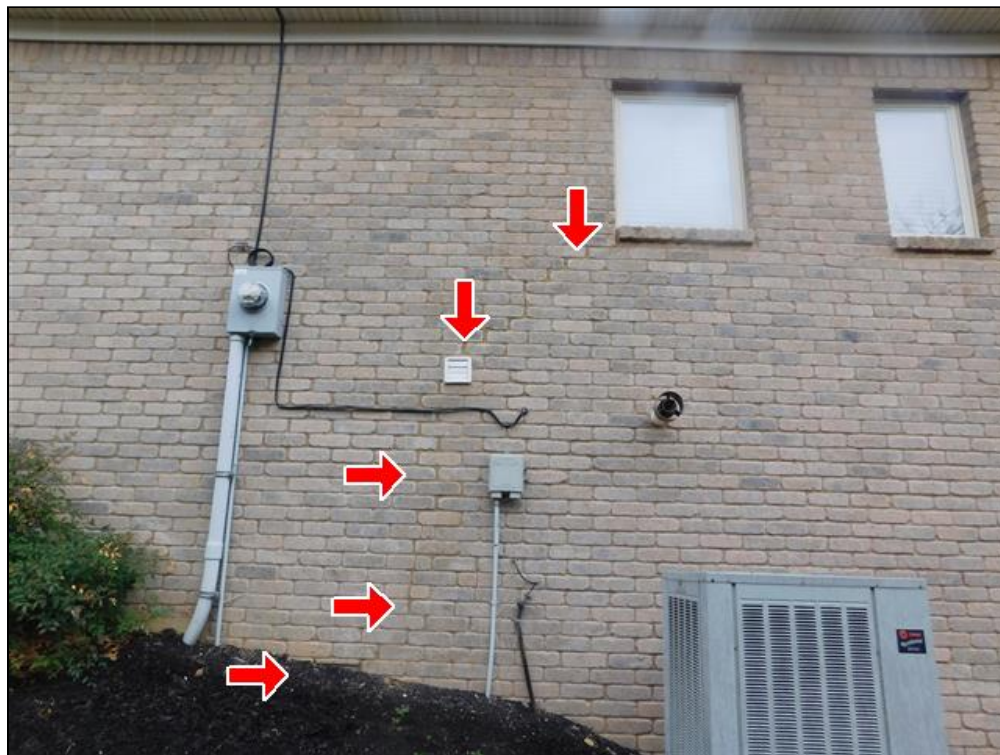
4.0 (3) There is cracking in the brick along the right side of the home. It looks like all of these cracks have been tuck-pointed repaired at one time but the cracks are coming back. This would suggest whatever was moving has not stopped moving. Again, you'll want to have a qualified brick mason take a look at the veneer wall. I would also reach out to the repair company (that fixed everything the first time) and have them come out and take a look to see why things are cracking again.

7. (3) There is cracking in the brick along the right side of the home. It looks like all of these cracks have been tuck-pointed repaired at one time but the cracks are coming back. This would suggest whatever was moving has not stopped moving. Again, you'll want to have a qualified brick mason take a look at the veneer wall. I would also reach out to the repair company (that fixed everything the first time) and have them come out and take a look to see why things are cracking again.

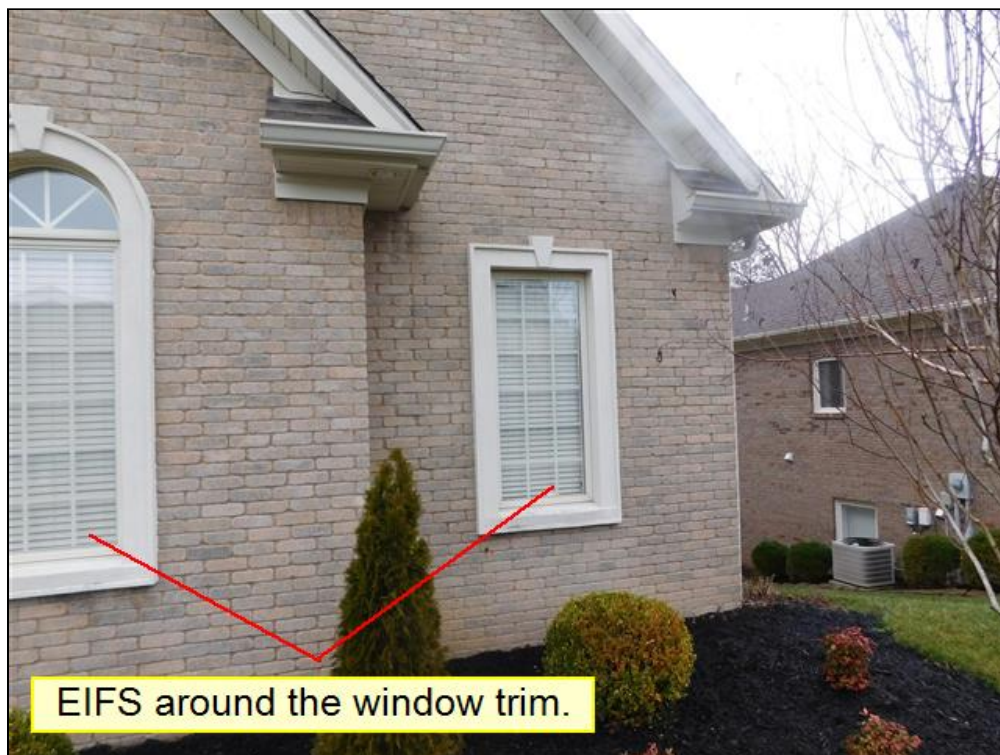
4.1 Item 1(Picture)

4.1 The windows are trimmed out in what looks to be synthetic stucco or Exterior Insulation and Finish System (EIFS). This material is known for having moisture intrusion issues if its not installed to the manufacture guidelines. It also requires special training to perform inspections on the material and is beyond the scope of a general home inspection. However, you can see the black staining across the windows in several spots (this usually means elevated moisture). I scanned several areas with a moisture meter and they did show elevated. You'll want to reach out to a EIFS certified inspector about the window trim and getting them checked out. If water is getting trapped behind EIFS it can cause lots of problems with rot and such.

EIFS around the window trim.

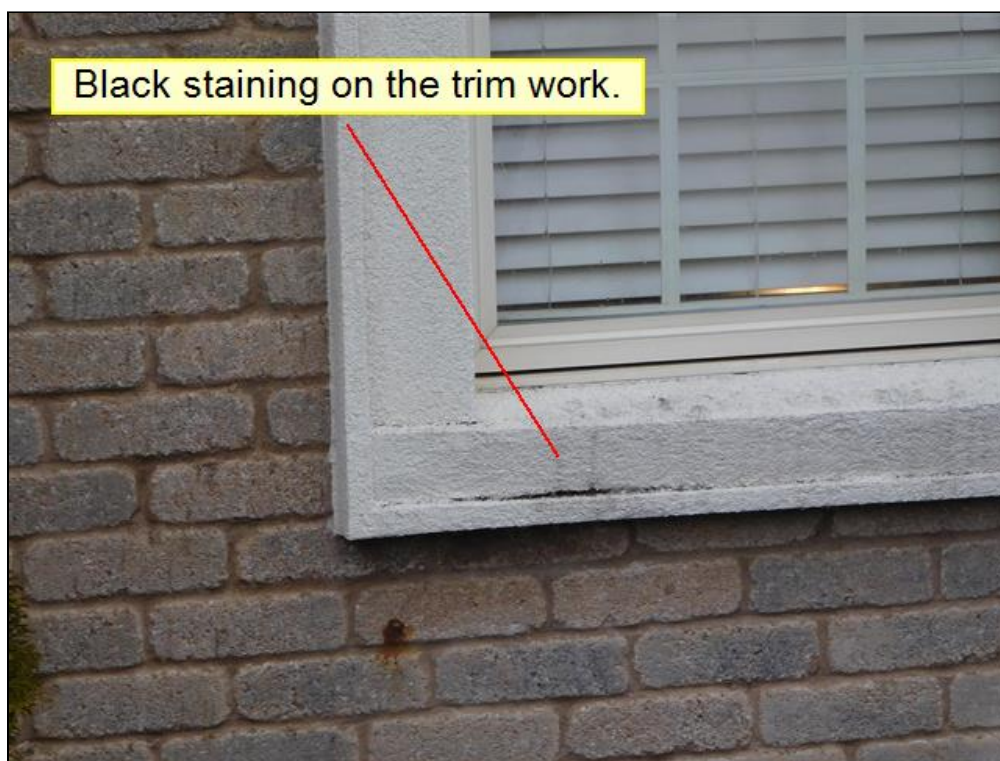
4.1 Item 2(Picture)

Black staining on the trim work.
