Home Inspection Report

Property Address:
198 Dream Home Blvd
Louisville KY 40245

ABI Home Inspection Service, LLC

Date: 3/10/2016	Time:	Report ID:
Property: 198 Dream Home Blvd Louisville KY 40245	Customer: Joe Smith	Real Estate Professional:

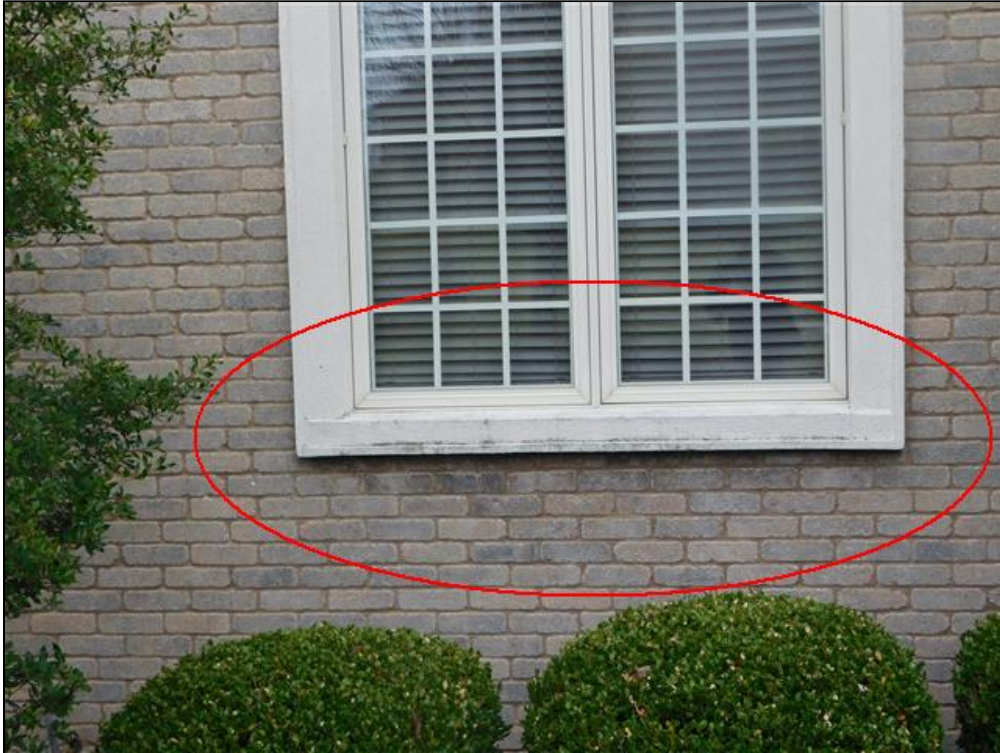
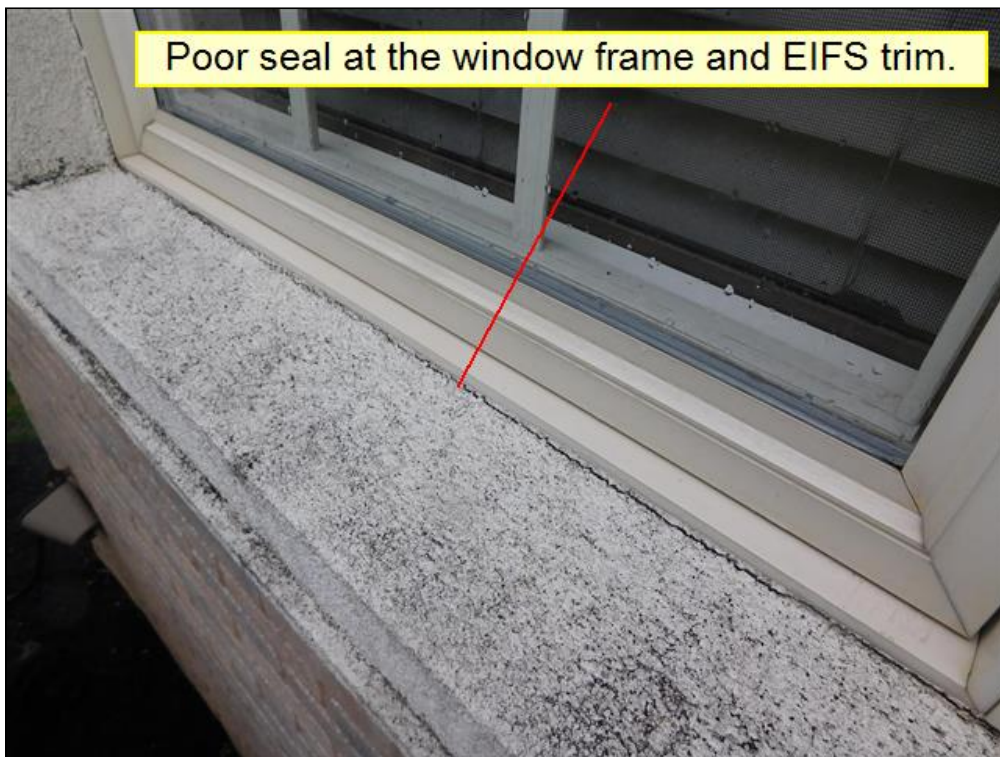
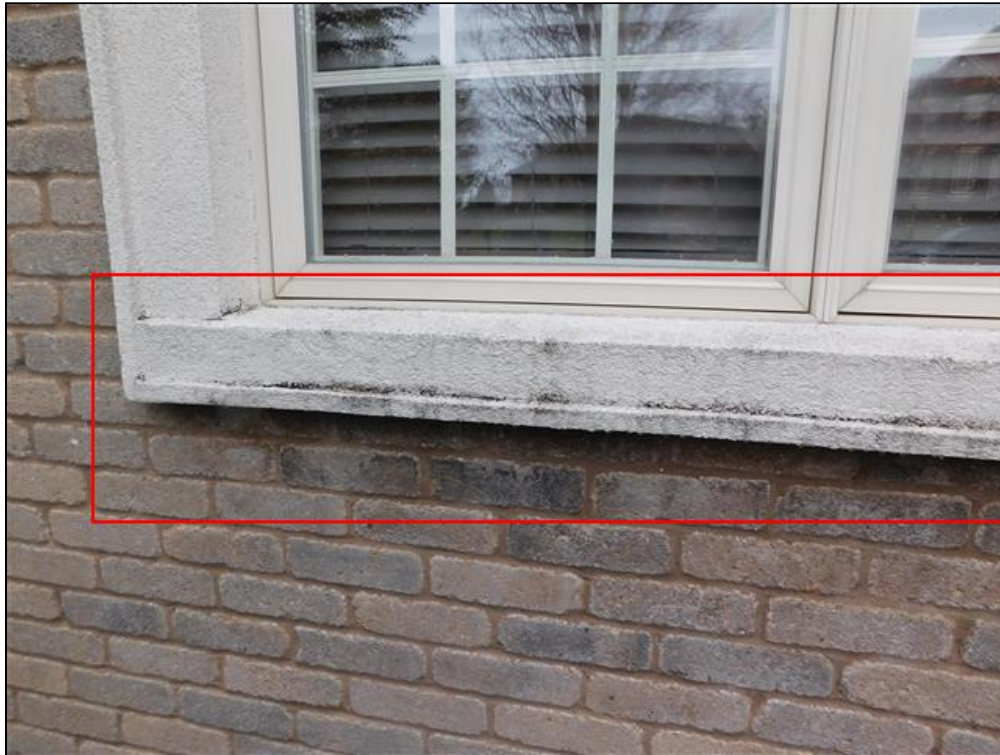
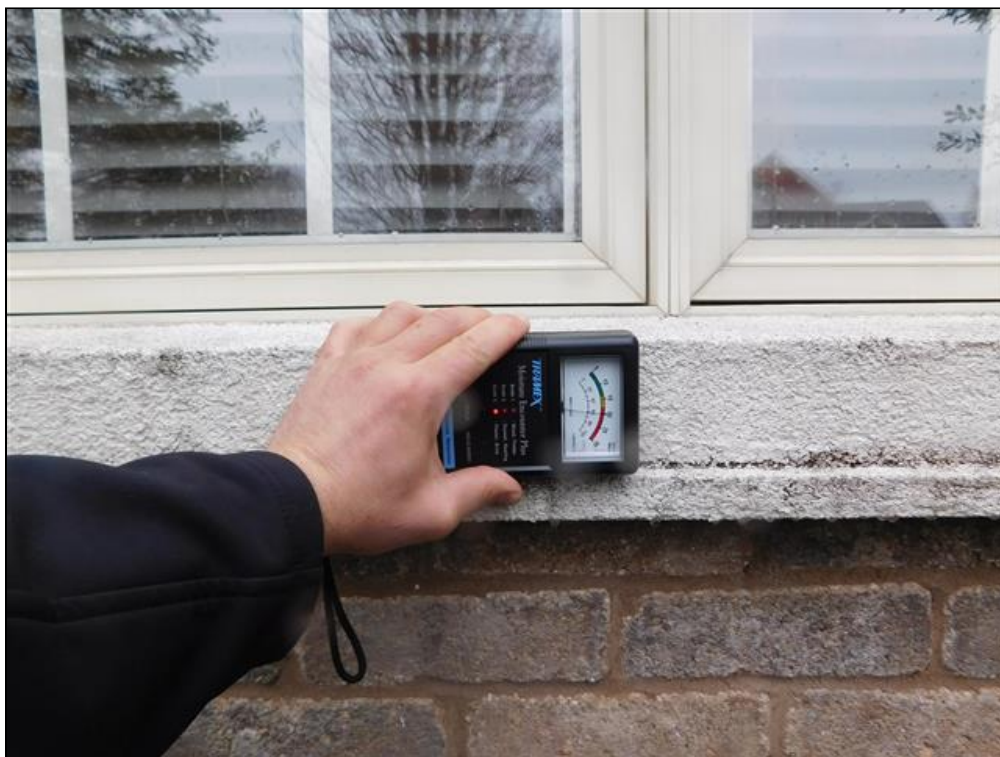
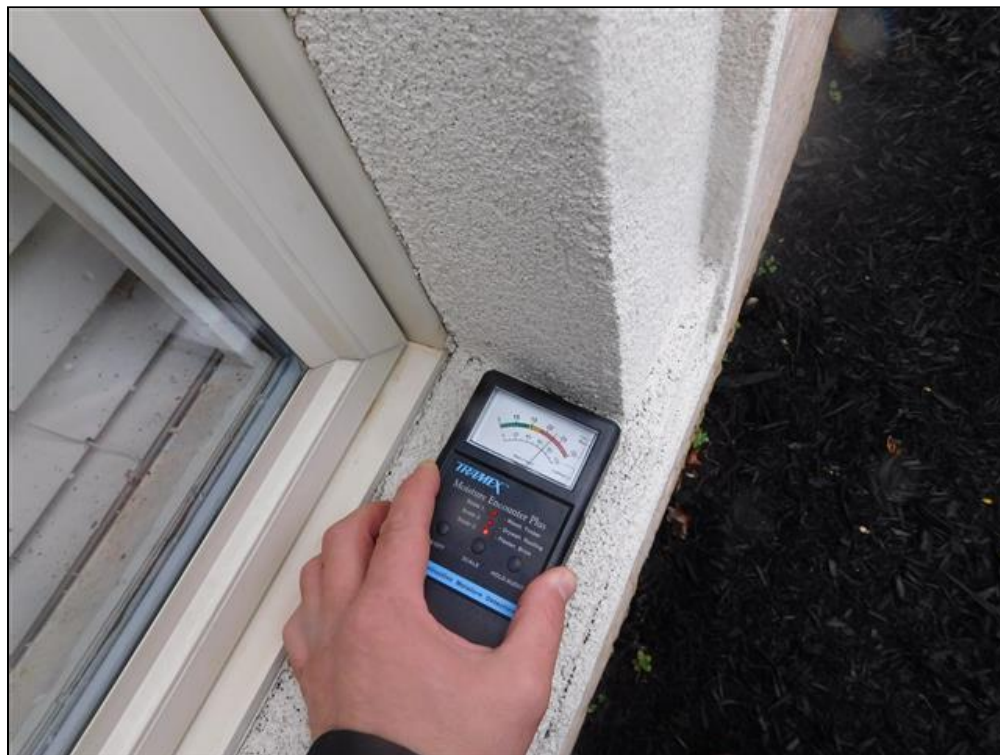
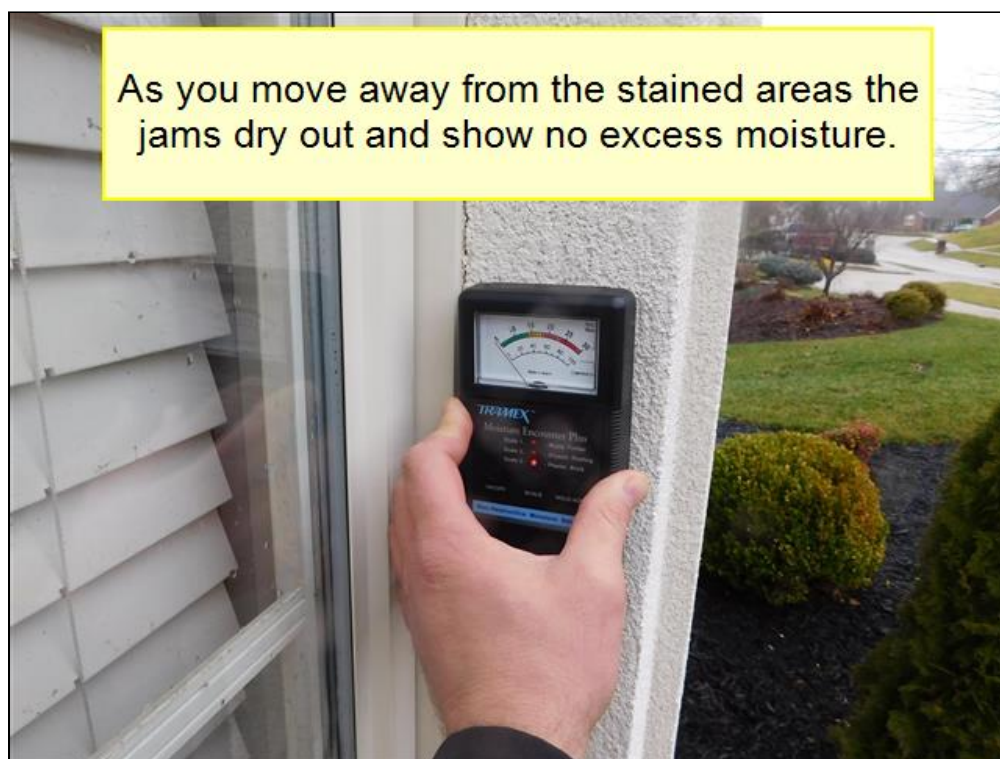
4.1 The windows are trimmed out in what looks to be synthetic stucco or Exterior Insulation and Finish System (EIFS). This material is known for having moisture intrusion issues if its not installed to the manufacture guidelines. It also requires special training to perform inspections on the material and is beyond the scope of a general home inspection. However, you can see the black staining across the windows in several spots (this usually means elevated moisture). I scanned several areas with a moisture meter and they did show elevated. You'll want to reach out to a EIFS certified inspector about the window trim and getting them checked out. If water is getting trapped behind EIFS it can cause lots of problems with rot and such.

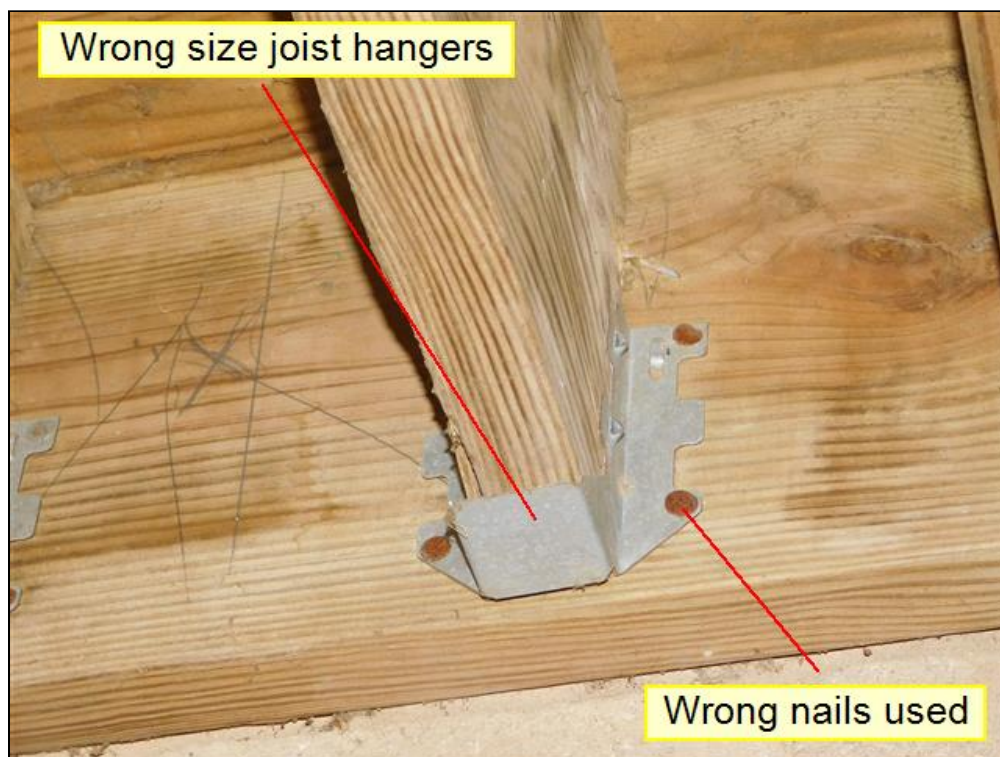
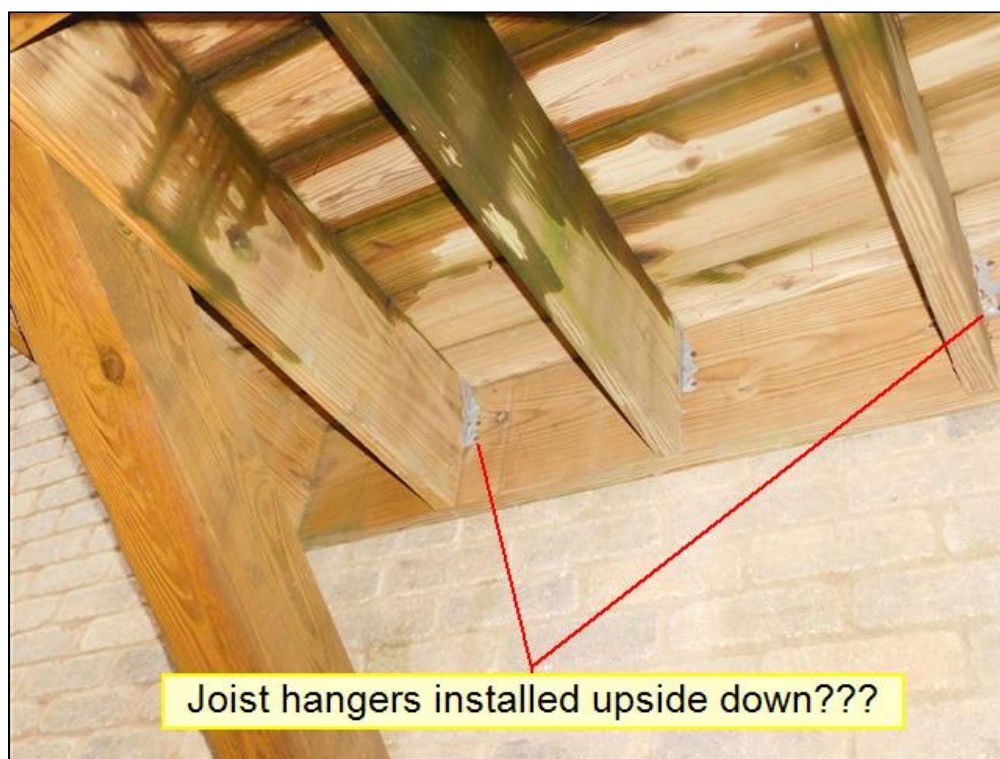
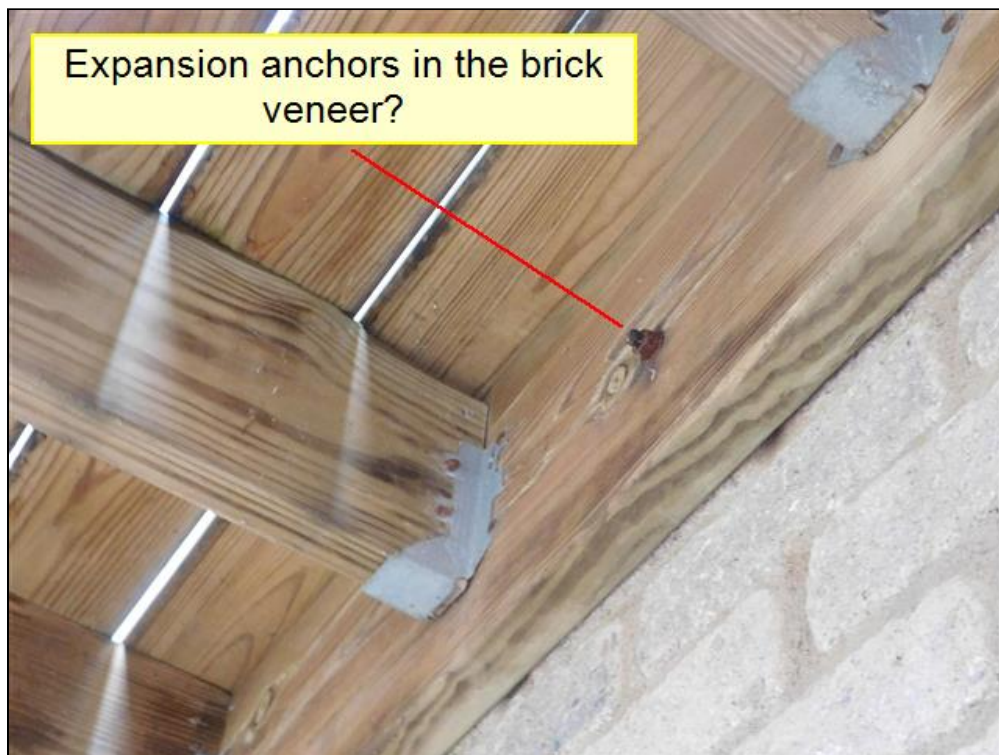
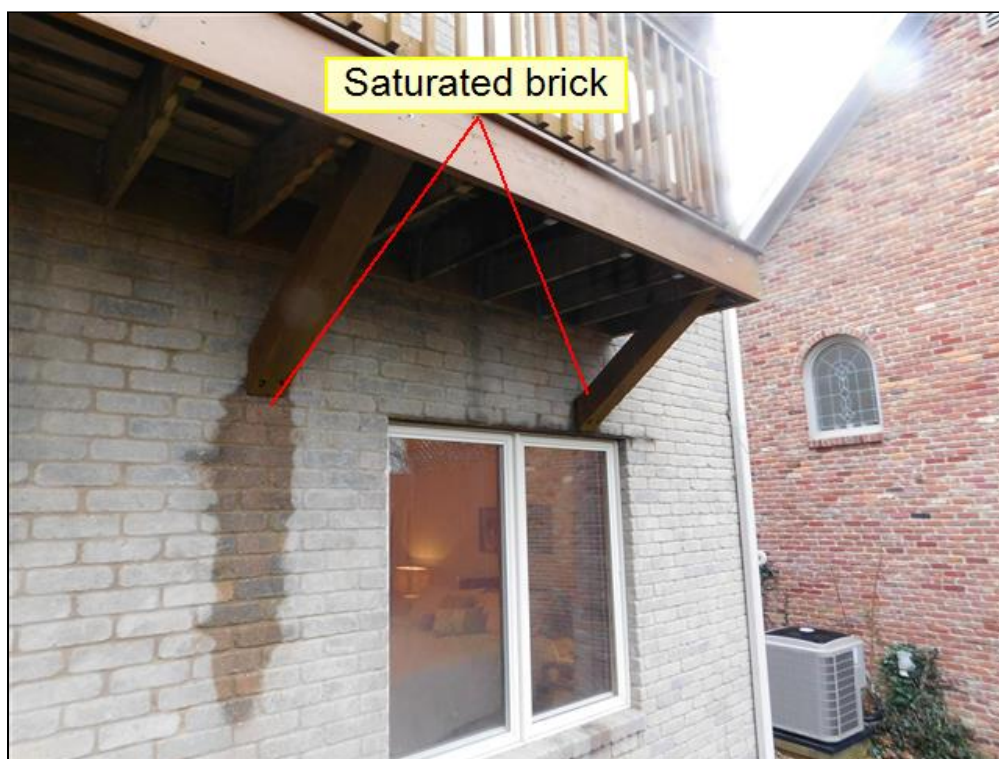
4.3 The deck has several issues that need to be addressed. You'll want to have a qualified deck contractor come out and evaluate and repair the deck as they see fit. Also, the deck is mounted and bolted to the brick in several spots. If the brick veneer were to fail on the home (see section 4.0) , the deck could come down as well. This is not something to take lightly.

-The right side balcony is showing bad moisture staining on the brick wall above the window. The bolts that are anchoring the supports appear to leaking back into the brick wall and allowing the veneer to become saturated. *This could cause rot to the framing if enough water gets behind the brick.*

-*None of the post and beam connections are bolted together. You want the structural connections to be bolted, not just nailed.*

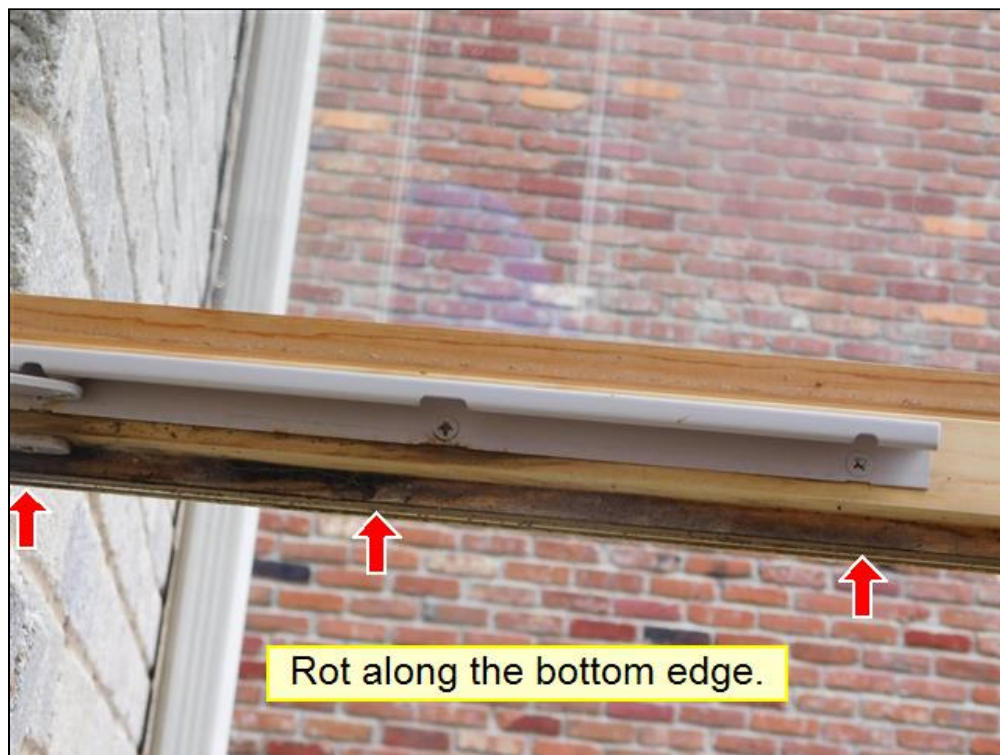
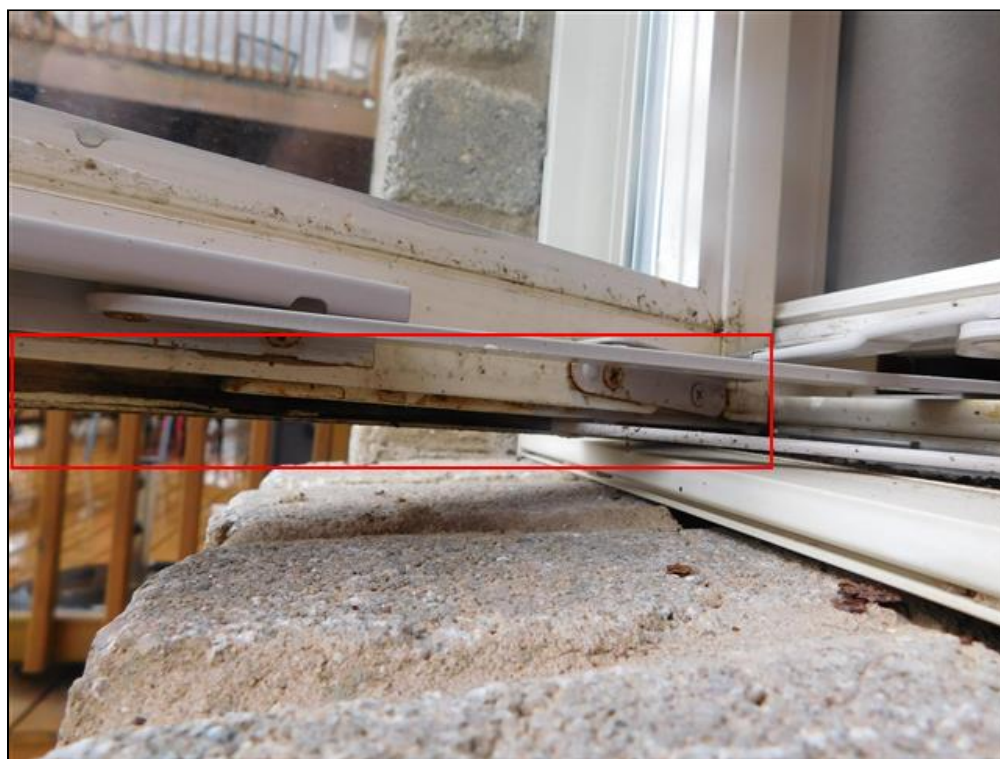
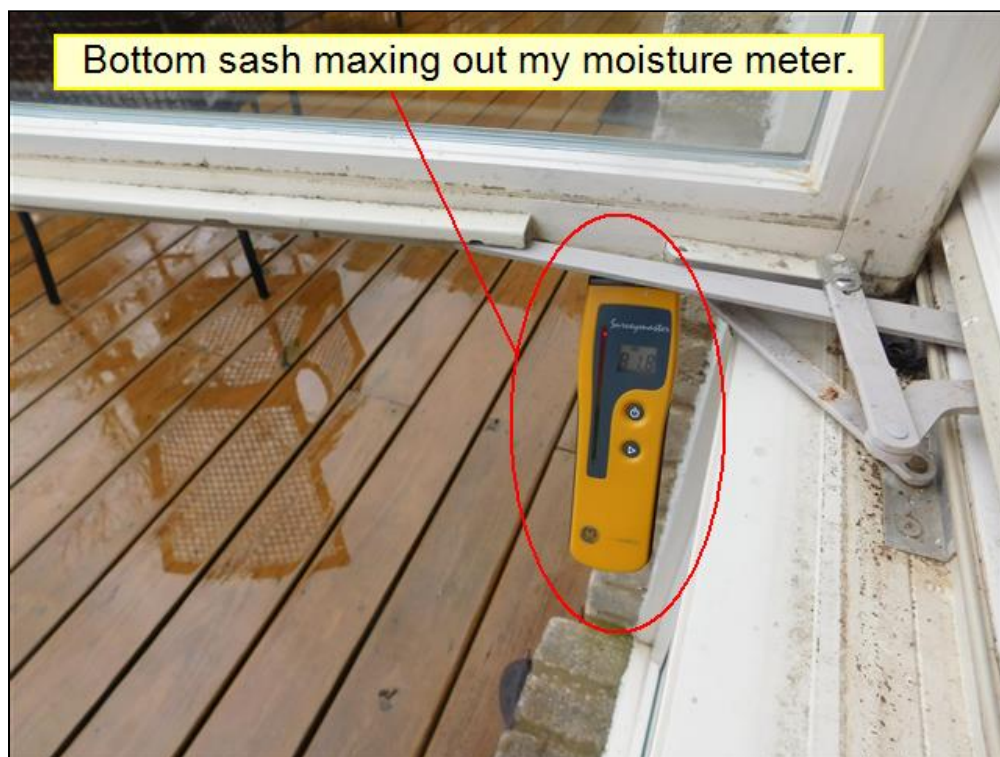
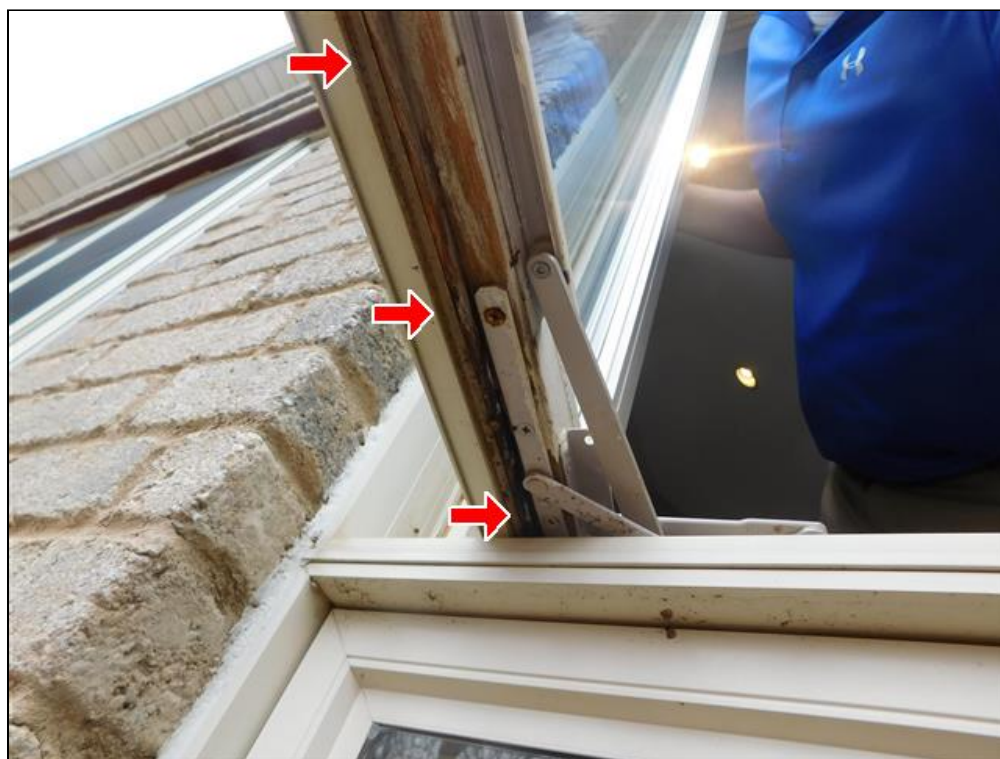
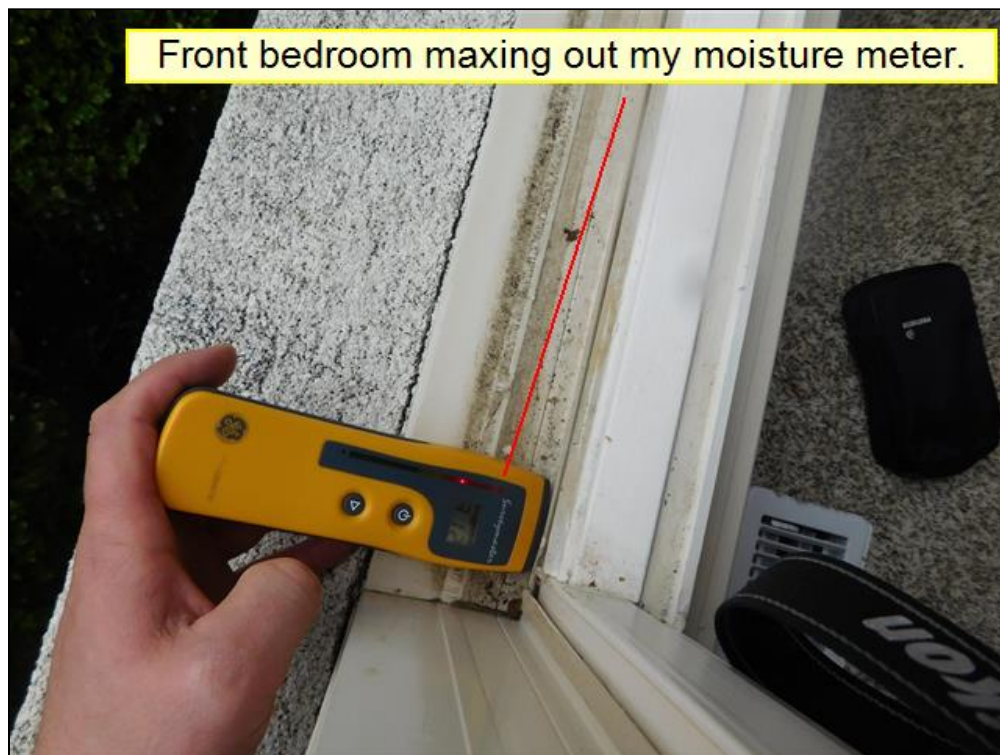
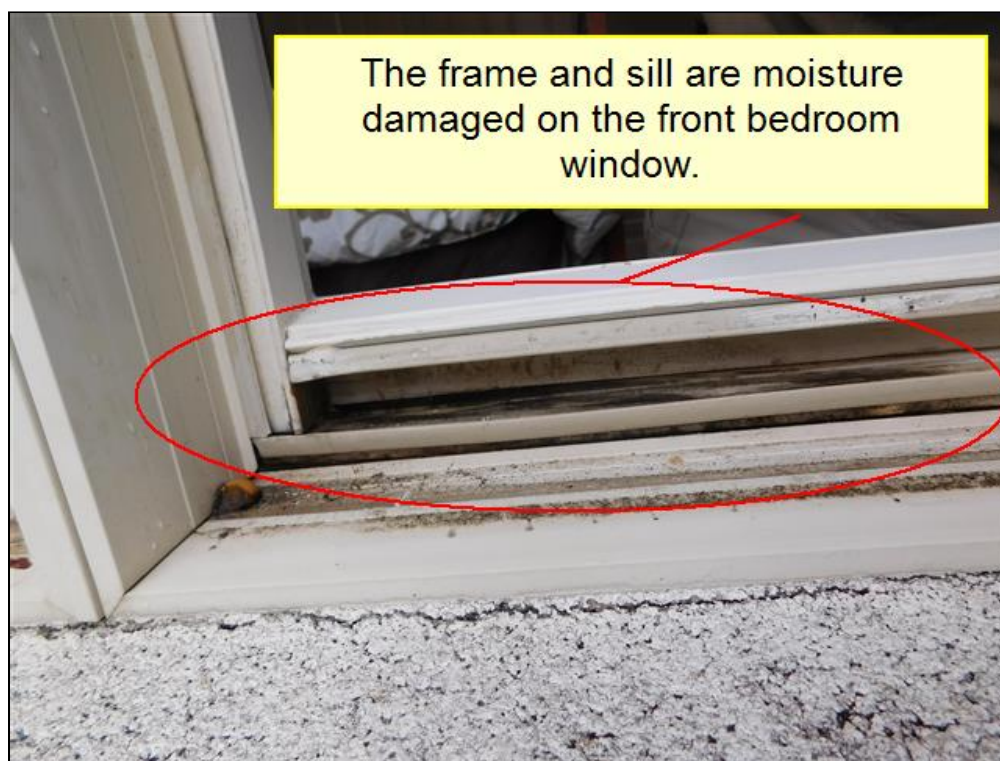
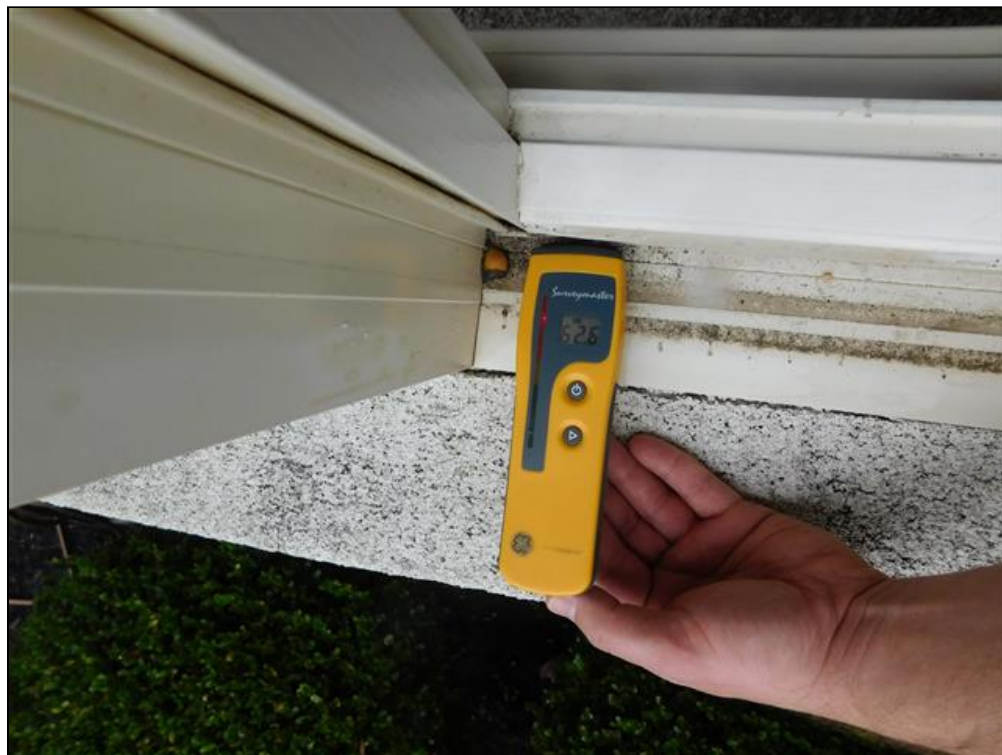
6.6 (1) Several of the crank-out windows in the home are moisture damaged. Some of the damage is on the window sashes themselves, and some is on the jam/sill of the frame. You'll want to speak with a window contractor about repair vs replacement and weight your options.

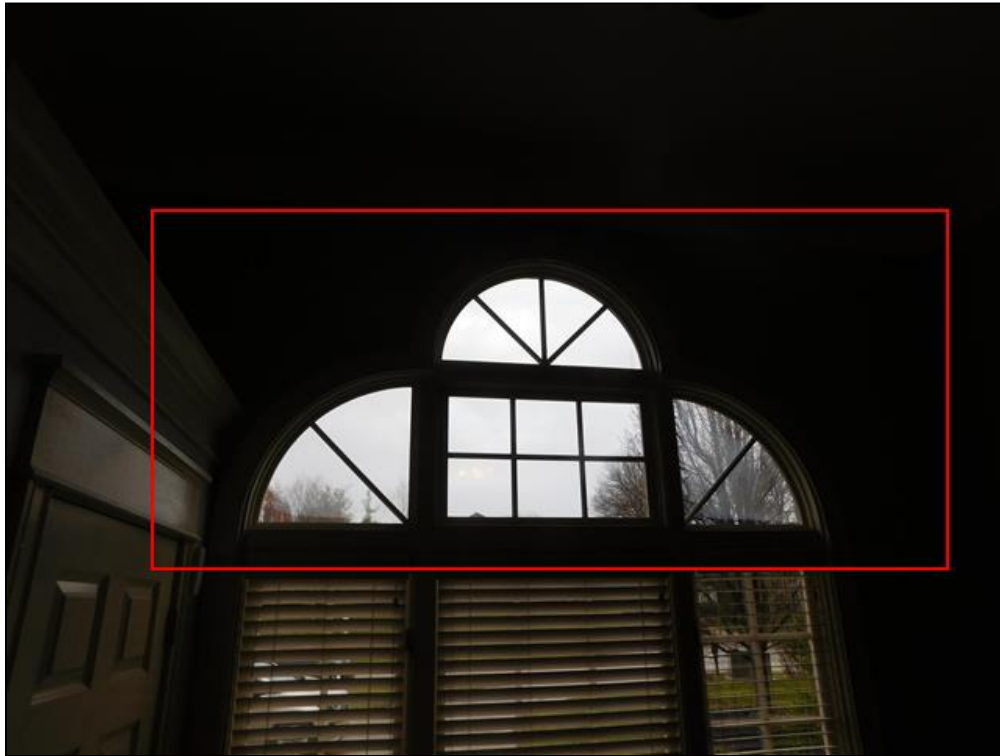
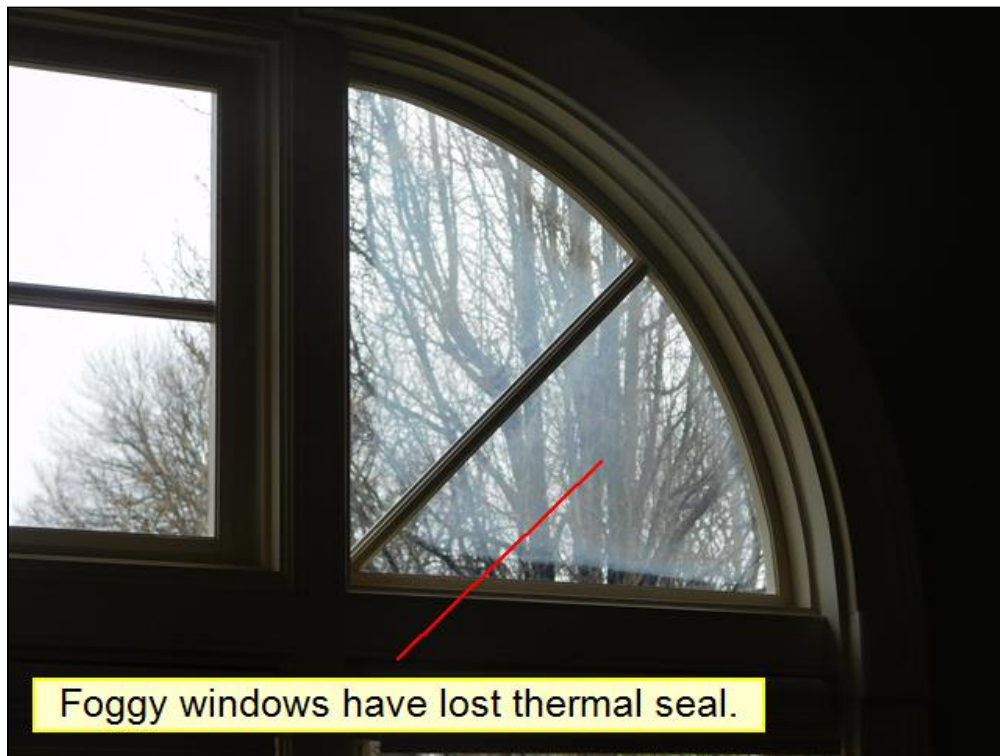
6.6 (2) The upper windows (semi-circles) have moisture in between the glass panes from a failed seal. Once the seals develop a leak between the glass panes they will collect moisture & dirt in between the panes of glass. There is not much that can be done about this besides replacing the the window sash.-FYI

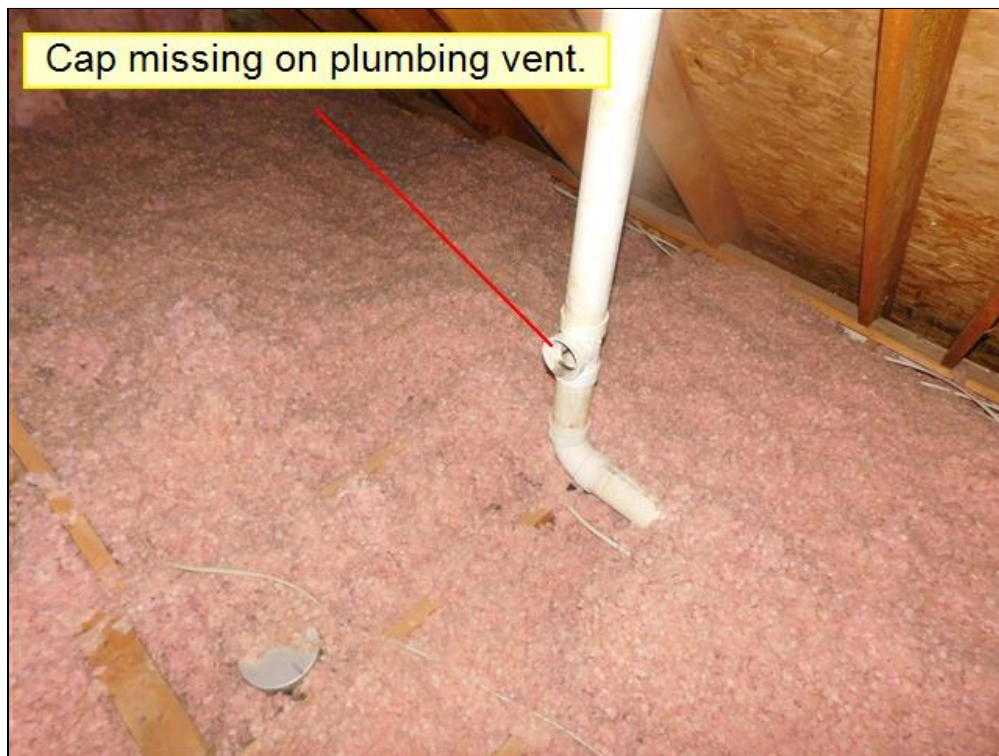
8.0 Item 1(Picture)

8.0 There is a plumbing vent in the attic missing the cap on the tee that is allowing a bit of water to leak in. Have a cap screwed into the hole to plug things up.

12. There is a plumbing vent in the attic missing the cap on the tee that is allowing a bit of water to leak in. Have a cap screwed into the hole to plug things up.

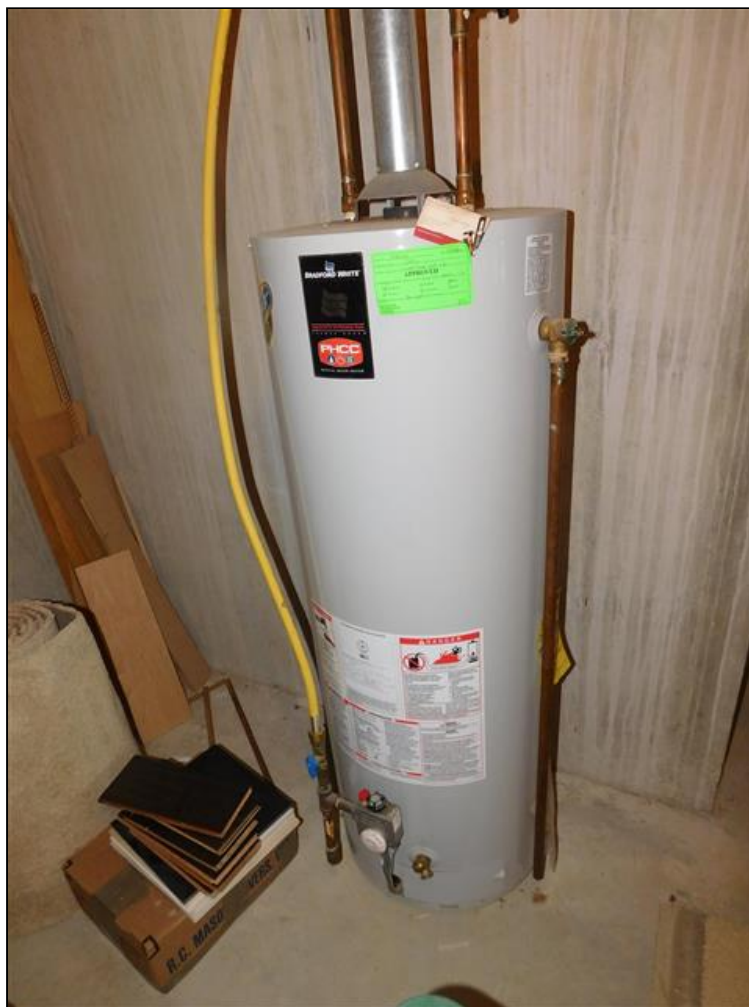
8.2 Item 1(Picture)

8.2 The water heater is older. The NAHB (National Association of Home Builders) case study says the average life expectancy of a gas or electric water heater is "about 10 years". Because of the age of the unit, you'll want to have it replaced sooner rather than later. Lots of water last longer than 10yrs, but flooding and failure is a risk you take the longer you leave it in place. The last thing you want is to come home to a failed tank on your water heater that has flooded your home. You can get the NAHB guide here: <http://abihomeservices.com/download/NAHB-Lifetimes.pdf>

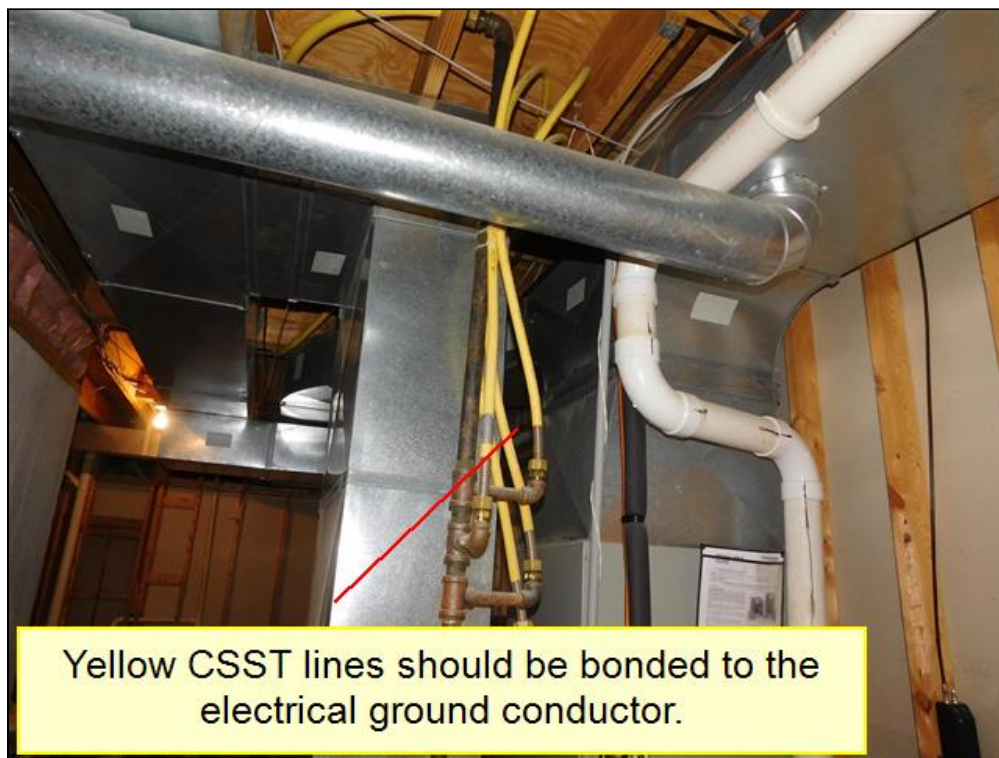
8.5 Item 1(Picture)

8.5 The flexible gas line is a product known as CSST (Corrugated Stainless Steel Tubing). CSST has had problems in the past on homes that were struck by lightning. The thin flexible wall of the product is not strong enough to handle the energy of a strike and can rupture because of it. All installations of CSST should be properly bonded to the home's electrical ground system to help supply a path for the energy to go in case of an incident. You should contact a electrician who is familiar with CSST and knows how to properly correct the install for your own safety. Keep in mind the bonding DOES NOT guarantee an accident proof installation.

Yellow CSST lines should be bonded to the electrical ground conductor.

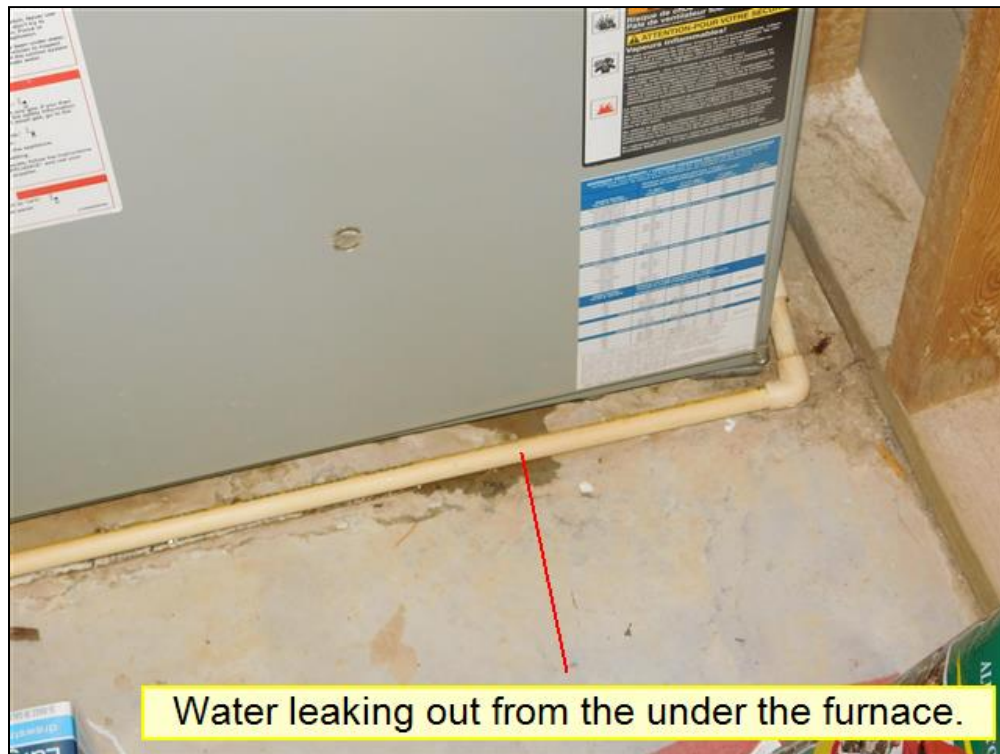
10.1 Item 1(Picture)

10.1 (1) There is water leaking out from the base of the furnace (likely from the condensate line). I wasn't able to find the source of the water, but you'll want to have a hvac tech take a look and repair as needed.

Water leaking out from the under the furnace.

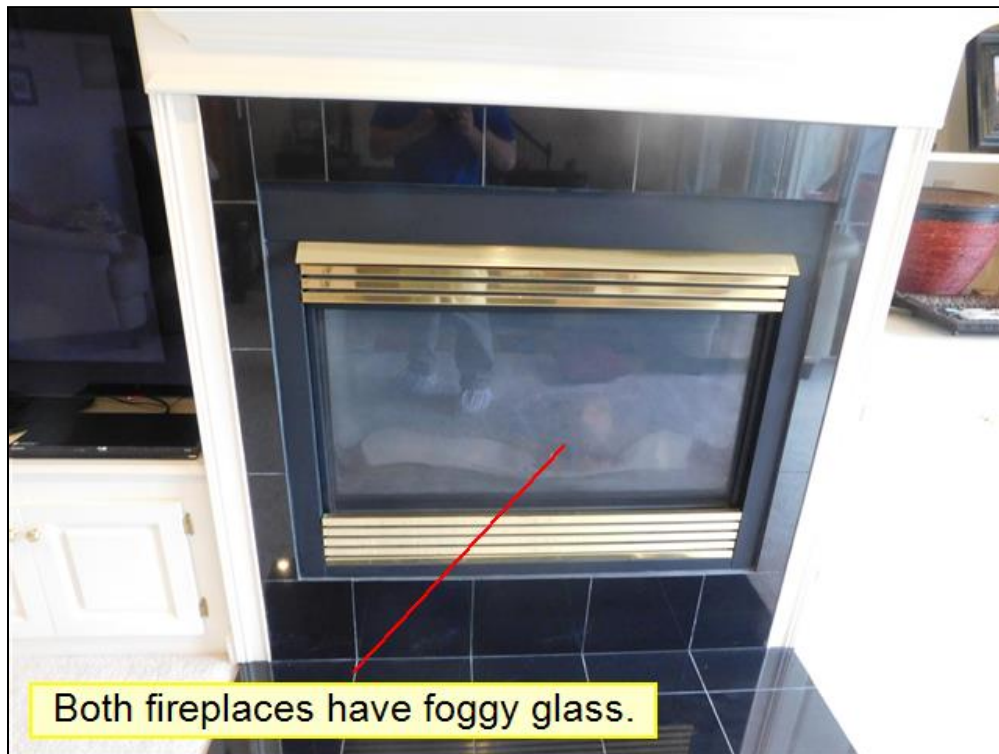
10.6 Item 1(Picture)

10.6 (1) The fireplace's glass door is discolored and hazed over (both basement and bedroom). You may be able to have the unit cleaned, but keep in the back of your mind if it won't come clean, a replacement door will be necessary.

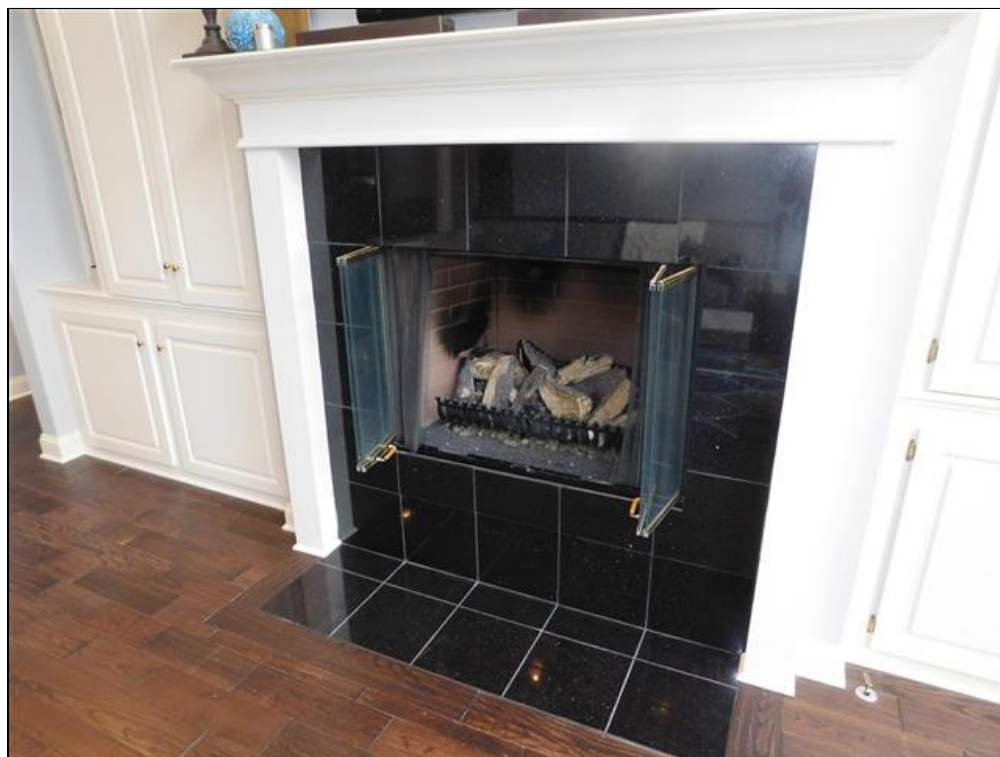
10.6 Item 2(Picture)

10.6 (2) The NFPA (National Fire Protection Agency) highly recommends an annual inspection of all fireplaces, chimneys, gas appliances and vents. They also recommend that an inspection take place upon the transfer of a property, the replacement of an appliance, an operating malfunction, or following an external event (such as an earthquake) likely to have caused damage. Our inspection of the fireplace and chimney pipe is limited to the readily visible areas and components, and a visual inspection such as that provided by your inspector is not adequate to discover hidden deficiencies or damage should they exist. A NFPA 211 Standard, Level II inspection, which includes cleaning the interior of the chimney pipe and the use of specialized tools and testing procedures, such as video cameras, etc., is needed to thoroughly evaluate the fireplace system. If one has not been performed over the past 12 months, such an inspection is recommended at this time for your safety.

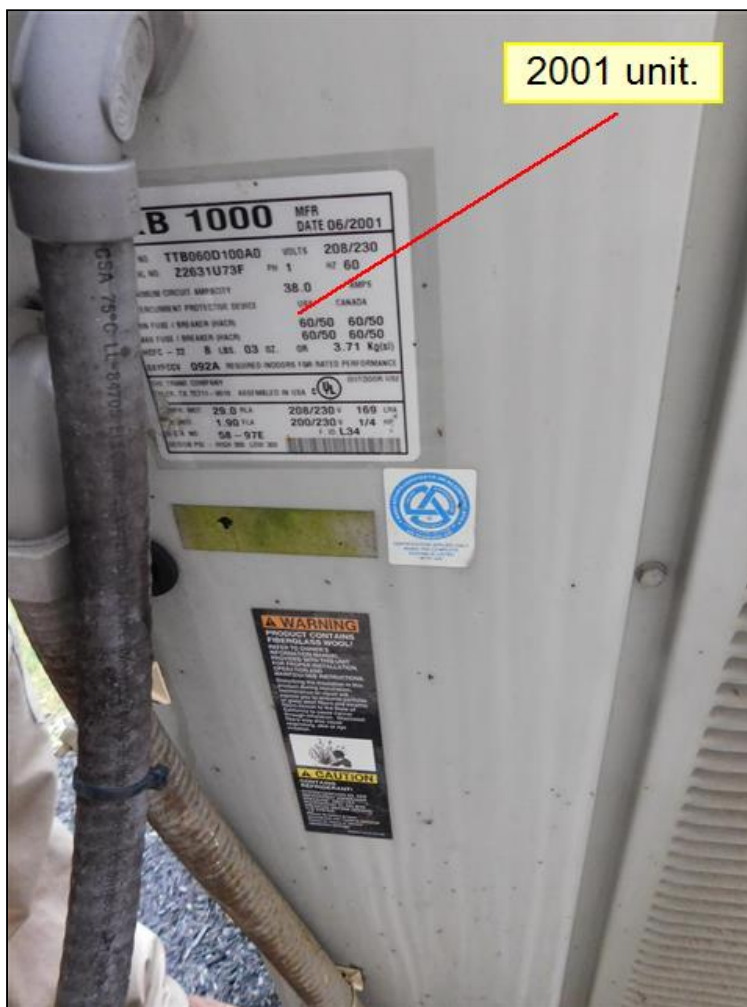
10.7 Item 1(Picture)

10.7 The A/C unit is around 15 yrs old. According to the NAHB (National Association of Home Builders) a typical A/C unit will last around 10-15 yrs. You'll want to keep in mind this unit is at the age where it could fail and will need to be replaced at any moment. -FYI

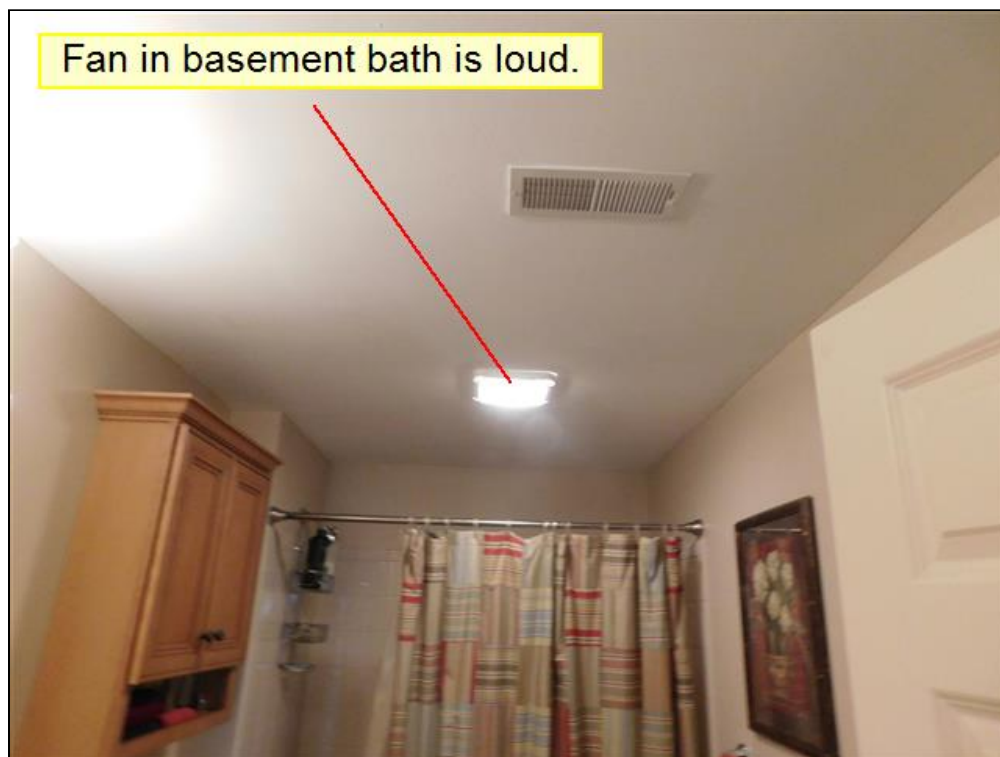
11.2 Item 1(Picture)

11.2 (1) The exhaust fan in the basement bath squeals loudly when ran. Replace the exhaust fan.
