Home Inspection Report

Property Address:
198 Dream Home Blvd
Louisville KY 40245

ABI Home Inspection Service, LLC

Date: 3/10/2016	Time:	Report ID:
Property: 198 Dream Home Blvd Louisville KY 40245	Customer: Joe Smith	Real Estate Professional:

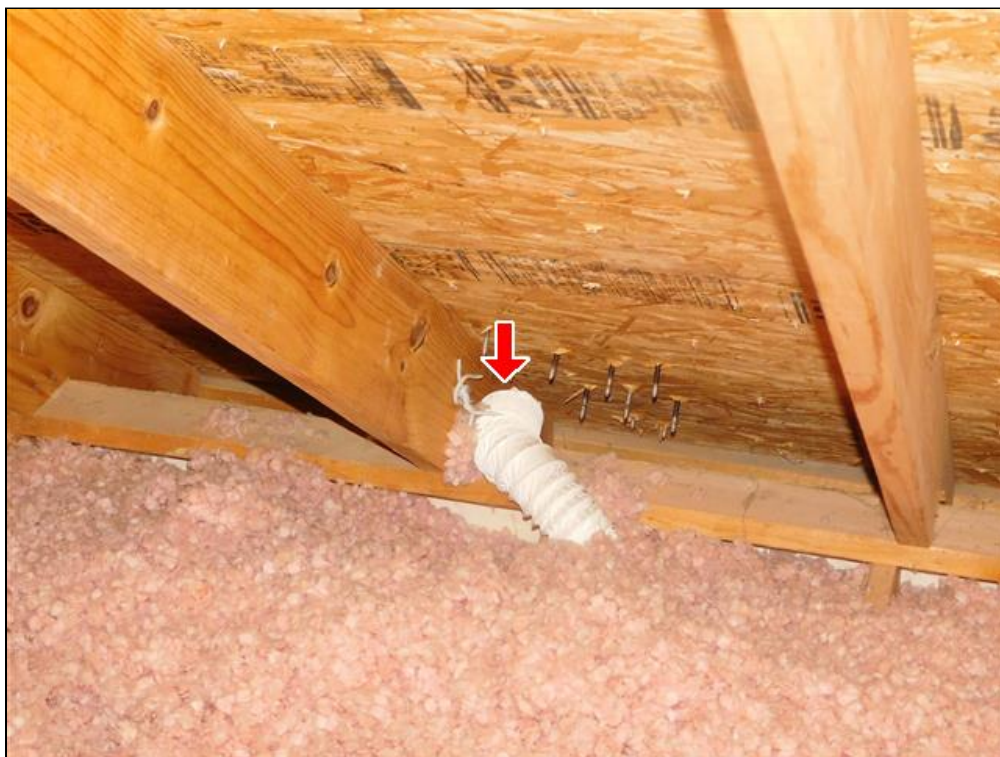
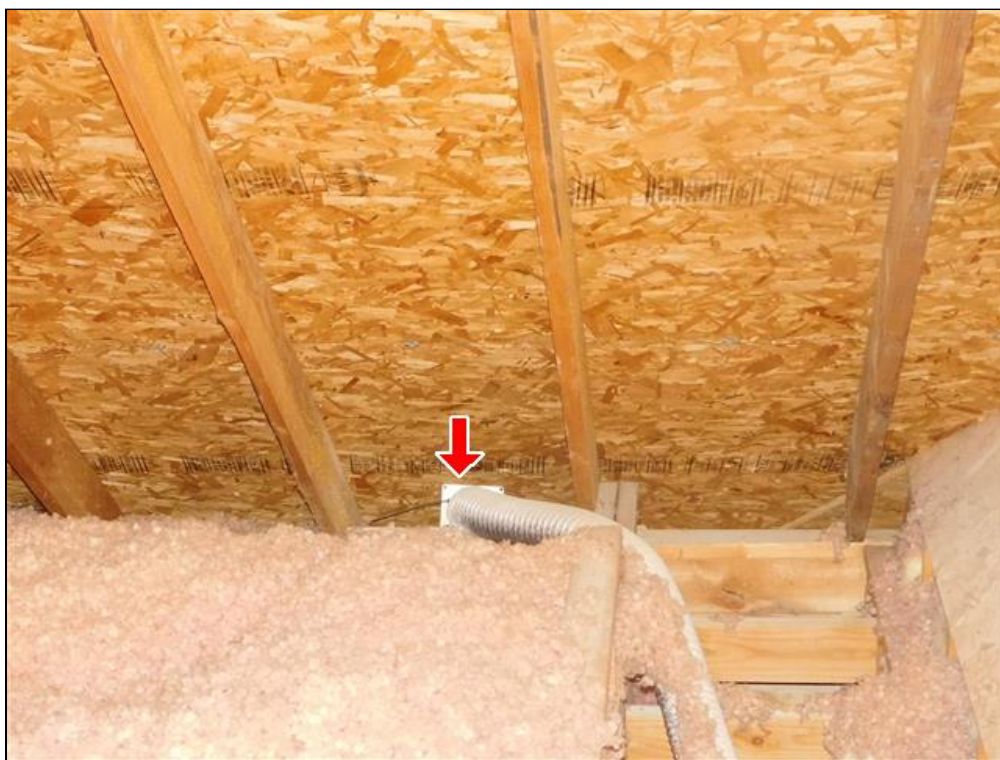
11.2 (2) The bathroom exhaust fans do not vent to the exterior like they should. Bathroom fans can carry out large amounts of moisture, and you do not want this to be left in you attic. Have the fans exhaust routed to the exterior of the home.

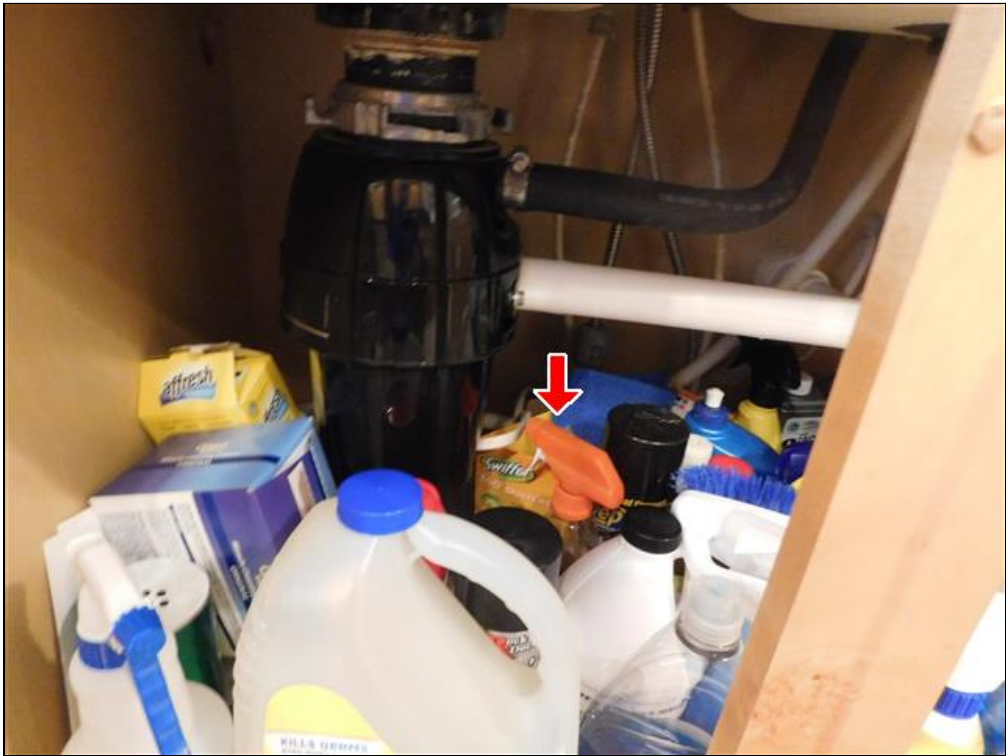
12.3 Item 1(Picture)

12.3 The romex line feeding power to the garbage disposal should be in flexible conduit for safety. You don't want electrical lines exposed where people can grab them.
