Home Inspection Report

Property Address:
123 Anywhere Drive
Louisville KY 40299

ABI Home Services, LLC

Date: 6/15/2015	Time:	Report ID:
Property: 123 Anywhere Drive Louisville KY 40299	Customer: Joe Smith	Real Estate Professional:

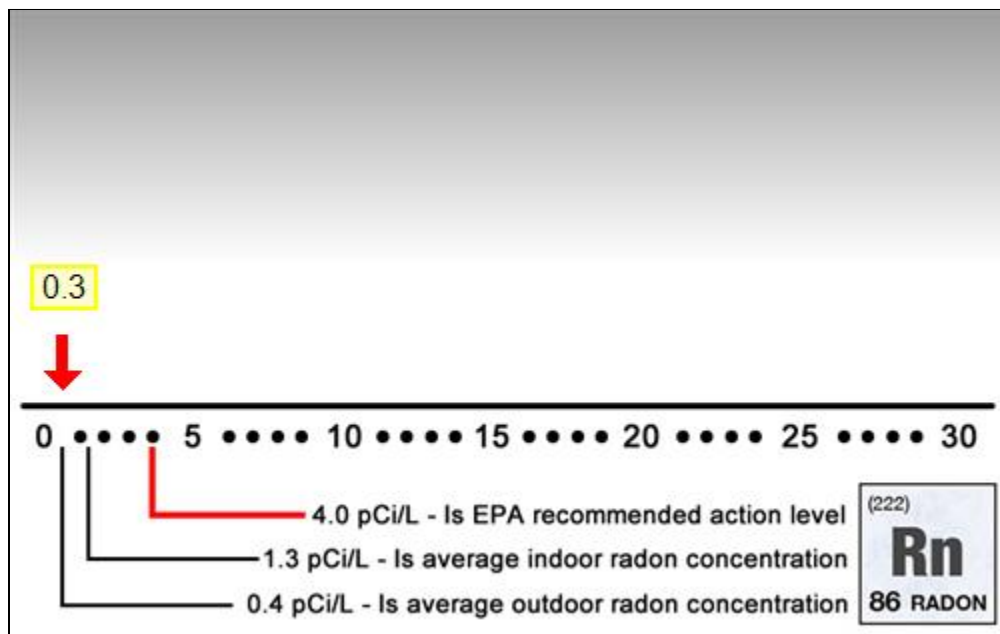
1.0 Item 1(Picture)

1.0 The home was tested for Radon gas using a Sun Nuclear 1027 continuous monitoring system. **The overall average of pCi/l (pico Curies per Liter) was 0.3** The EPA recommends mitigation (removal system) for all homes with a level of 4.0pCi/l or more.

Overall Avg.= 0.4

EPA Protocol Avg.= 0.3

With numbers this low, it's doubtful you'll ever have elevated Radon levels, but if you do large amounts of air sealing and home weatherization, you will seal up the house, and those numbers will rise.-FYI

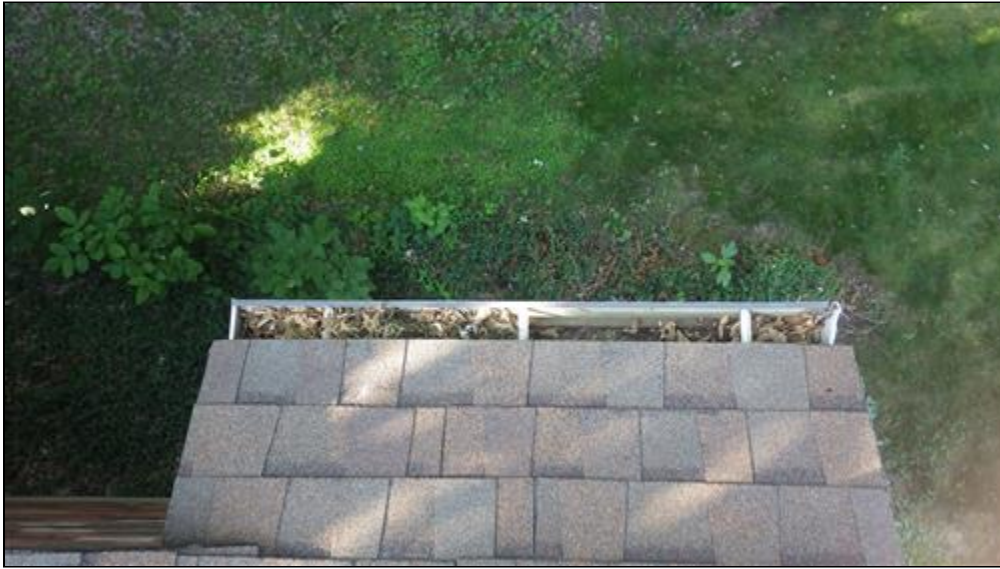
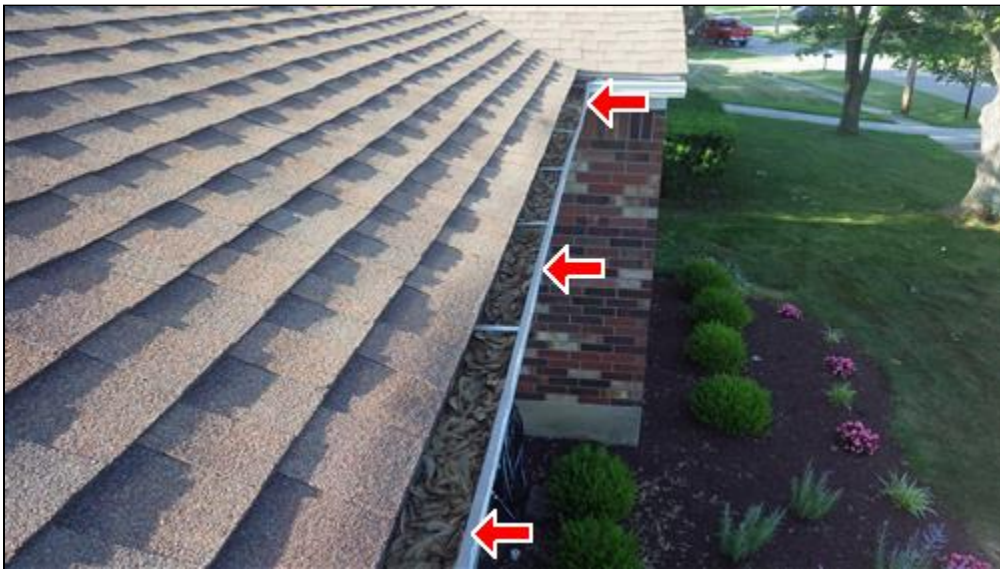
2.2 Item 1(Picture)

2.2 (1) The gutters are full of debris and need to be cleaned out to allow the roof water to flow properly.

1. (1) The gutters are full of debris and need to be cleaned out to allow the roof water to flow properly.
(2) The downspouts around the home need to have extensions added to them. They are discharging water near the
2. homes foundation, which can cause moisture issues around the house. You want to get water away from the foundation at least 5 feet.

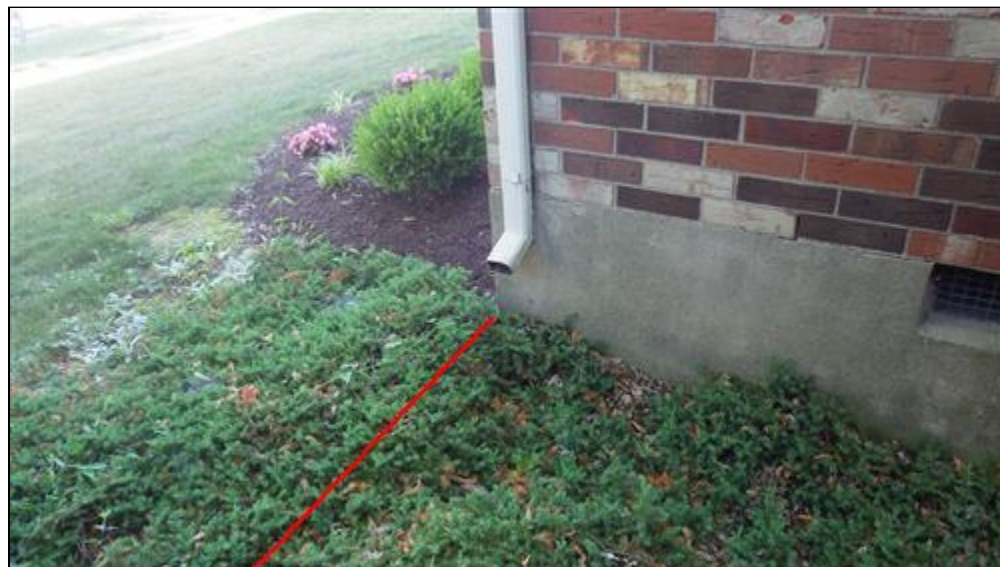
2.2 Item 3(Picture)

2.2 (2) The downspouts around the home need to have extensions added to them. They are discharging water near the homes foundation, which can cause moisture issues around the house. You want to get water away from the foundation at least 5 feet.

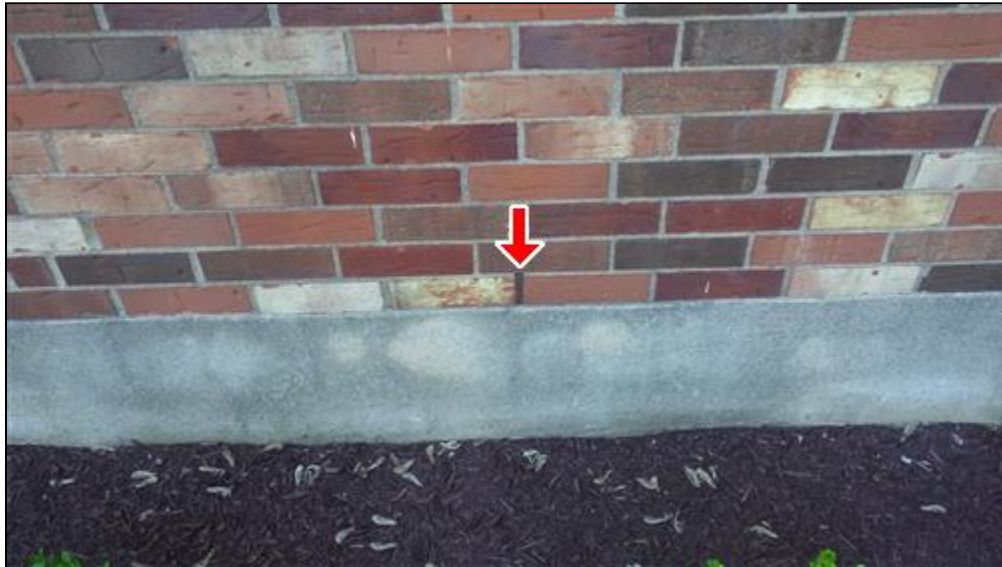
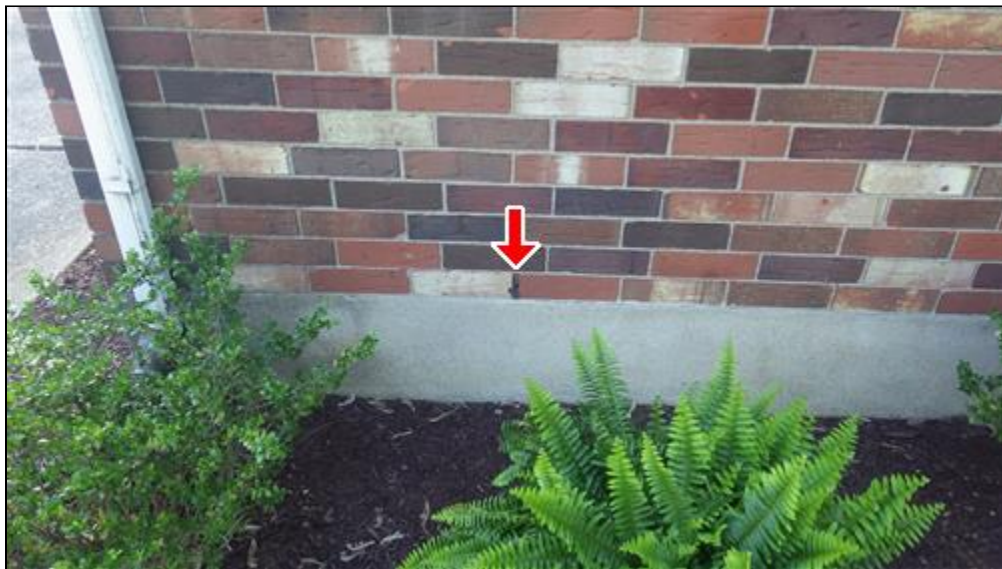
3.0 Item 1(Picture)

3.0 The weep holes on the bottom of the wall have been filled with silicone. These should be left open to allow moisture a path to escape, and fresh air a way to get in the wall. Have the caulk removed from all the weeps around the house.

3. The weep holes on the bottom of the wall have been filled with silicone. These should be left open to allow moisture a path to escape, and fresh air a way to get in the wall. Have the caulk removed from all the weeps around the house.

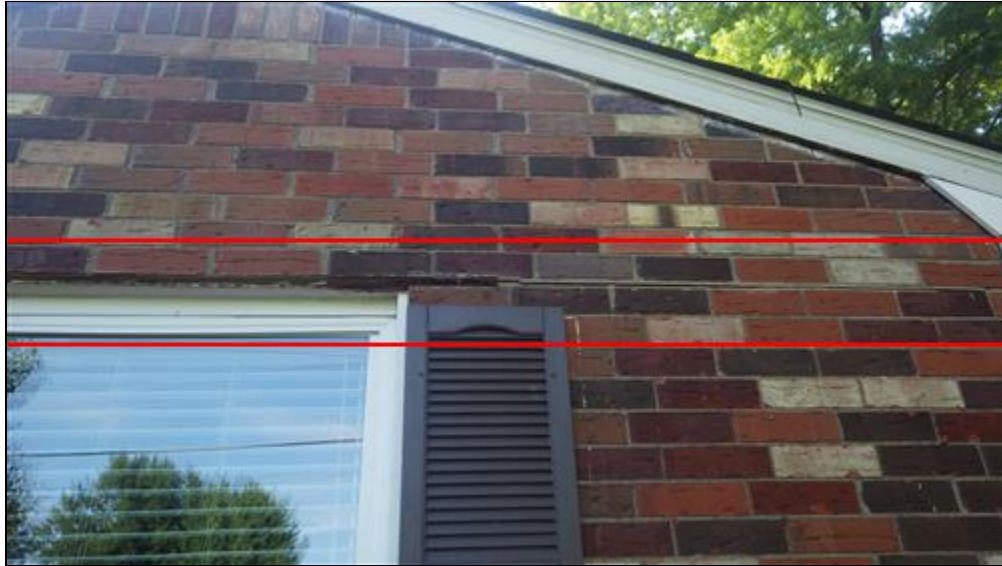
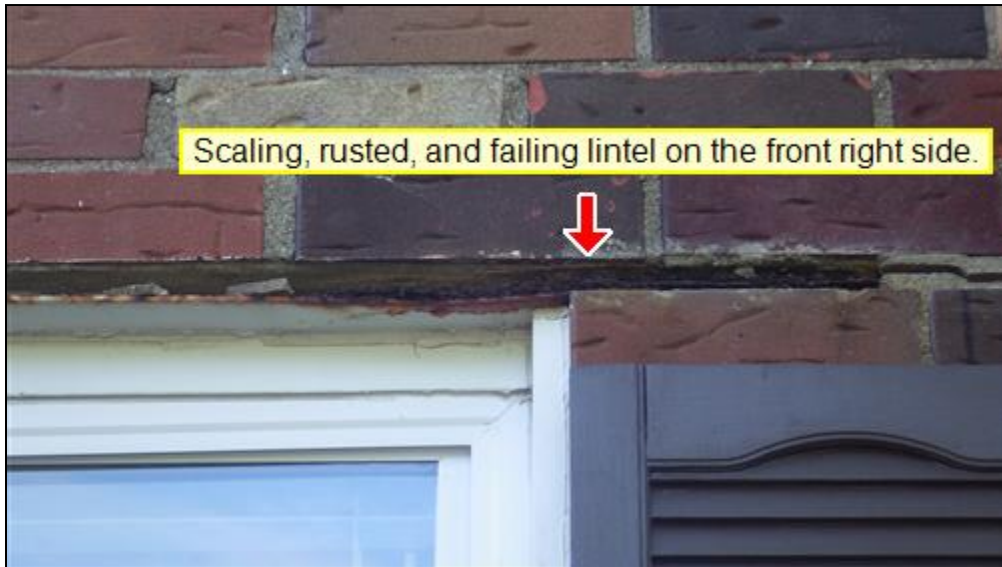
3.1 Item 1(Picture)

3.1 The brick lintel on the front of the house has failed and needs to be replaced. The rusting of the steel lintel (which is the steel support that holds the bricks above it in the air) is far beyond most for this age of a house. Have a brick mason replace the lintel and install the proper drainage and flashing around this point so it doesn't happen again.

4. The brick lintel on the front of the house has failed and needs to be replaced. The rusting of the steel lintel (which is the steel support that holds the bricks above it in the air) is far beyond most for this age of a house. Have a brick mason replace the lintel and install the proper drainage and flashing around this point so it doesn't happen again.

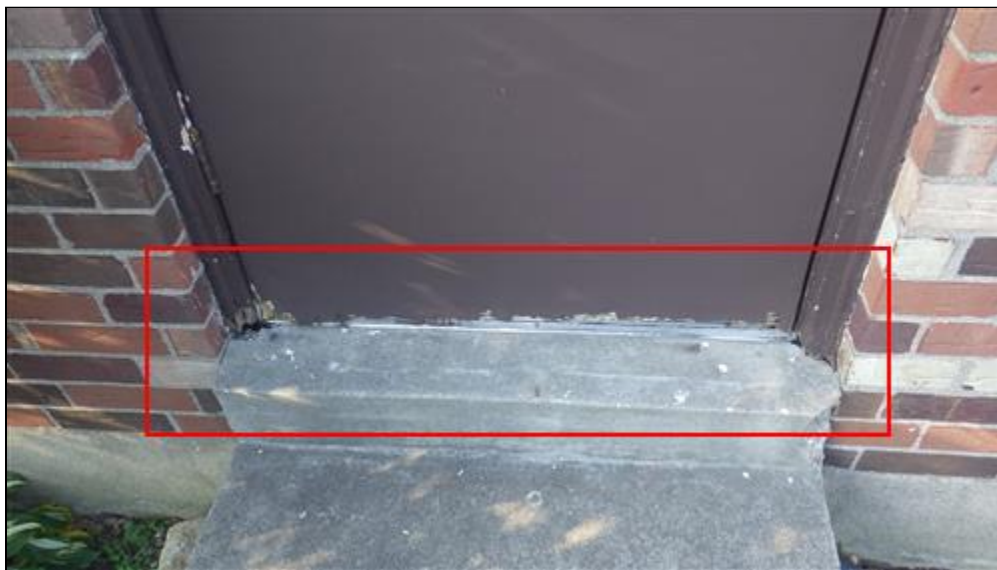
3.2 Item 1(Picture)

3.2 The side door to the storage area is rotten along the bottom and needs to be repaired/replaced.

5. The side door to the storage area is rotten along the bottom and needs to be repaired/replaced.

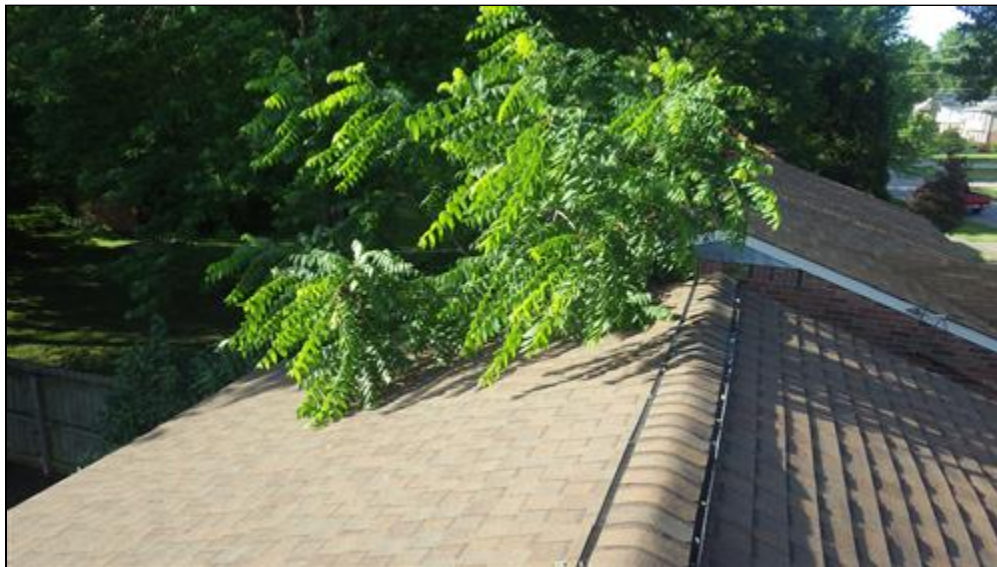
3.4 Item 1(Picture)

3.4 There is a tree growing on the roof. Cut it back/down so it does not touch the house. Vegetation touching the home will damage it over time.

6. There is a tree growing on the roof. Cut it back/down so it does not touch the house. Vegetation touching the home will damage it over time.

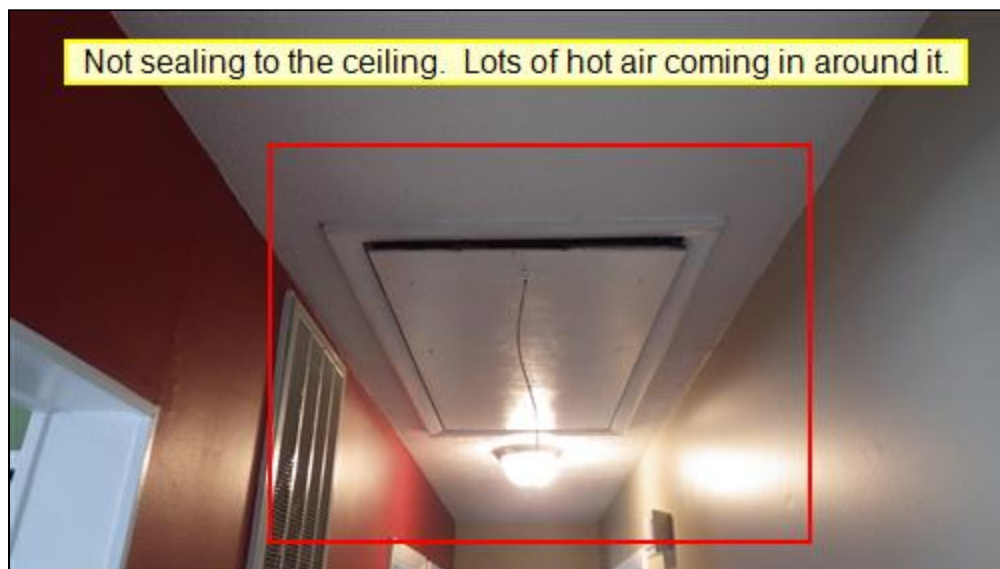
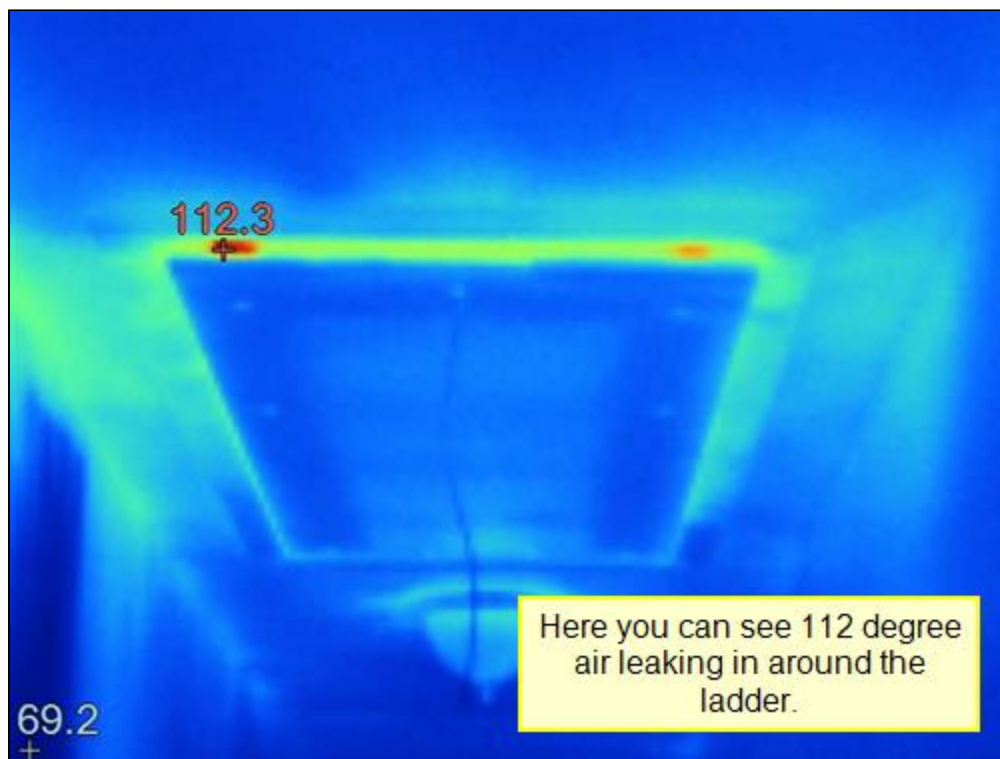
4.3 Item 1(Picture)

4.3 The attic ladder is not sealing to the ceiling in the hallway. This will allow lots of hot attic air to leak into the living space. You'll need to air seal the attic and insulate around the opening. You can see the temperature difference via thermal imaging. At 11am this morning I had 112 degree air coming into the hallway.

8. The attic ladder is not sealing to the ceiling in the hallway. This will allow lots of hot attic air to leak into the living space. You'll need to air seal the attic and insulate around the opening. You can see the temperature difference via thermal imaging. At 11am this morning I had 112 degree air coming into the hallway.

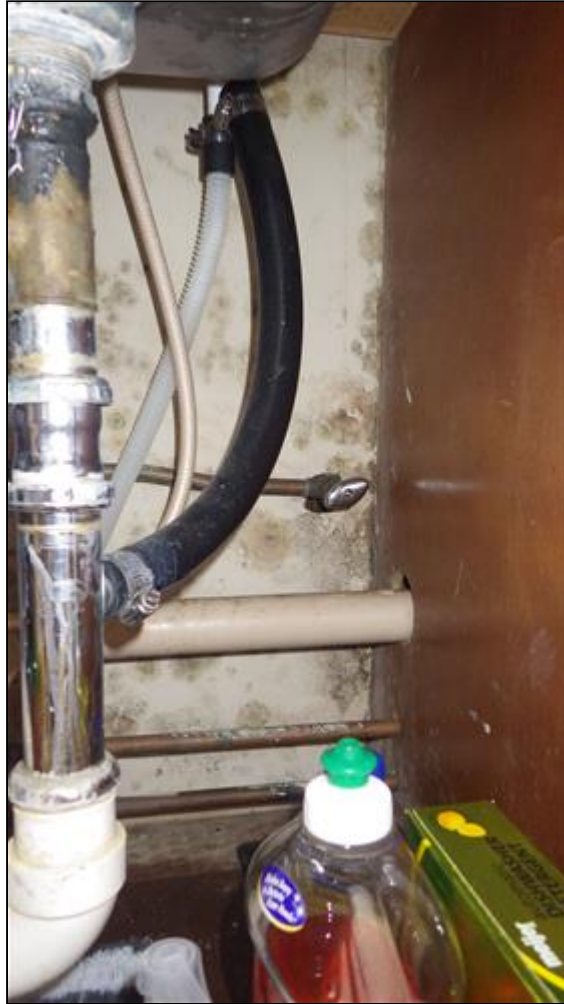
4.4 Item 1(Picture)

4.4 The back wall of the kitchen sink cabinet has some kind of mold growth on it. You'll want to have the damaged drywall removed and area repaired by a qualified contractor.

9. The back wall of the kitchen sink cabinet has some kind of mold growth on it. You'll want to have the damaged drywall removed and area repaired by a qualified contractor.

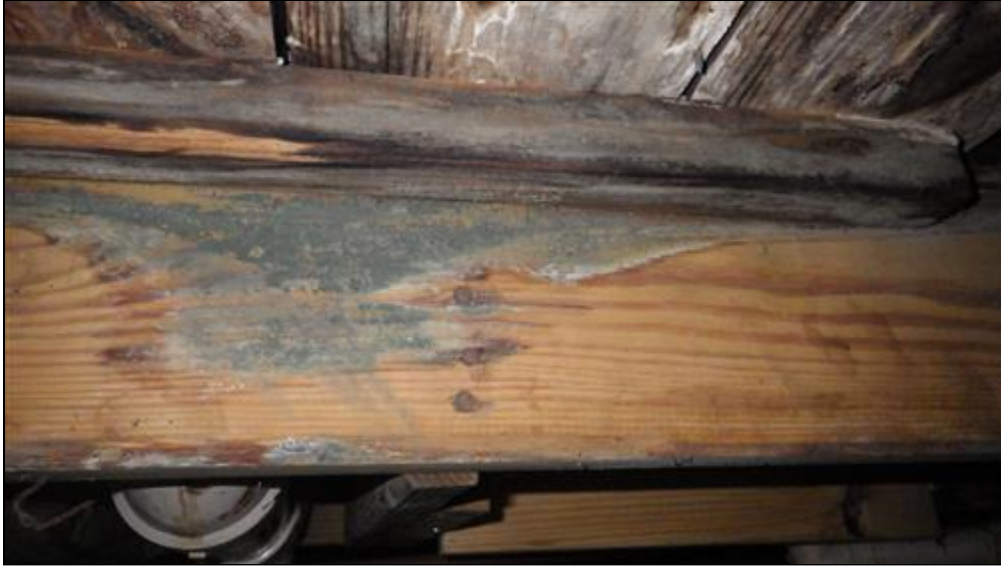
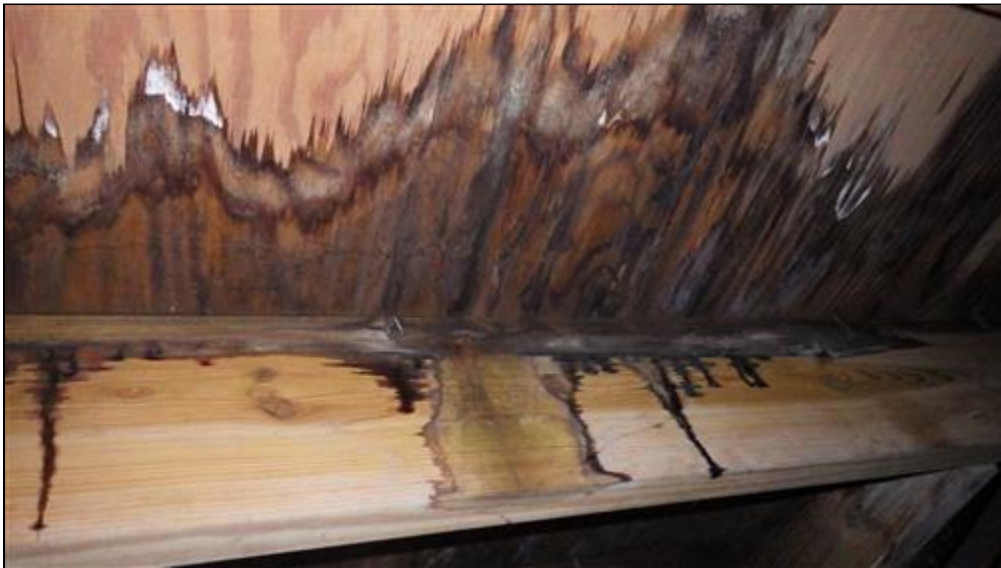
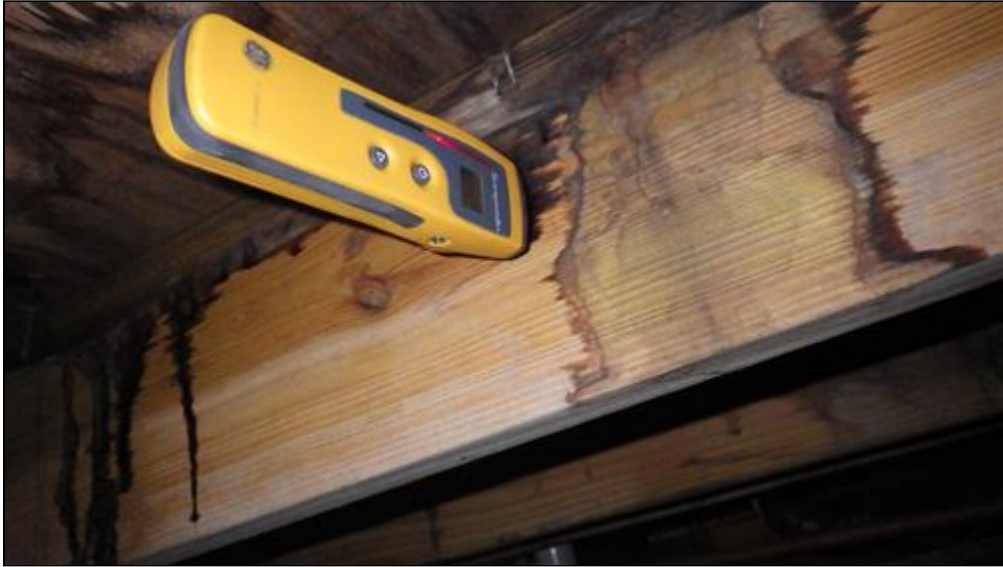
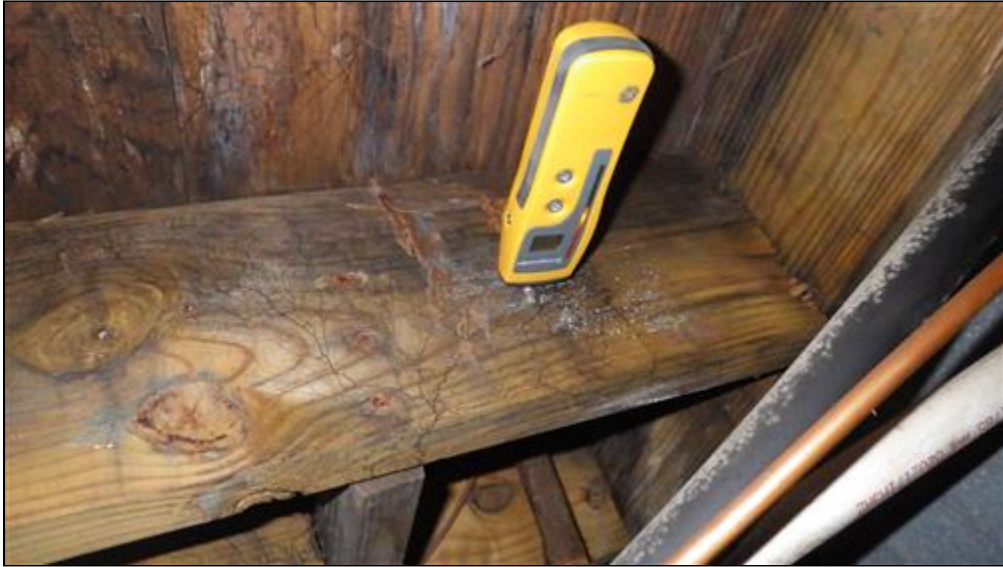
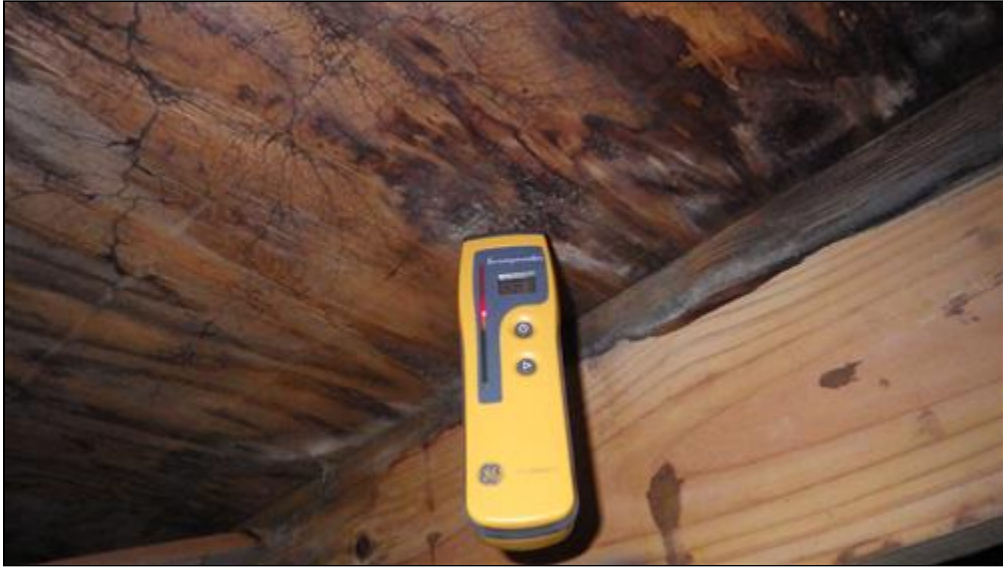
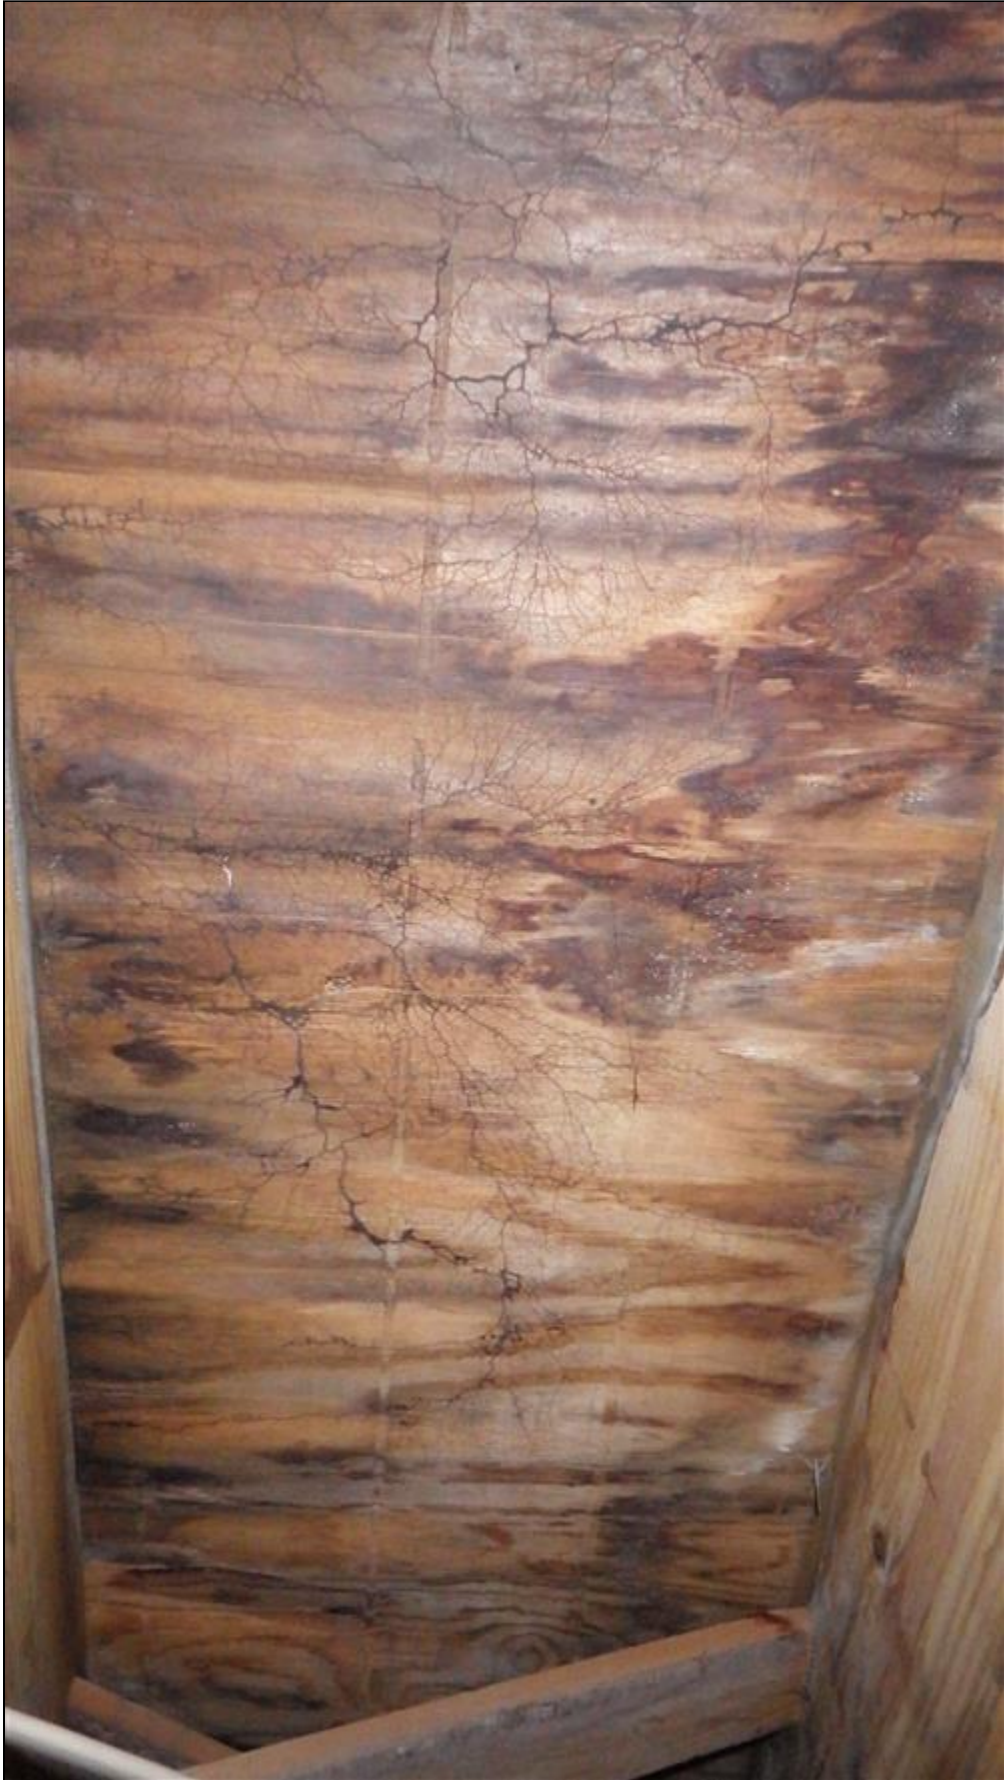
5.3 Item 1(Picture)

5.3 There is quite a bit of moisture damage to the sub-floor and floor joist in the crawlspace around the HVAC and plumbing. This seems to be from a combination of water sources that have allowed the growth to compromise the structure of the wood. It's all scanning wet, and some of the subfloor is coming apart and delaminating.

You'll want to get a few estimates on getting this area repaired. If all the wood in this area has to be replaced this could get expensive as it would need to come up from above.

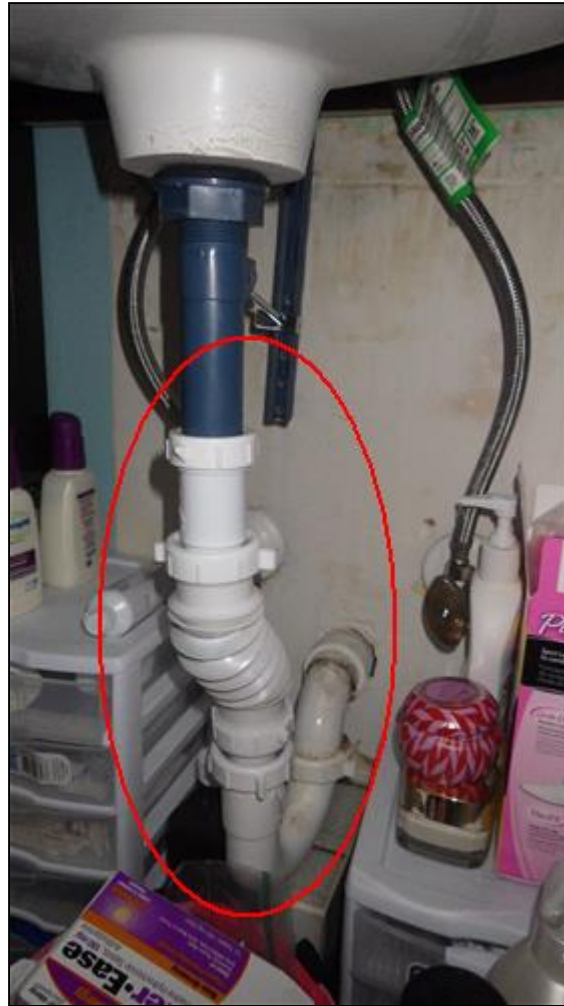
6.0 Item 1(Picture)

6.0 The flexible drain lines that are installed may cause the sinks to drain slowly, or clog easily. I recommend you have the drains replaced with rigid PVC pipe. (FYI)

11. The flexible drain lines that are installed may cause the sinks to drain slowly, or clog easily. I recommend you have the drains replaced with rigid PVC pipe. (FYI)

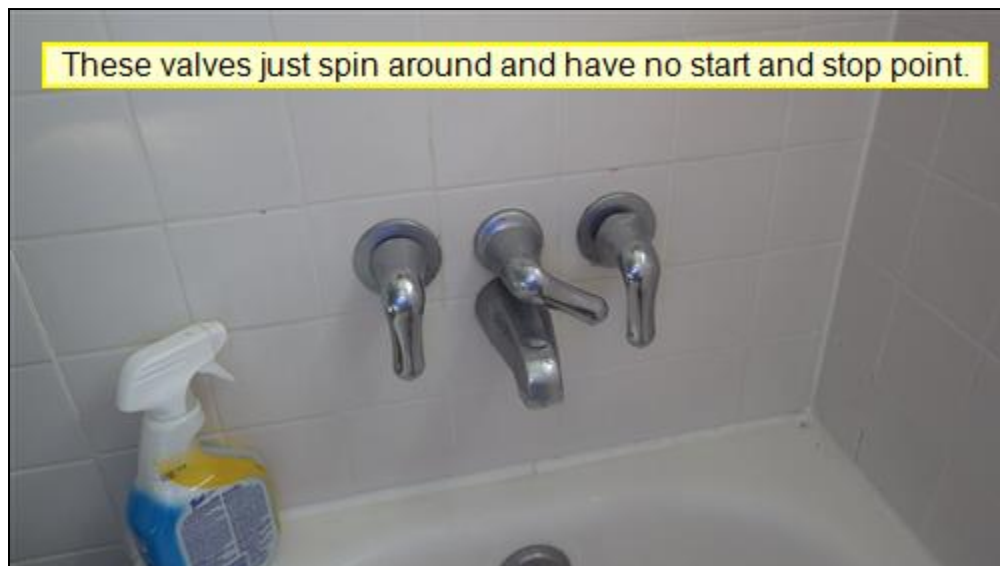
6.1 Item 1(Picture)

6.1 The shower valves do not have stops and just free spin. The handles will also pull off with no resistance. Repair as needed.

12. The shower valves do not have stops and just free spin. The handles will also pull off with no resistance. Repair as needed.

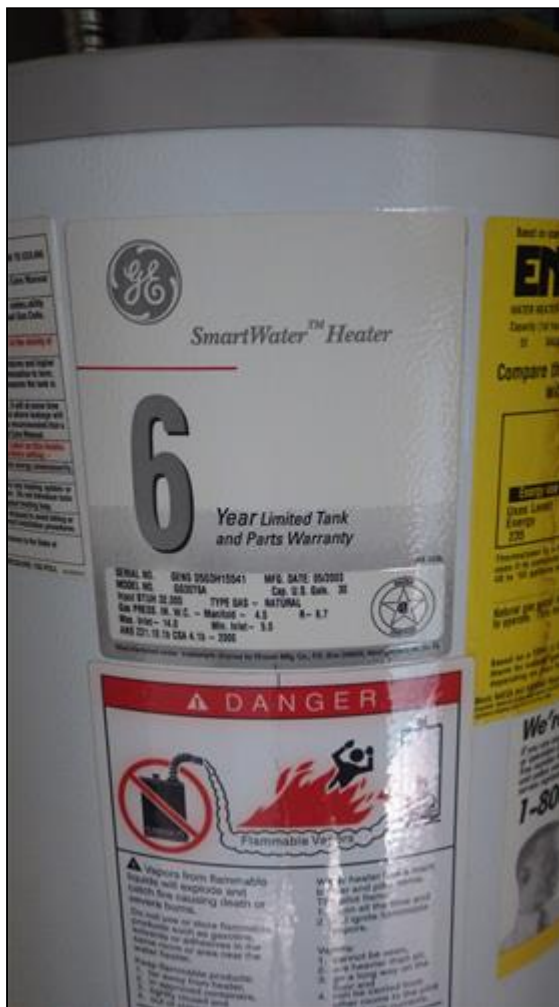
6.2 Item 1(Picture)

6.2 (1) The water heater is older. The NAHB (National Association of Home Builders) case study says the average life expectancy of a gas or electric water heater is "about 10 years". Because of the age of the unit, you'll want to have it replaced. The last thing you want is to come home to a failed tank on your water heater that has flooded your home. You can get the NAHB guide here: <http://abihomeservices.com/download/NAHB-Lifetimes.pdf>

13. (1) The water heater is older. The NAHB (National Association of Home Builders) case study says the average life expectancy of a gas or electric water heater is "about 10 years". Because of the age of the unit, you'll want to have it replaced. The last thing you want is to come home to a failed tank on your water heater that has flooded your home. You can get the NAHB guide here: <http://abihomeservices.com/download/NAHB-Lifetimes.pdf>
14. (2) The water heater is missing the required sediment trap. The trap is in place to catch contaminants that could otherwise damage appliances. Recommend having a plumber install trap to prevent future issues.

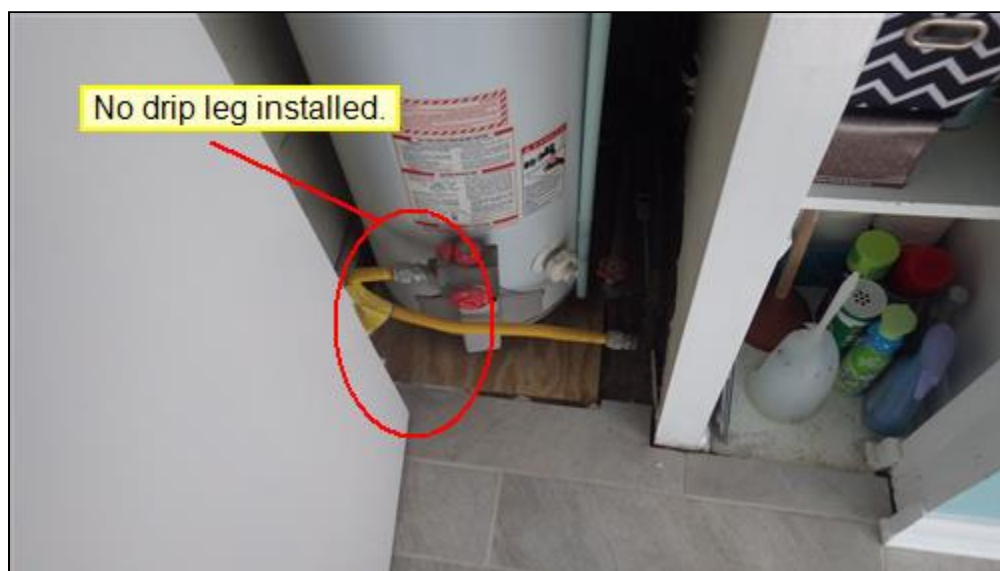
6.2 Item 2(Picture)

6.2 (2) The water heater is missing the required sediment trap. The trap is in place to catch contaminants that could otherwise damage appliances. Recommend having a plumber install trap to prevent future issues.

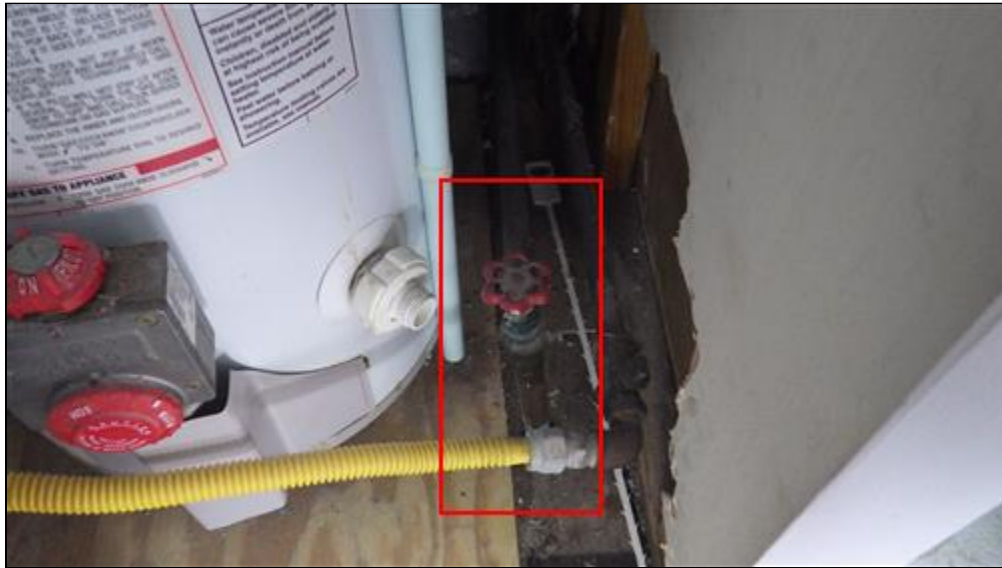
6.3 Item 1(Picture)

6.3 The main water shut off is in the closet with the water heater.

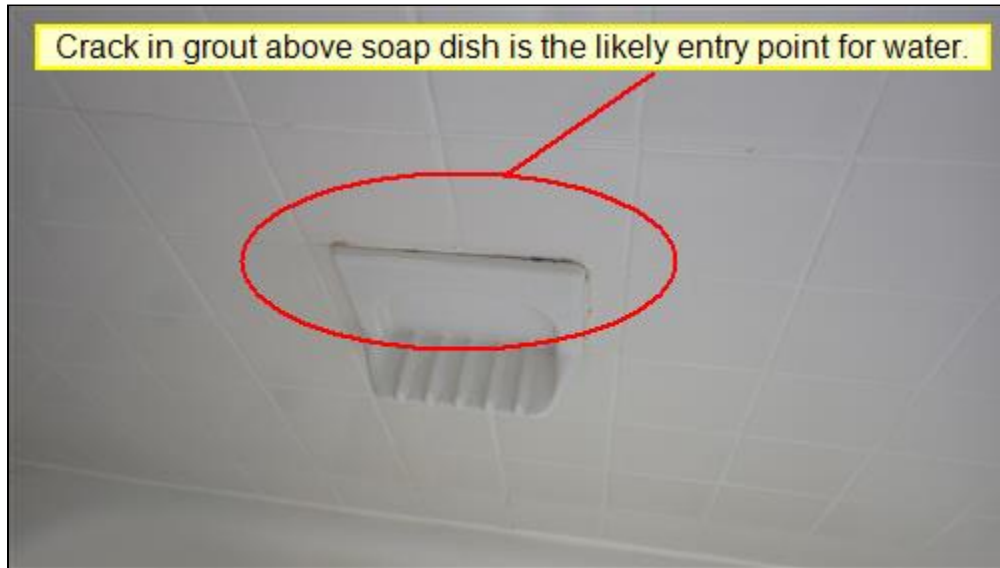
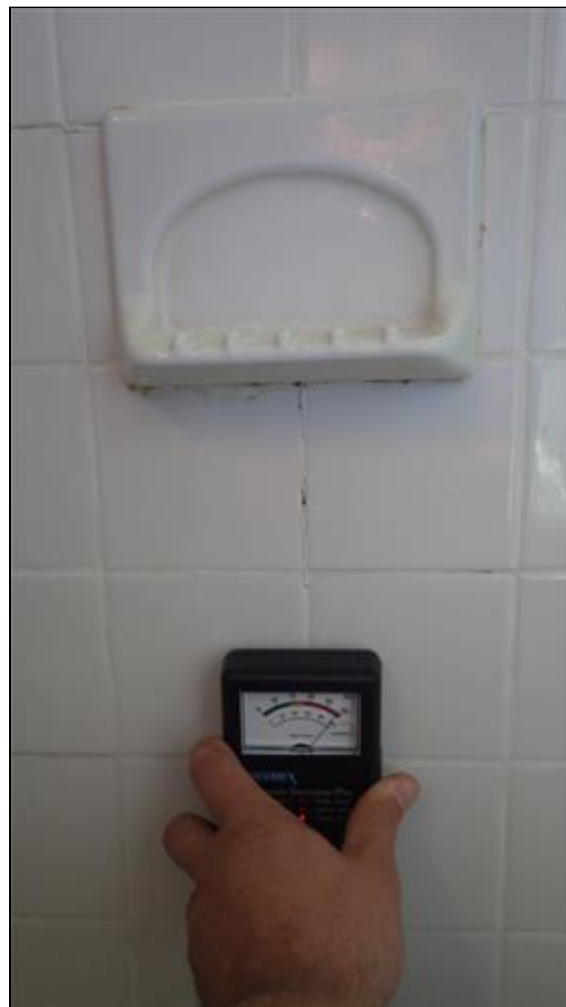
6.8 Item 1(Picture)

6.8 The wall under the soap dish in the shower is scanning wet with my moisture meter. There is a crack in the grout line that is allowing water to seep in and run down the wall. This was the only area I found to be "wet". Unfortunately there is no way of knowing how bad the damage is without removing some tiles.

15. The wall under the soap dish in the shower is scanning wet with my moisture meter. There is a crack in the grout line that is allowing water to seep in and run down the wall. This was the only area I found to be "wet". Unfortunately there is no way of knowing how bad the damage is without removing some tiles.

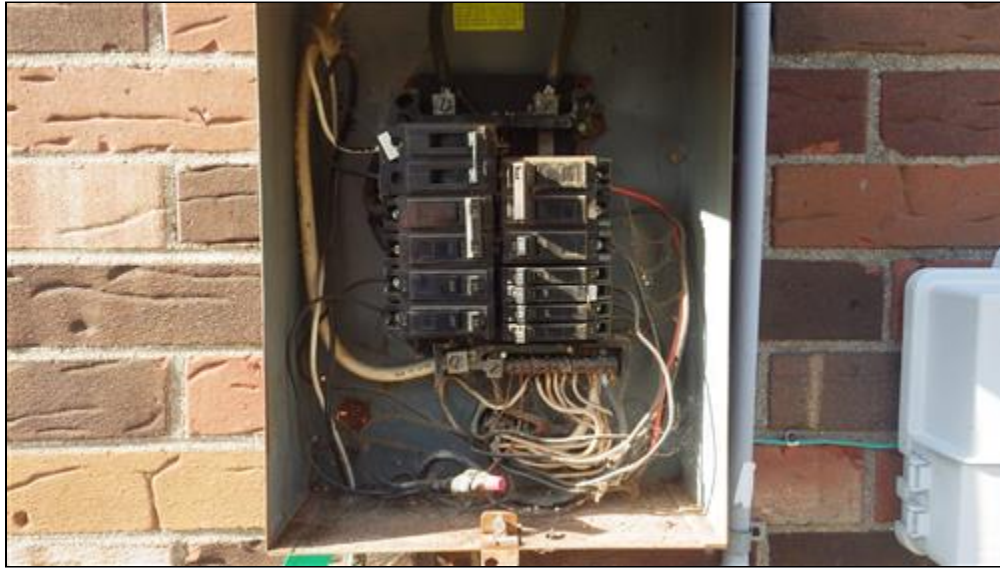
7.1 Item 1(Picture)

7.1 The main panel is located outside on the side of the house.

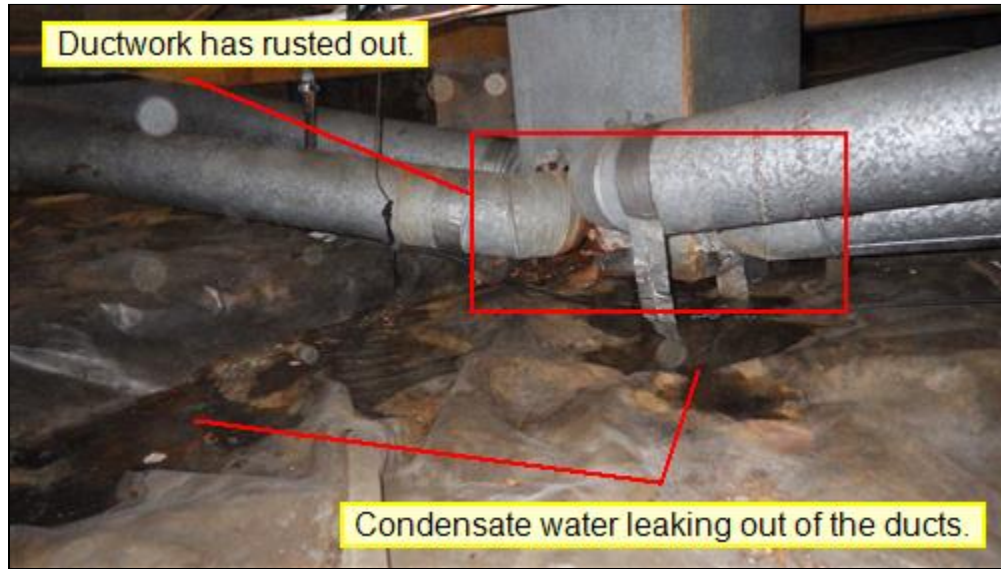
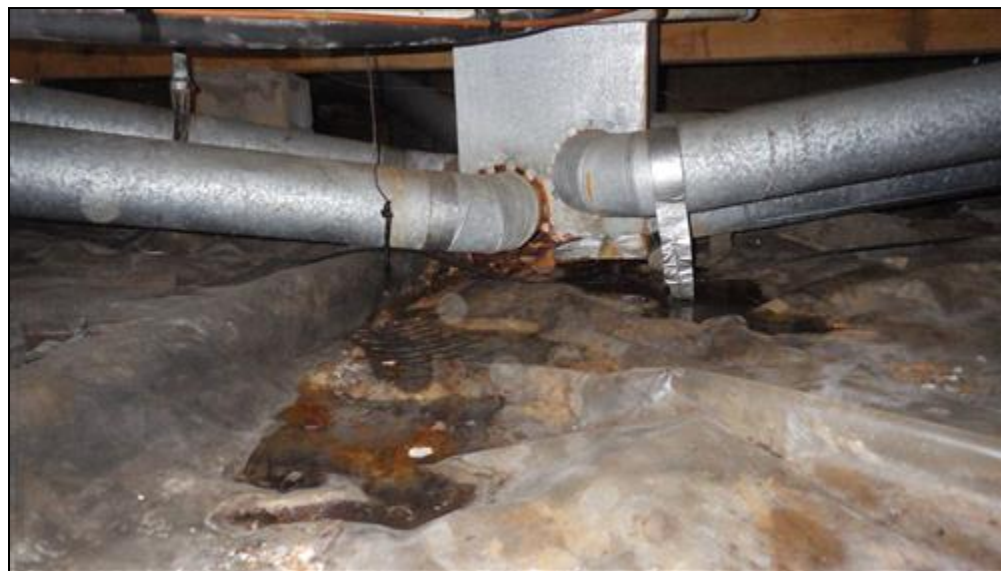
8.2 Item 1(Picture)

8.2 The main trunk line duct of the HVAC has rusted out and needs to be replaced. There is also water spilling onto the ground (from what I think is the condensate line)

18. The main trunk line duct of the HVAC has rusted out and needs to be replaced. There is also water spilling onto the ground (from what I think is the condensate line)

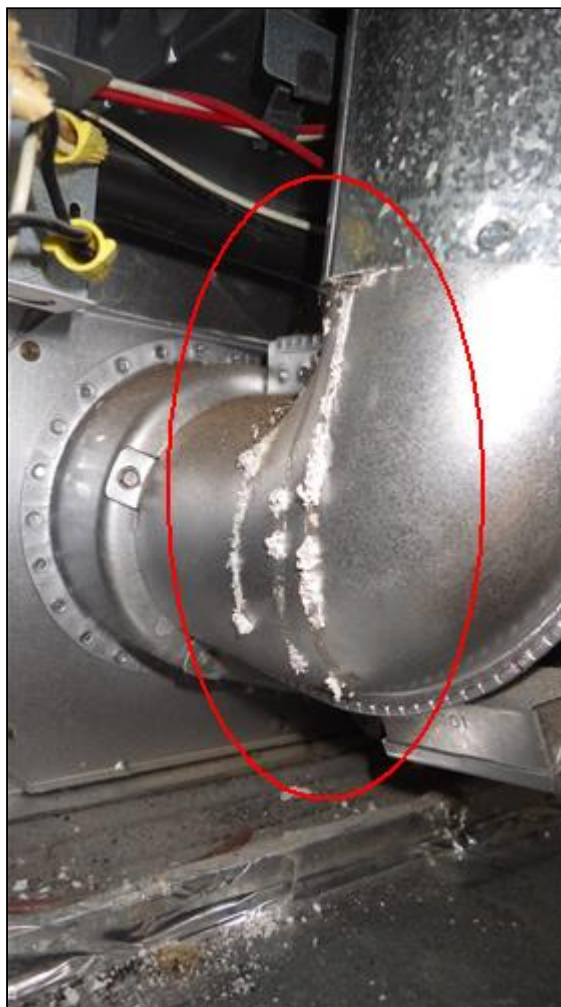
8.4 Item 1(Picture)

8.4 There are streaks running down the flue pipe on the furnace, which is a sign of poor venting, and flue gases are condensing and running back in.

When gas burns, the byproducts are mostly water, sulfur and nitrogen (acid). If that gas can't rise up out of the stack and dissipate, it condenses on the inside of the vent and then drains back to the furnace. The white residue is the mineral salts left over after the acid reacts with the zinc coating in the galvanized coating on the pipe. This happens when the unit is not venting correctly. Have an HVAC tech take a look at it and repair as needed.

the mineral salts left over after the acid reacts with the zinc coating in the galvanized coating on the pipe. This happens when the unit is not venting correctly. Have an HVAC tech take a look at it and repair as needed.

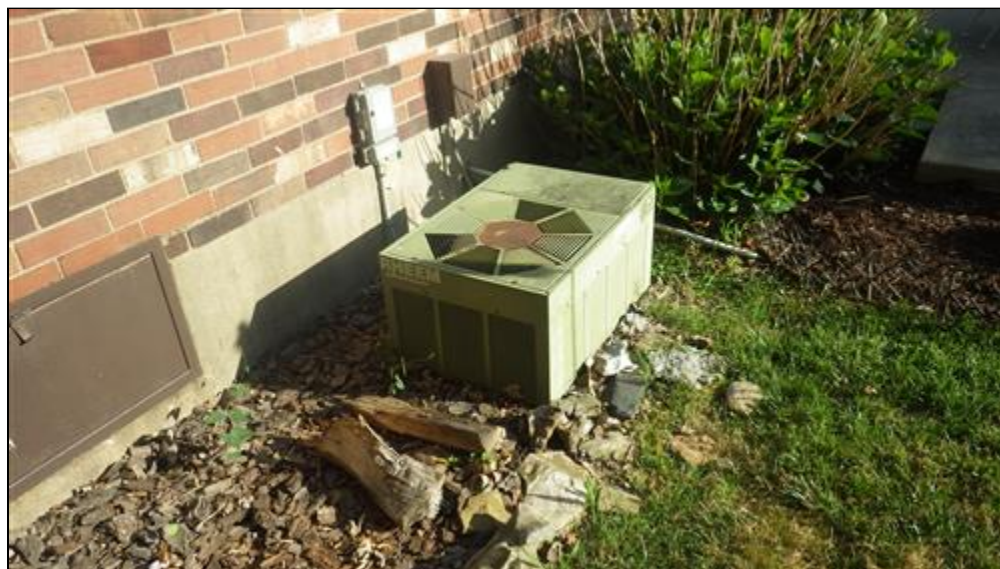
8.5 Item 1(Picture)

8.5 The condenser outside (AC unit) is very old and may last a few years more, but maybe not. I have seen units fail shortly after a home inspection during the seasonal change from mild to hot weather. I cannot determine how long your AC will last before a replacement is necessary.

20. The condenser outside (AC unit) is very old and may last a few years more, but maybe not. I have seen units fail shortly after a home inspection during the seasonal change from mild to hot weather. I cannot determine how long your AC will last before a replacement is necessary.

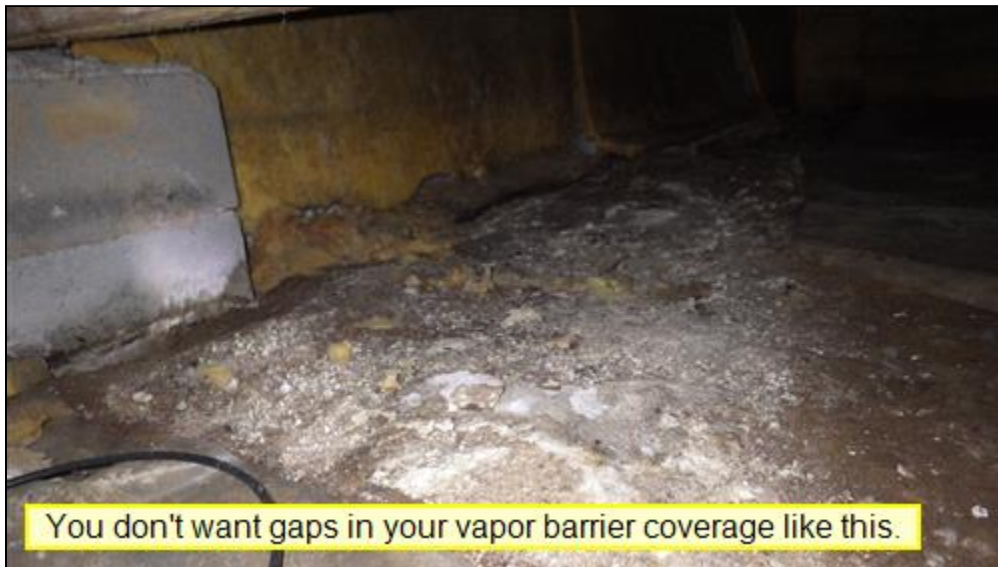
9.2 Item 1(Picture)

9.2 There is a vapor barrier present in the crawlspace. However, it is poorly installed leaving large areas of the crawl space floor open. This will allow moisture to seep up through the ground and release unwanted moisture into the air. In the crawlspace, remove all debris, rake the the soil clean, and install a 6-mil black polyethylene vapor barrier to completely cover the soil. Broadly overlap the seams and place bricks along the edges to hold the plastic in place.

21. There is a vapor barrier present in the crawlspace. However, it is poorly installed leaving large areas of the crawl space floor open. This will allow moisture to seep up through the ground and release unwanted moisture into the air. In the crawlspace, remove all debris, rake the the soil clean, and install a 6-mil black polyethylene vapor barrier to completely cover the soil. Broadly overlap the seams and place bricks along the edges to hold the plastic in place.
