Home Inspection Report

Property Address:
123 Anywhere Drive
Louisville KY 40299

ABI Home Services, LLC

Date: 6/15/2015	Time:	Report ID:
Property: 123 Anywhere Drive Louisville KY 40299	Customer: Joe Smith	Real Estate Professional:

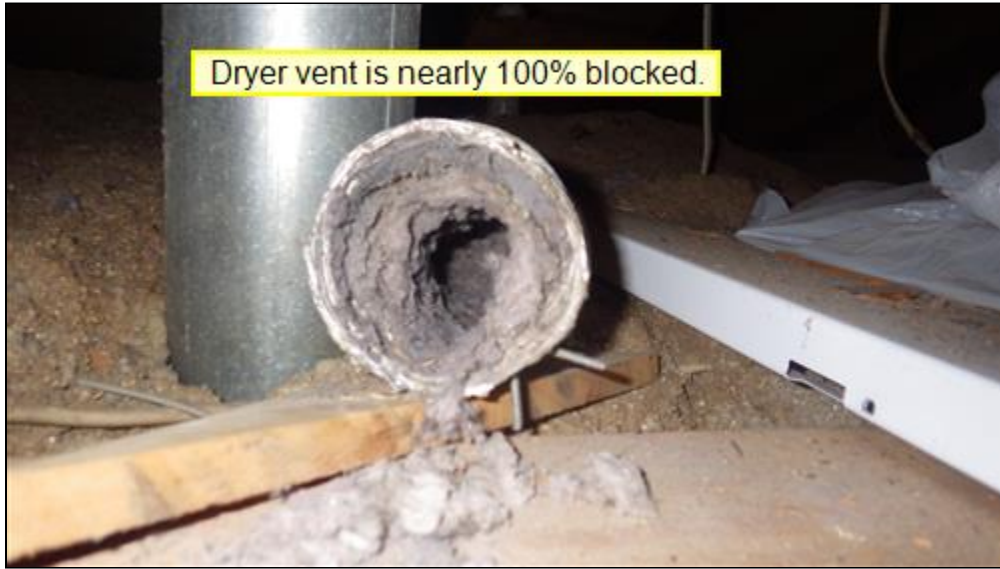
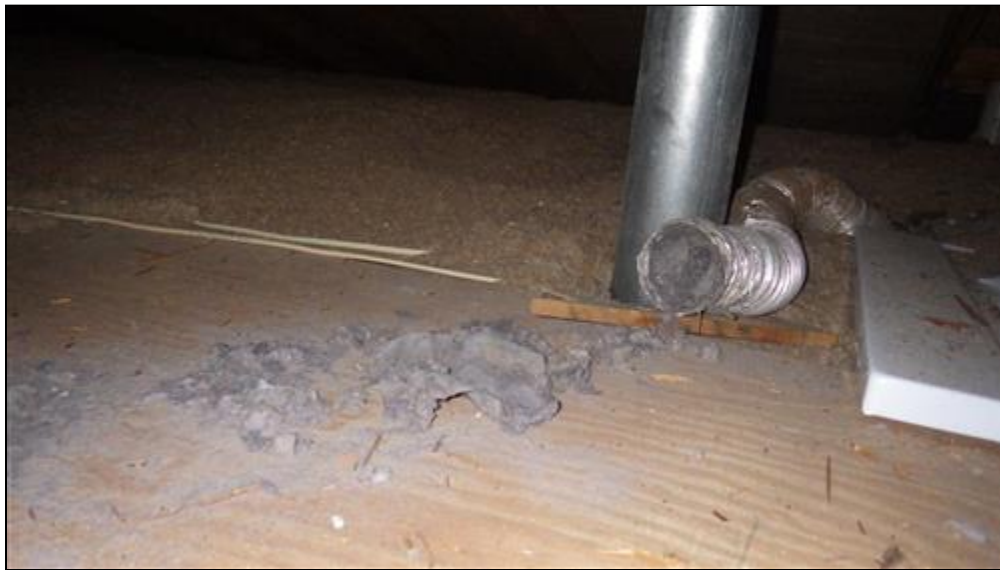
9.4 Item 1(Picture)

9.4 (1) The dryer vent is clogged in the attic and needs to be replaced. It's asking a lot for a dryer to push the lint this far in the air. It would be a good idea to relocate the vent to the crawlspace and out the back of the house with a smooth wall pipe.

22. (1) The dryer vent is clogged in the attic and needs to be replaced. It's asking a lot for a dryer to push the lint this far in the air. It would be a good idea to relocate the vent to the crawlspace and out the back of the house with a smooth wall pipe.
23. (2) The bathroom exhaust fans do not vent to the exterior like they should. Bathroom fans can carry out large amounts of moisture, and you do not want this to be left in you attic. Have the fans exhaust routed to the exterior of the home.

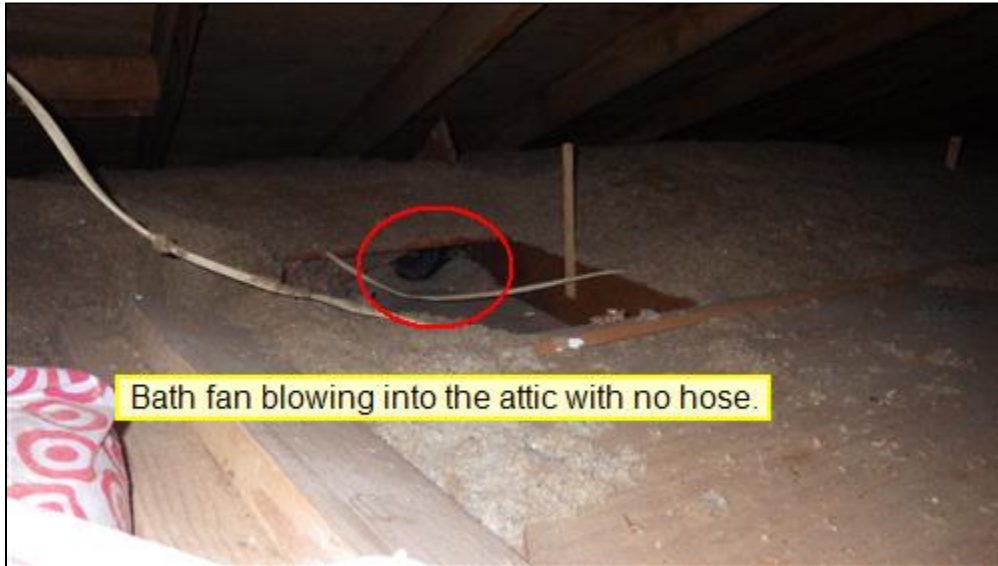
9.4 Item 3(Picture)

9.4 (2) The bathroom exhaust fans do not vent to the exterior like they should. Bathroom fans can carry out large amounts of moisture, and you do not want this to be left in you attic. Have the fans exhaust routed to the exterior of the home.
