Home Inspection Report

Property Address:
1234 Flipper Lane
Lagrange KY 40031

ABI Home Inspection Service, LLC

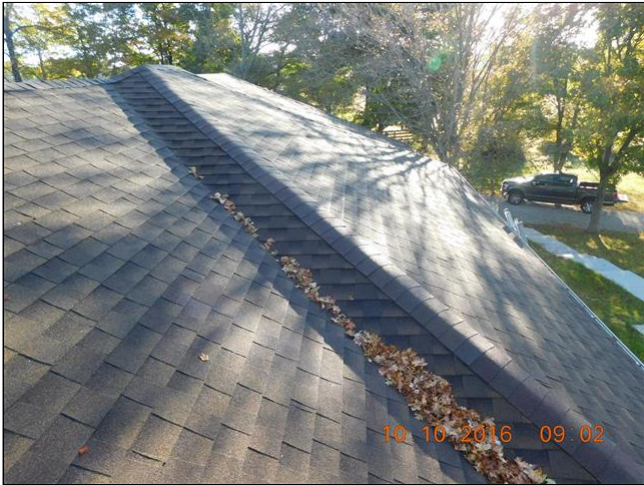
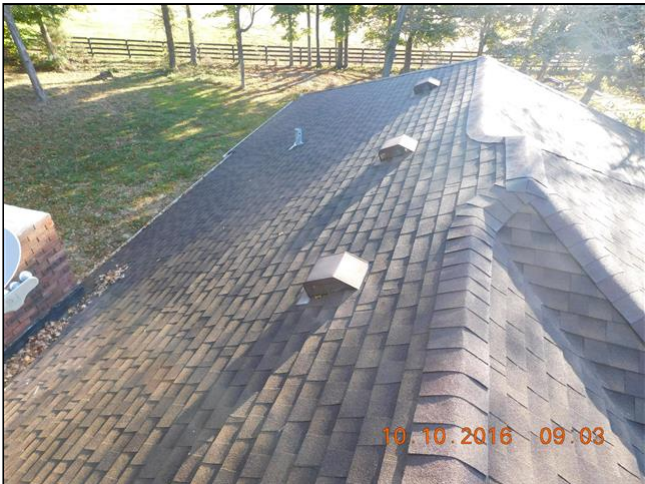
2.0 The roof (shingles) seems to be in overall good condition. There is no excess grit loss, and no damaged shingles on the house.

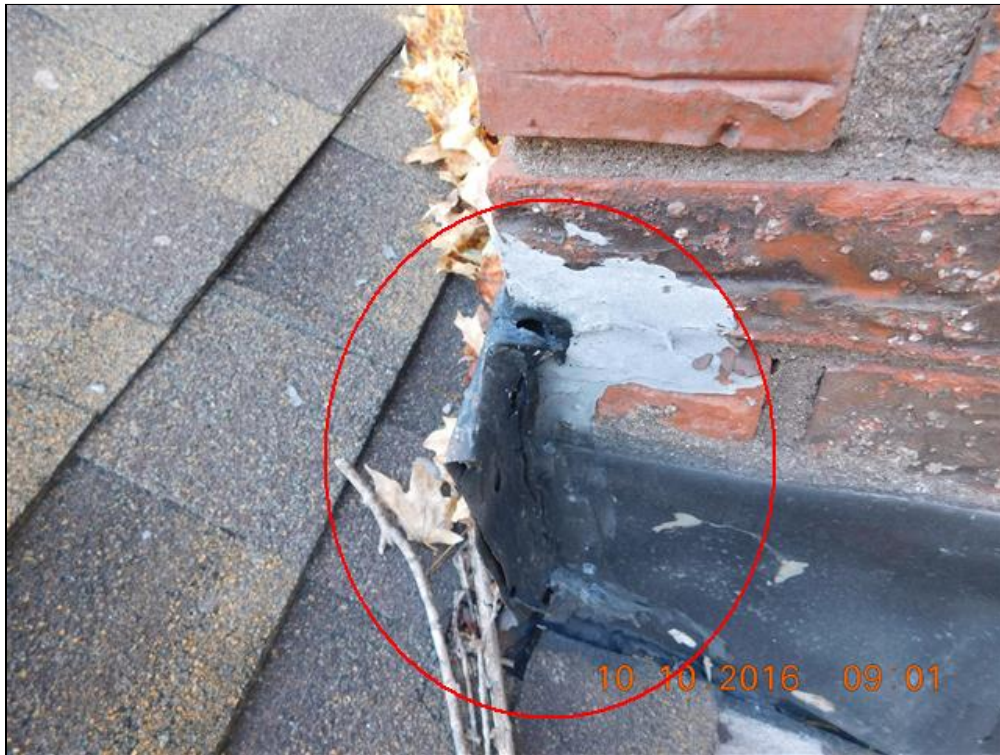
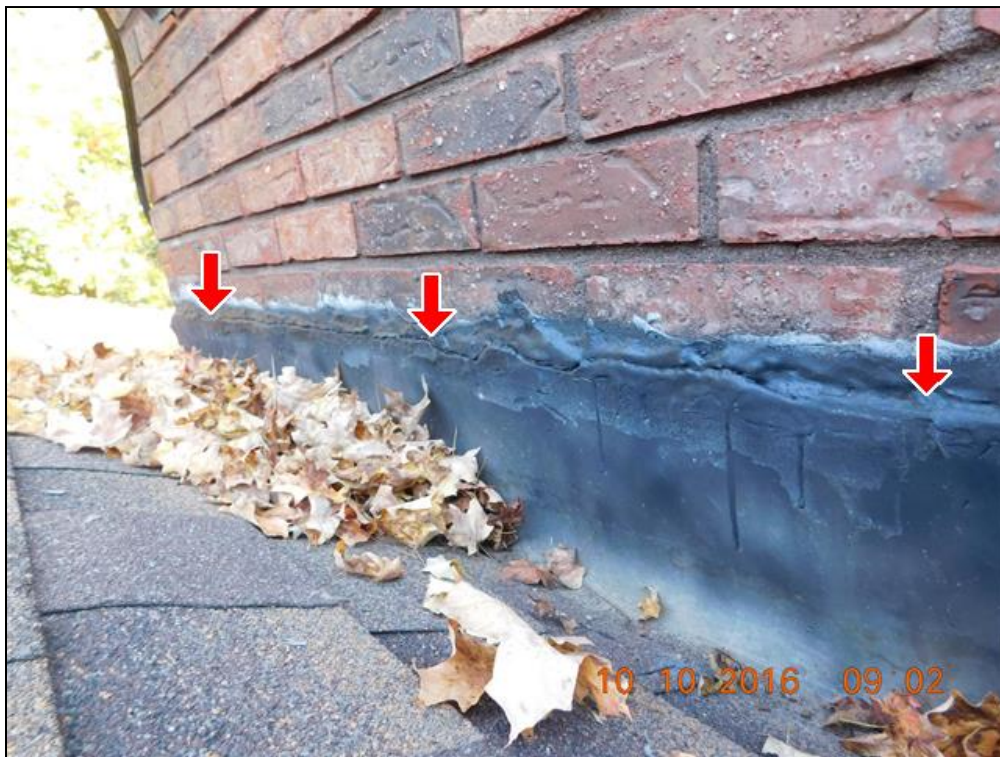
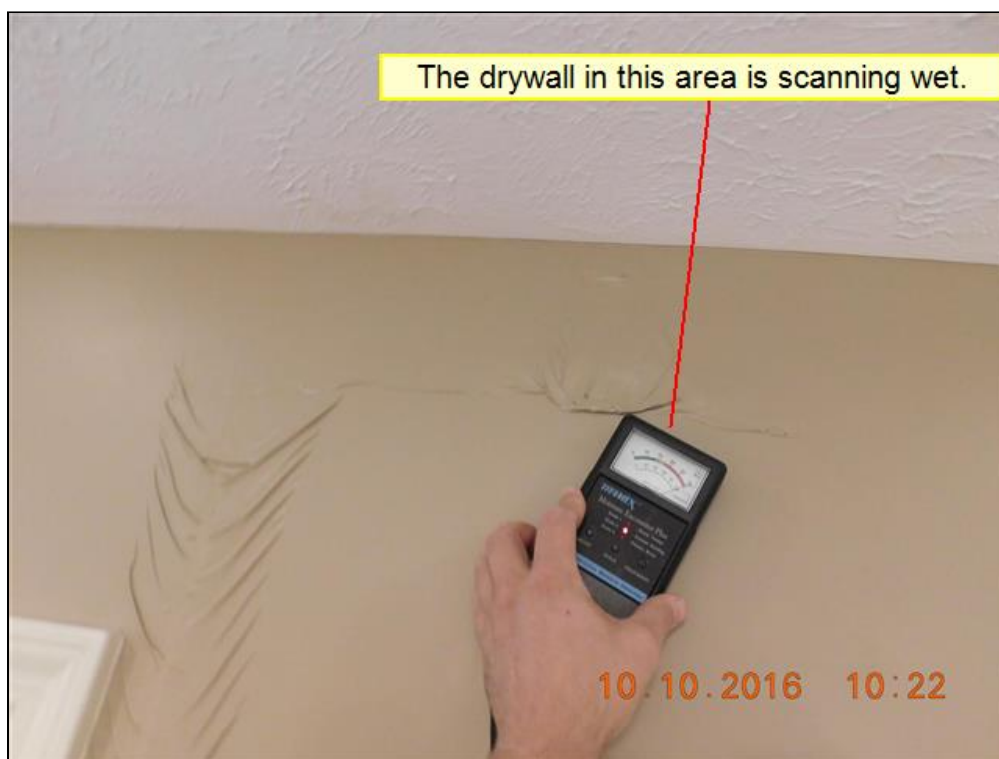
2.1 The flashing around the chimney has holes in the corners, the back wall of the chimney has a horizontal crack in the flashing, and several places have had goo smeared on it (a poor attempt to stop a leak I would guess.) Clearly this has leaked in the past as the wall above the fireplace is bubbling up, and maxing out my moisture meter on the inside wall. You'll want to have a roofer take a look and repair/replace the flashing as needed.

1. The flashing around the chimney has holes in the corners, the back wall of the chimney has a horizontal crack in the flashing, and several places have had goo smeared on it (a poor attempt to stop a leak I would guess.) Clearly this has leaked in the past as the wall above the fireplace is bubbling up, and maxing out my moisture meter on the inside wall. You'll want to have a roofer take a look and repair/replace the flashing as needed.

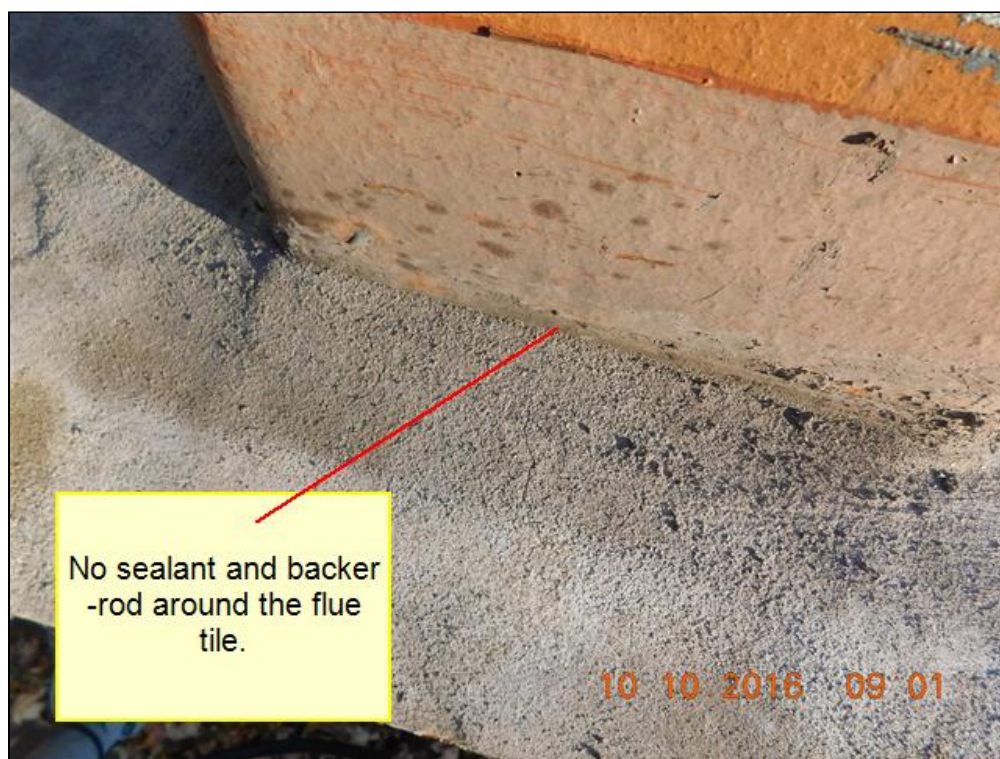
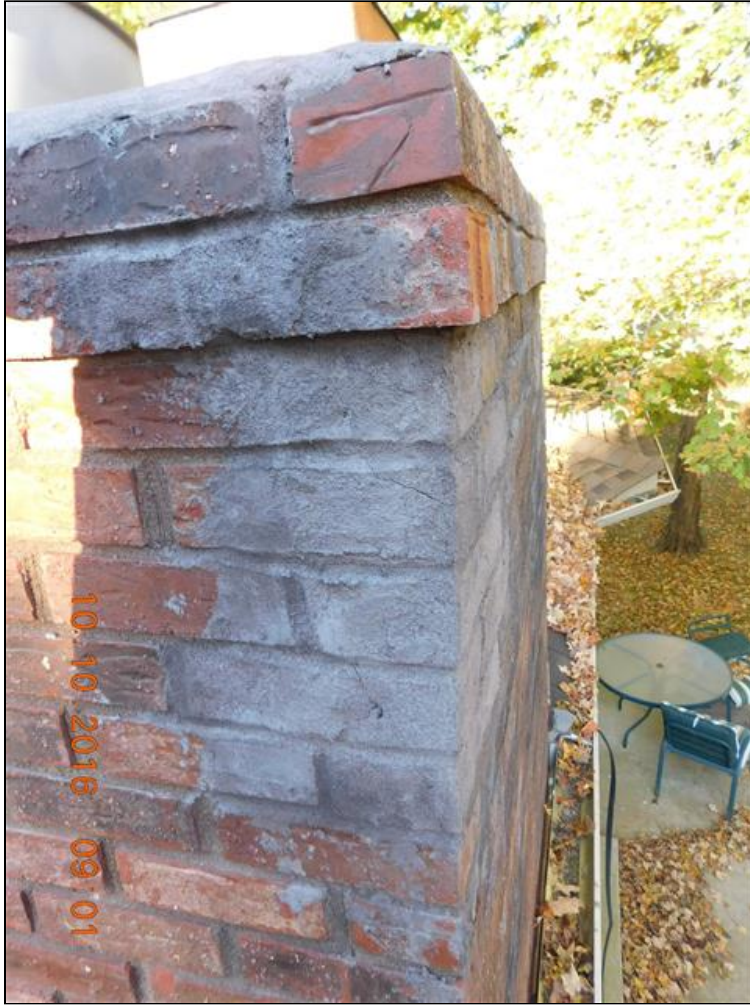
2.2 The mortar cap on the chimney looks new(ish) compared to the rest of the chimney. However, it does have cracks already forming in the top (likely from the mixture being too wet). They also did not leave an expansion gap around the flue tile, and there is an overhang around the edge. I've attached a small pic to explain what a great cap looks like for your reference. Have a chimney sweep take a look and repair the cap as they see fit.

2. The mortar cap on the chimney looks new(ish) compared to the rest of the chimney. However, it does have cracks already forming in the top (likely from the mixture being too wet). They also did not leave an expansion gap around the flue tile, and there is an overhang around the edge. I've attached a small pic to explain what a great cap looks like for your reference. Have a chimney sweep take a look and repair the cap as they see fit.

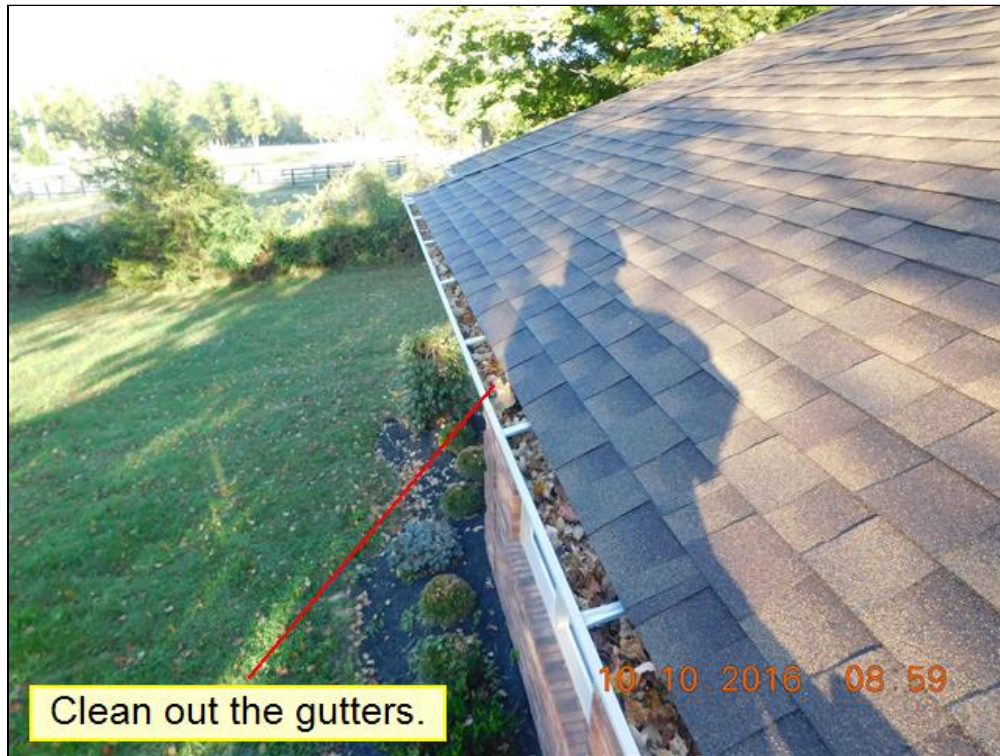
2.3 Item 1(Picture)

2.3 (1) The gutters are full of debris and need to be cleaned out to allow the roof water to flow properly.

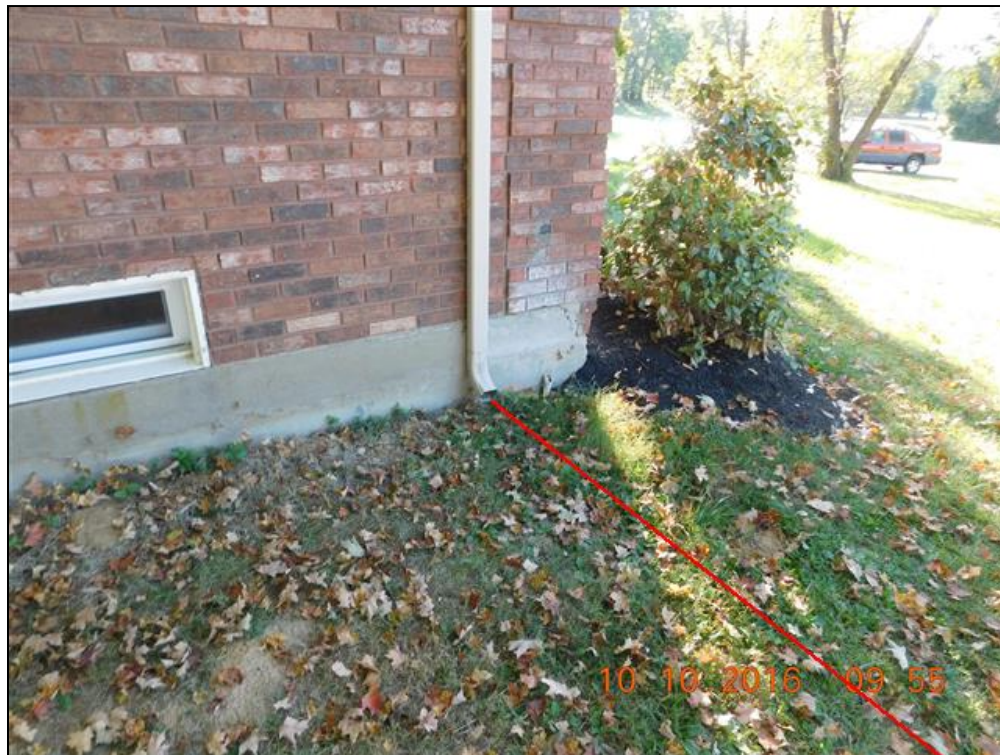
2.3 Item 2(Picture)

2.3 (2) The downspouts around the home need to have extensions added to them. They are discharging water near the homes foundation, which can cause moisture issues around the house. You want to get water away from the foundation at least 5 feet. Read this for more info: <http://abihomeservices.com/how-to-prevent-a-leaky-basement/>

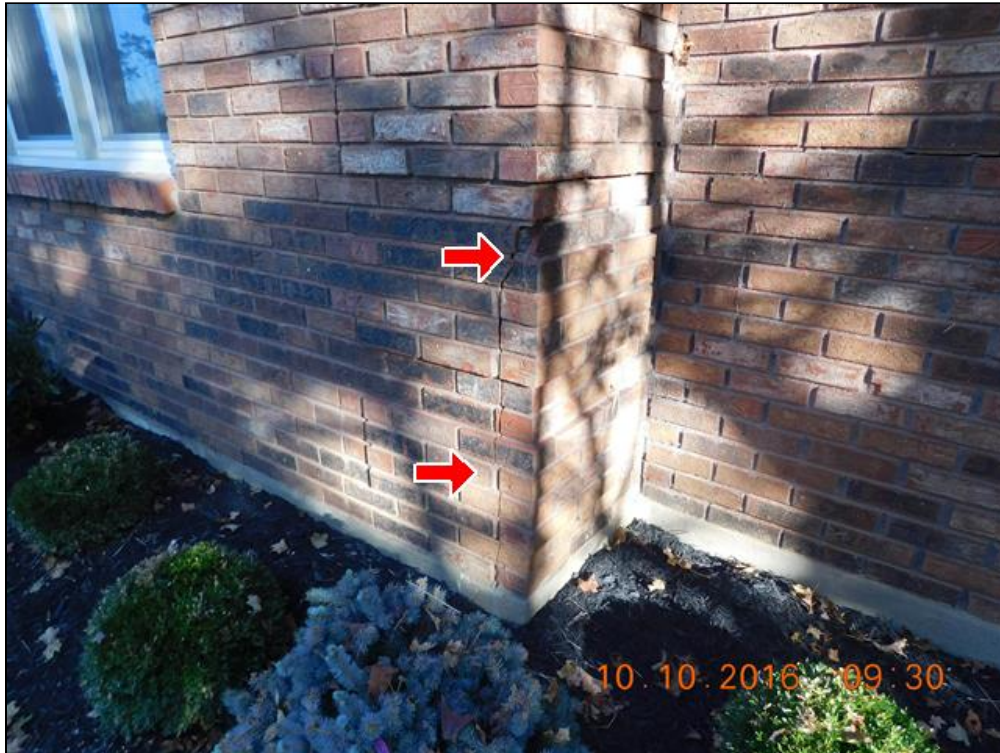
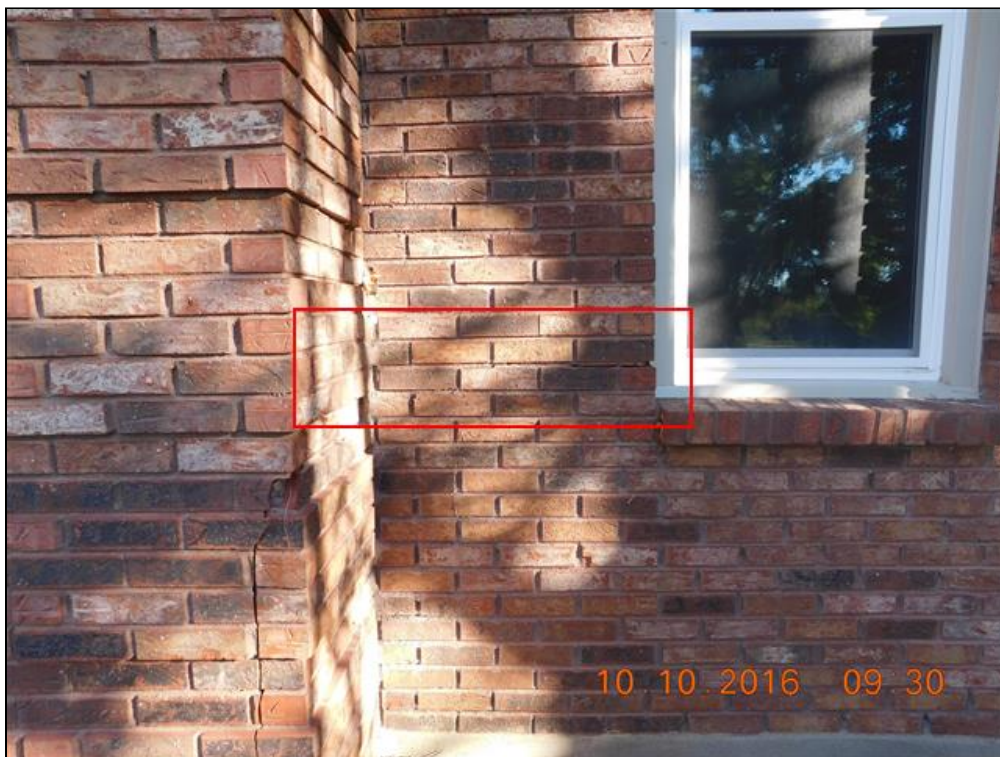
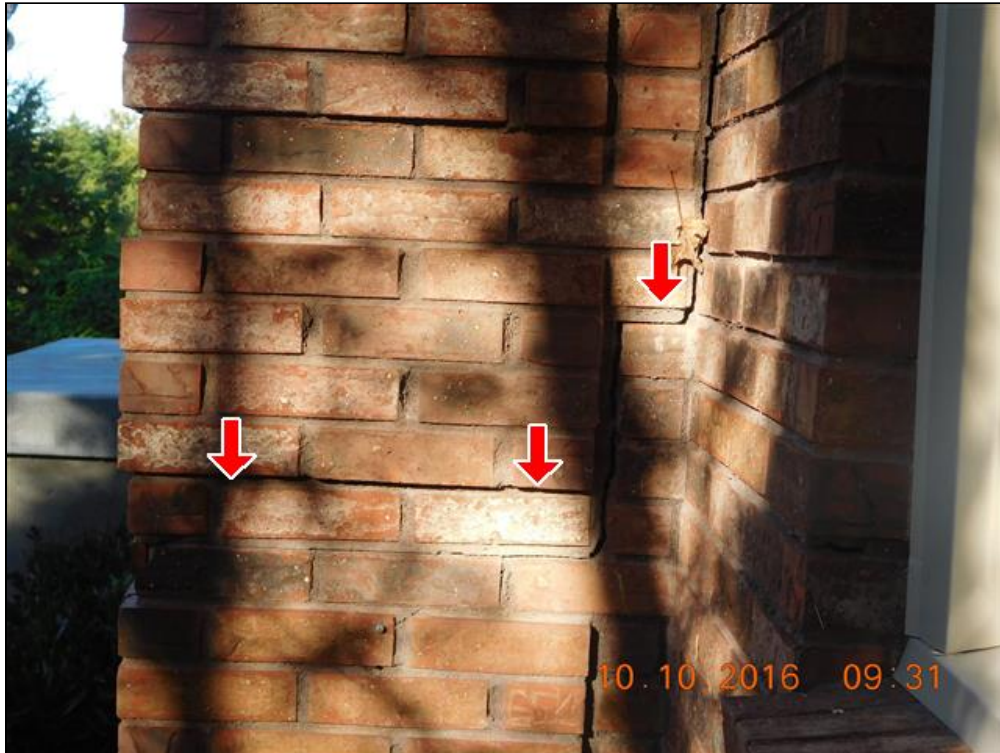
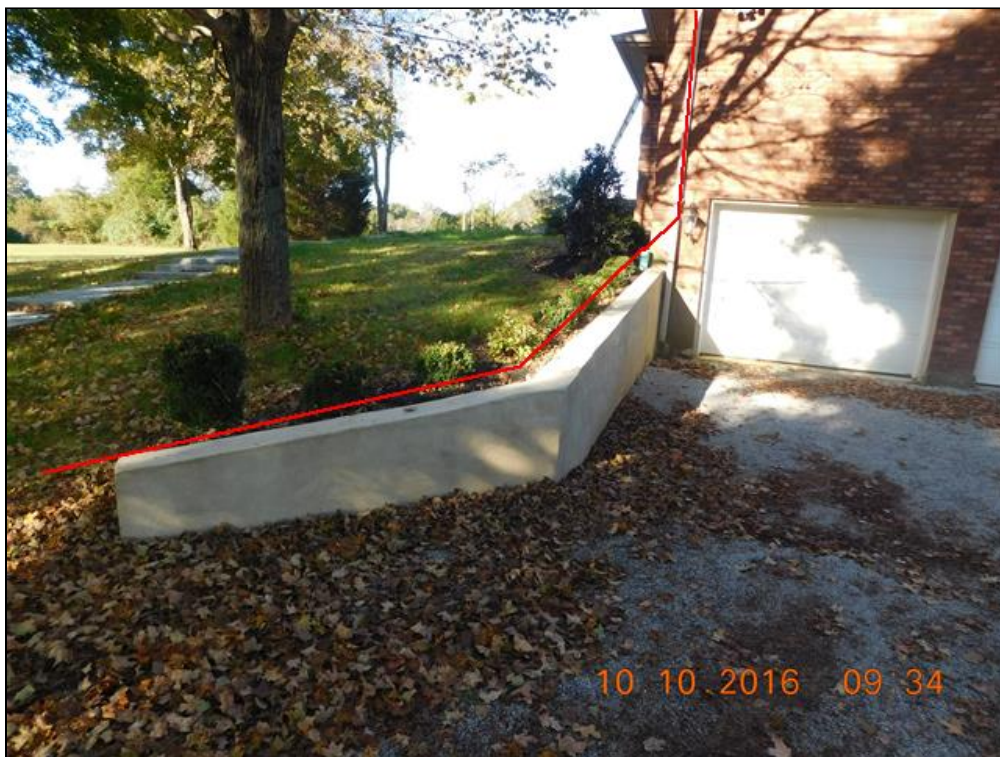
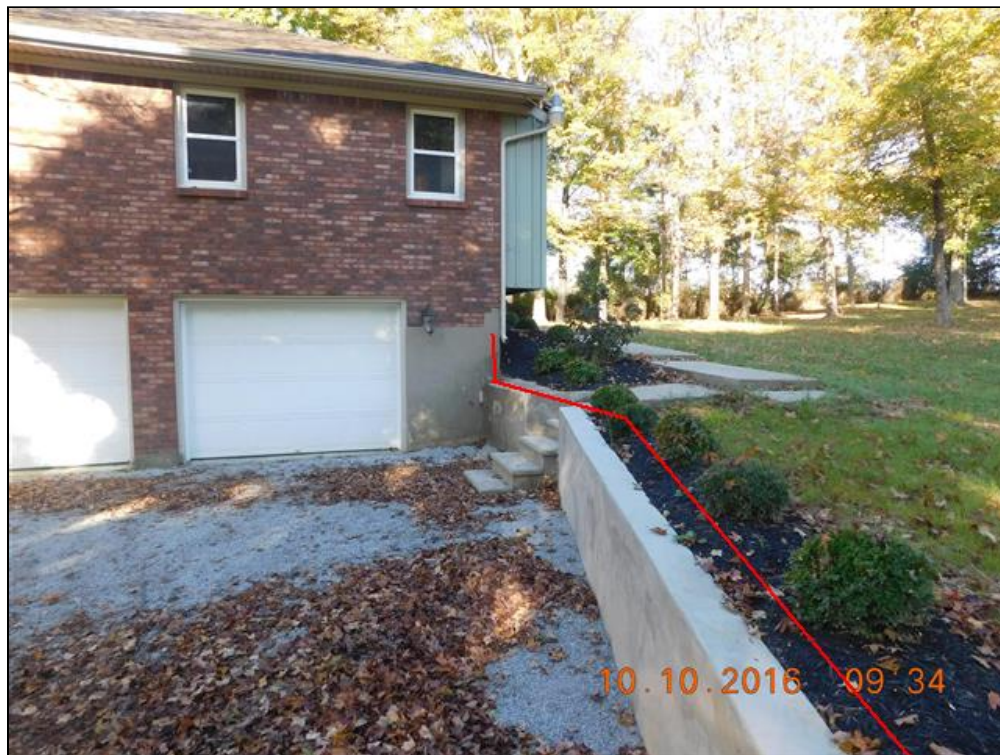
3.0 (1) The front brick on the right side of the house has settled down from what appears to be poor water management. When gutters are allowed to drain next to the foundation, they can soften the ground up enough where things can (and usually do) sink. These cracks seem to be from this as well. It's possible things have moved all they are going to. They could get worse, but if you do a good job in keeping the gutters cleaned out, and the downspouts extended away from the house, you'll stack the odds in your favor. Have a brick mason tuck point the wall to help keep the water out, and keep an eye on things. If you notice the area moving even more than it already has, you'll need to reach out to a foundation contractor about having piling installed.

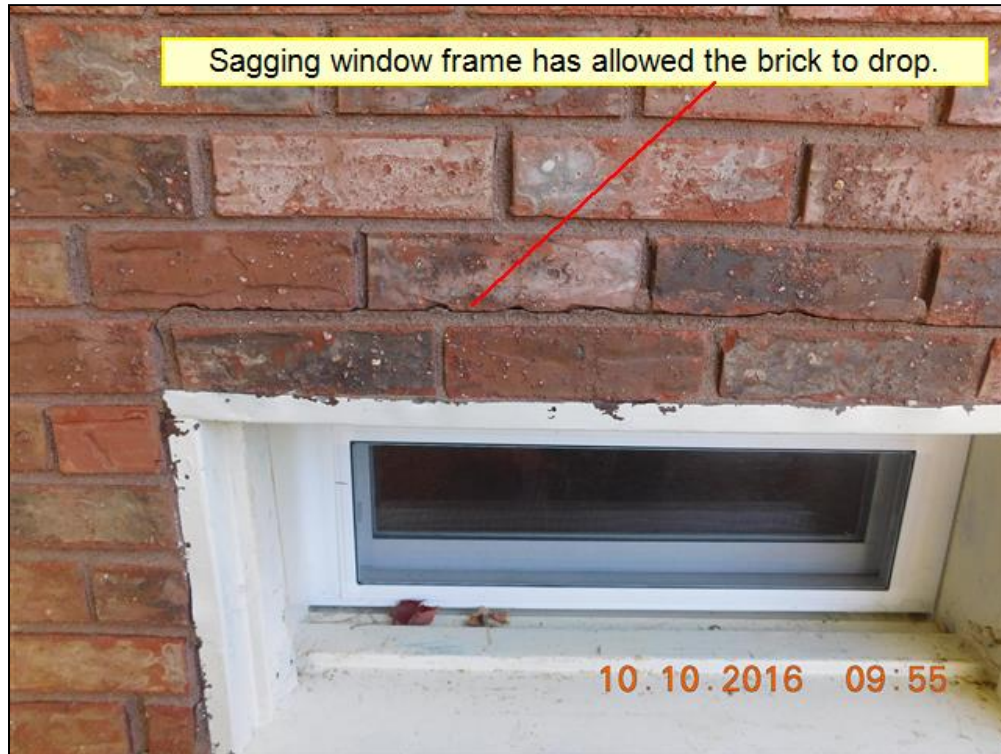
3.1 Item 1(Picture)

3.1 The metal window frame around the left side is is sagging and allowing the brick to crack and drop as well. Not much can be done short of replacing the frame and having the brick repaired.

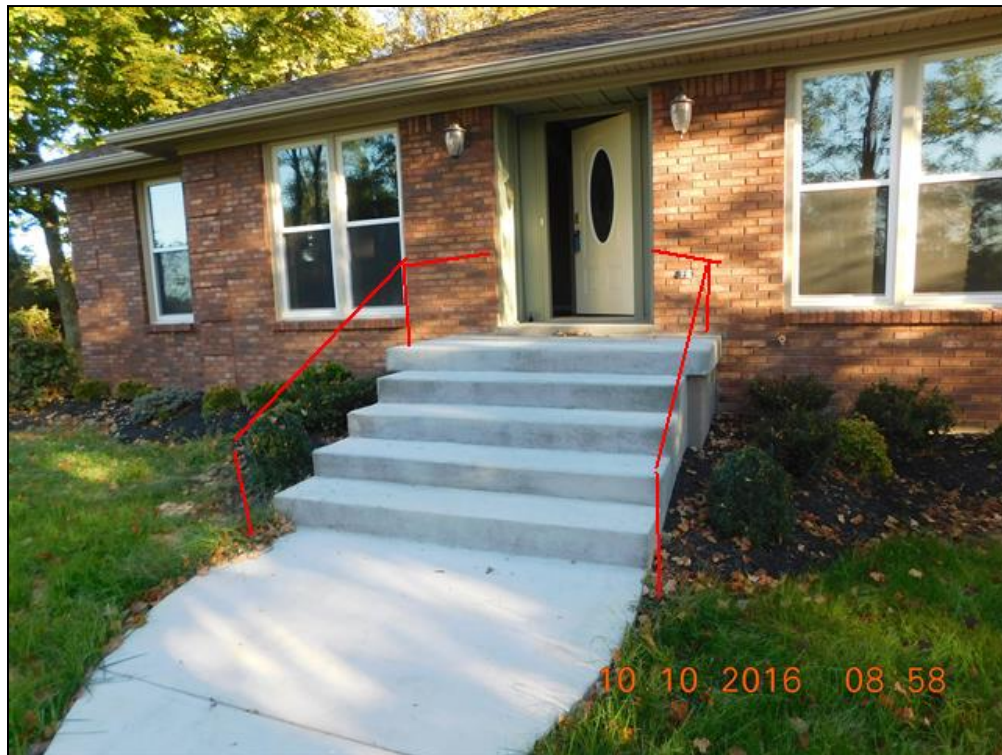
3.3 Item 1(Picture)

3.3 (1) The front porch is high enough you'll want to have a guard rail and hand rail installed for safety. It also needs a handrail down the steps as well.

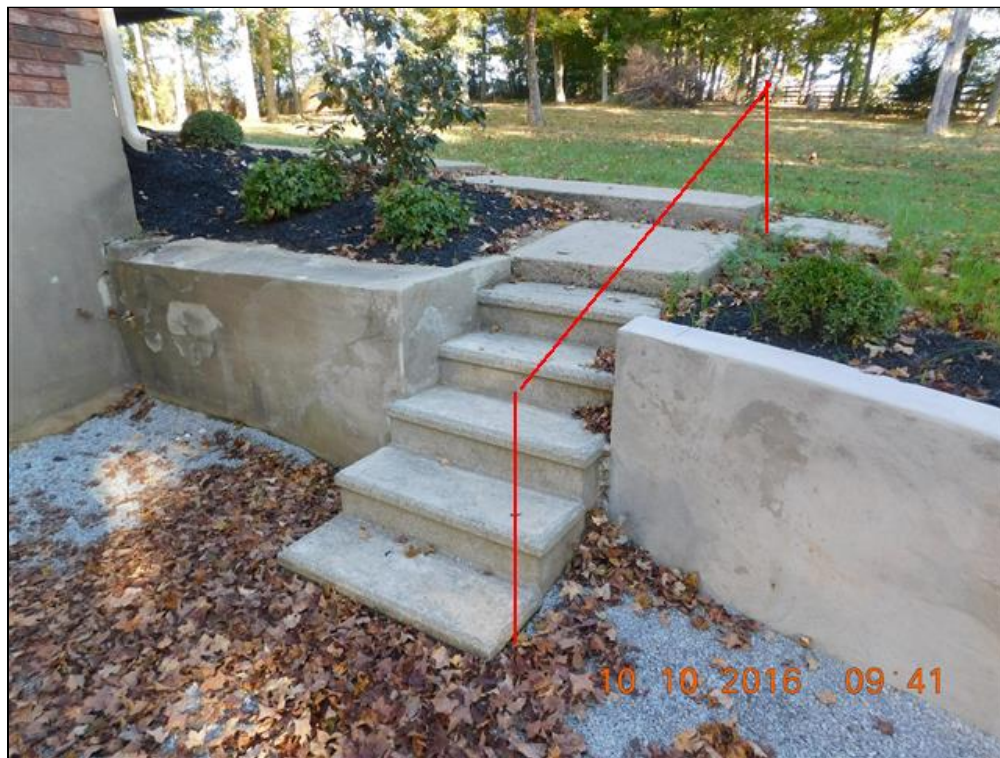
3.3 Item 2(Picture)

3.3 (2) The side steps that lead up into the backyard need a handrail installed.

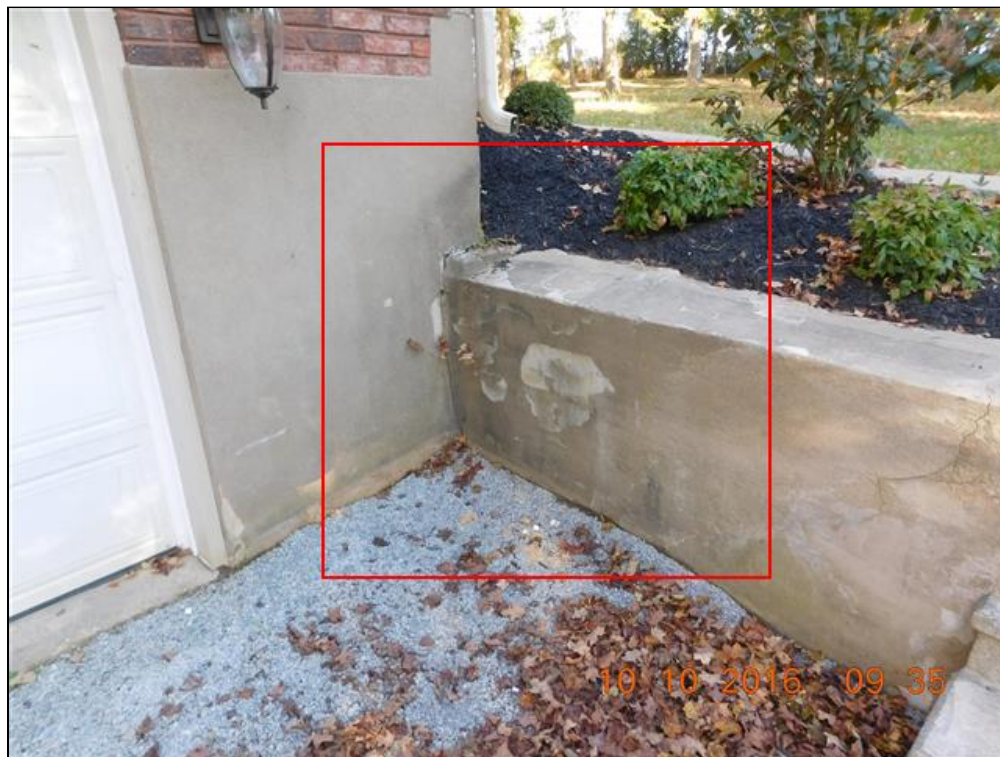
3.4 Item 1(Picture)

3.4 The retaining wall near the back yard is water stained and deteriorated. Extending the downspout should take care future issues, but you'll still have the damage to deal with. Have a concrete contractor repair as they see fit.

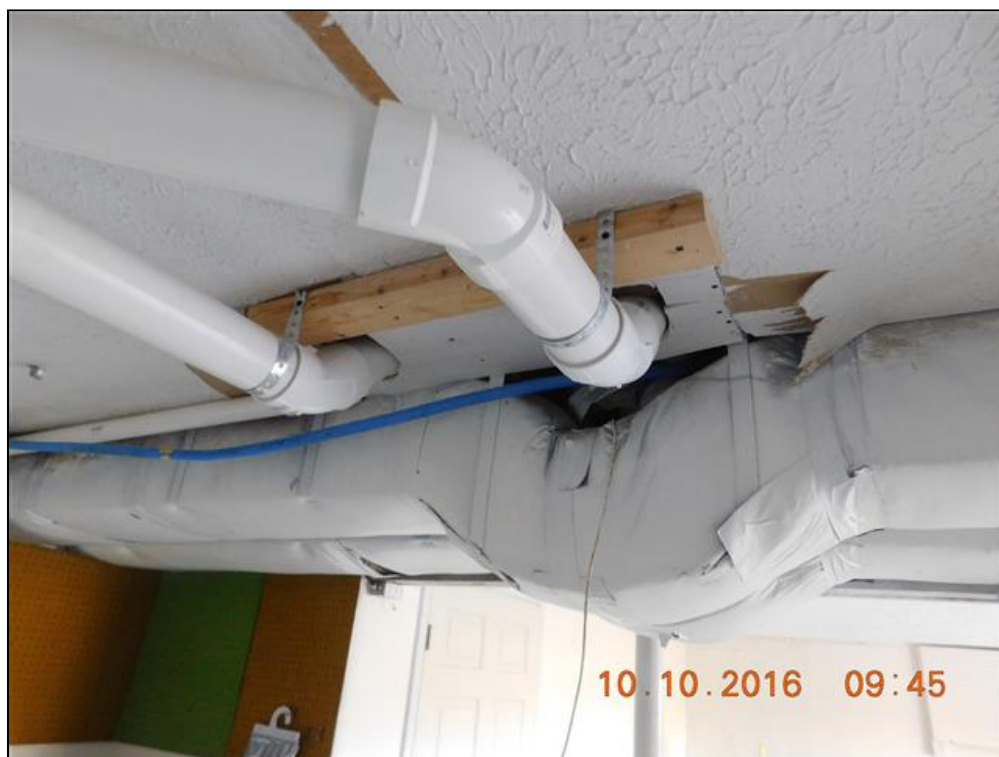
4.0 The garage of the home is under the living space. The drywall is not air sealed from the living space. If a person were to leave a car running in the garage, it could allow carbon monoxide to seep into the home. You'll want to have the ceilings and walls completely air sealed from the rest of the house for safety.

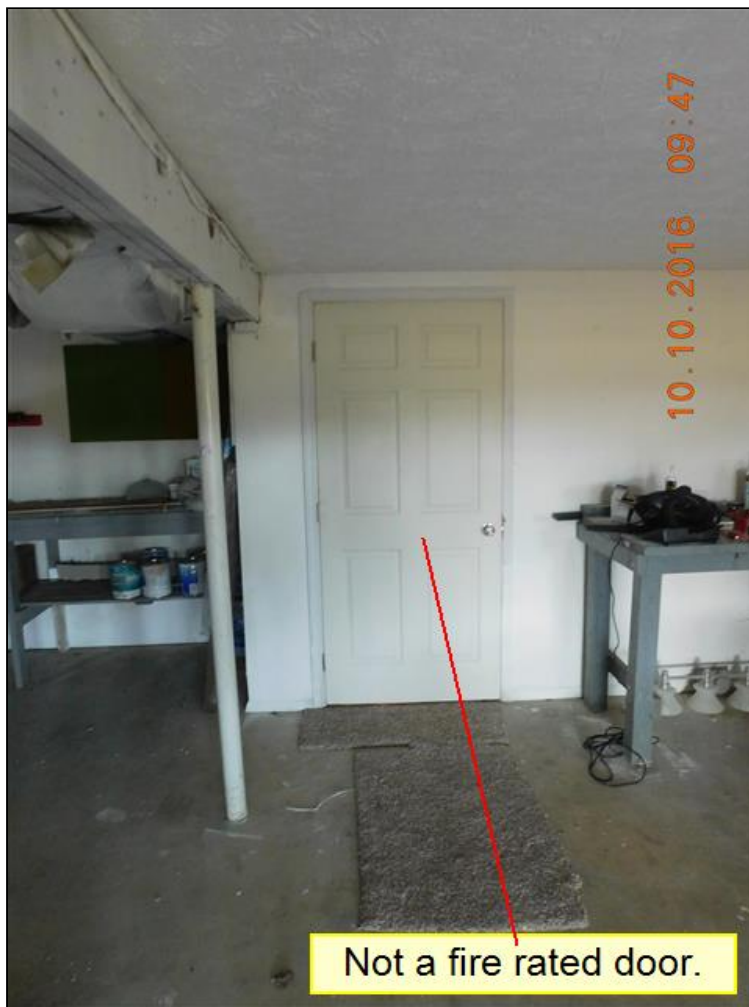
4.3 Item 1(Picture)

4.3 The occupant door from inside garage to inside the home is not a fire rated door. This means that should a fire occur in garage, the occupant door does not afford protection until fireman arrive. This door should be replaced with a fire rated door.

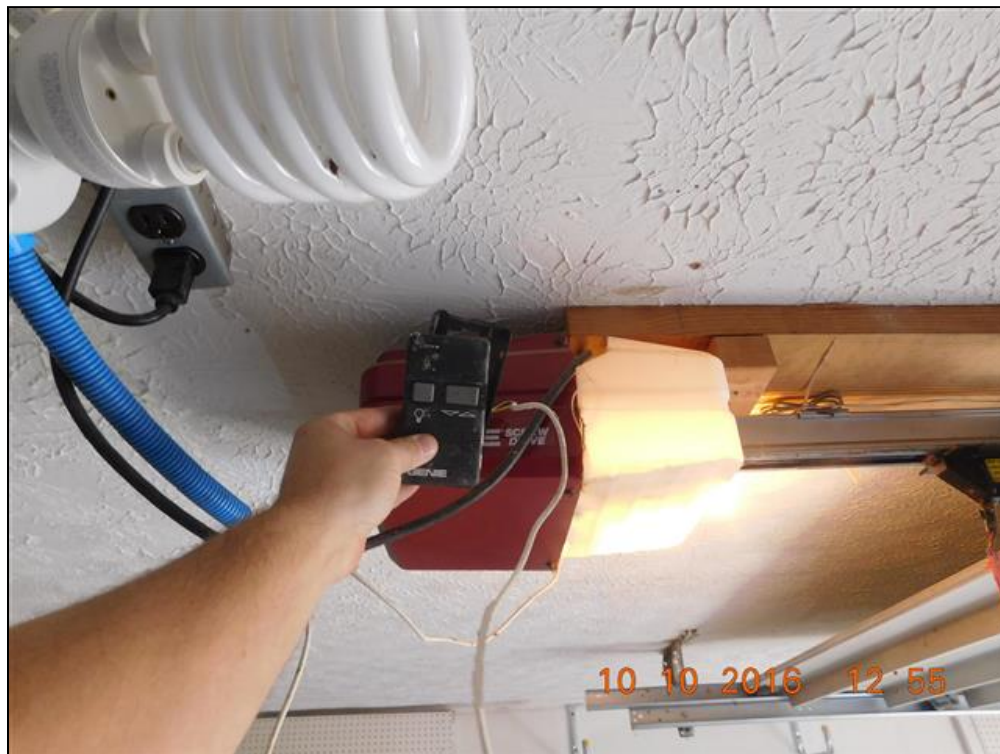
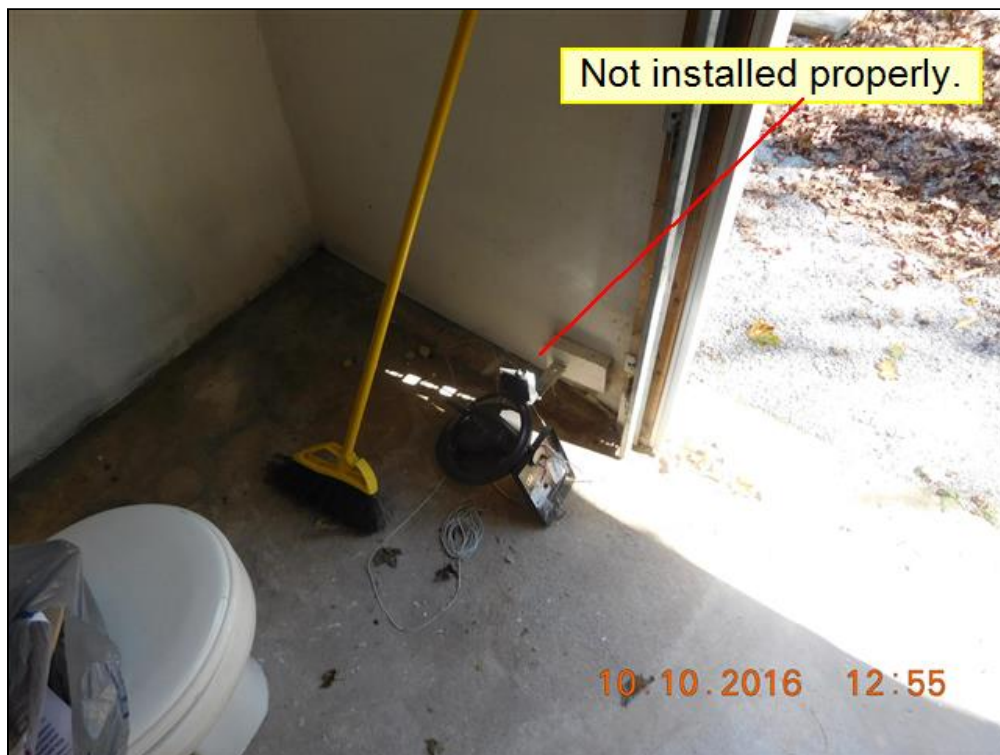
4.4 The opener does not work. The switch is not mounted, and the eyes that protect things from being crushed are not setup. Repair/replace as needed.

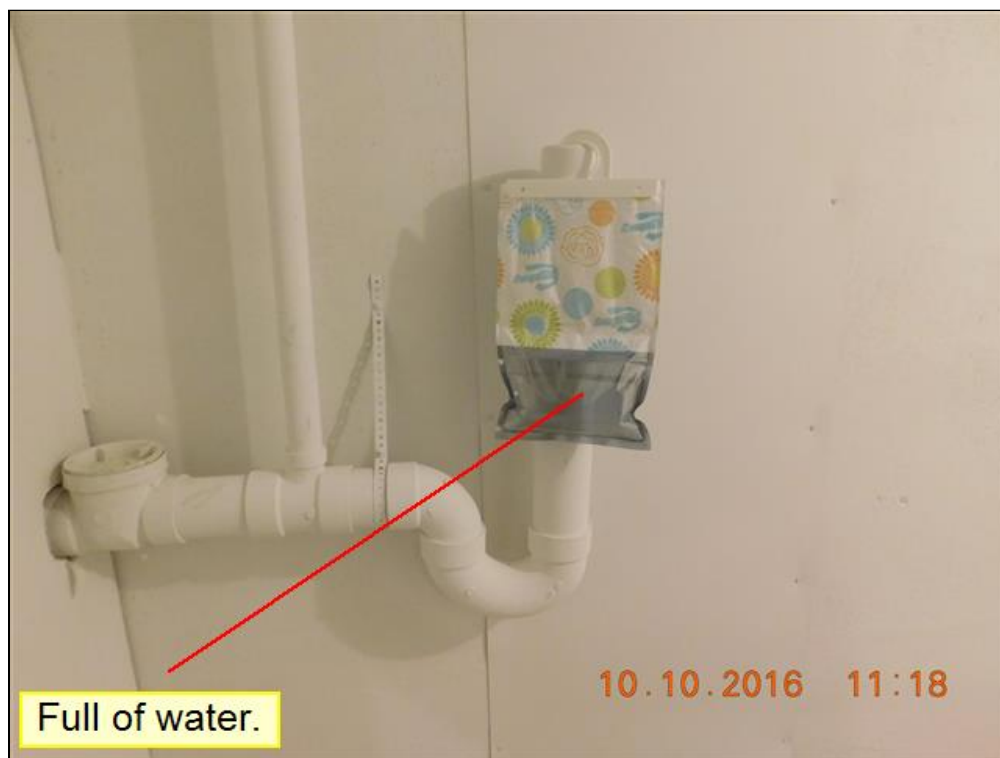
5.0 Item 1(Picture)

5.0 There are several bags of Damp-rid (moisture removal) hanging around the house. It's common to see these in houses that water problems (like ones with leaking basements). I did not find any leaks in the basement, but it hasn't rained in some time. You'll want to check with the sellers about why these are needed in the home. Has the basement ever leaked? What was done to correct things if so?

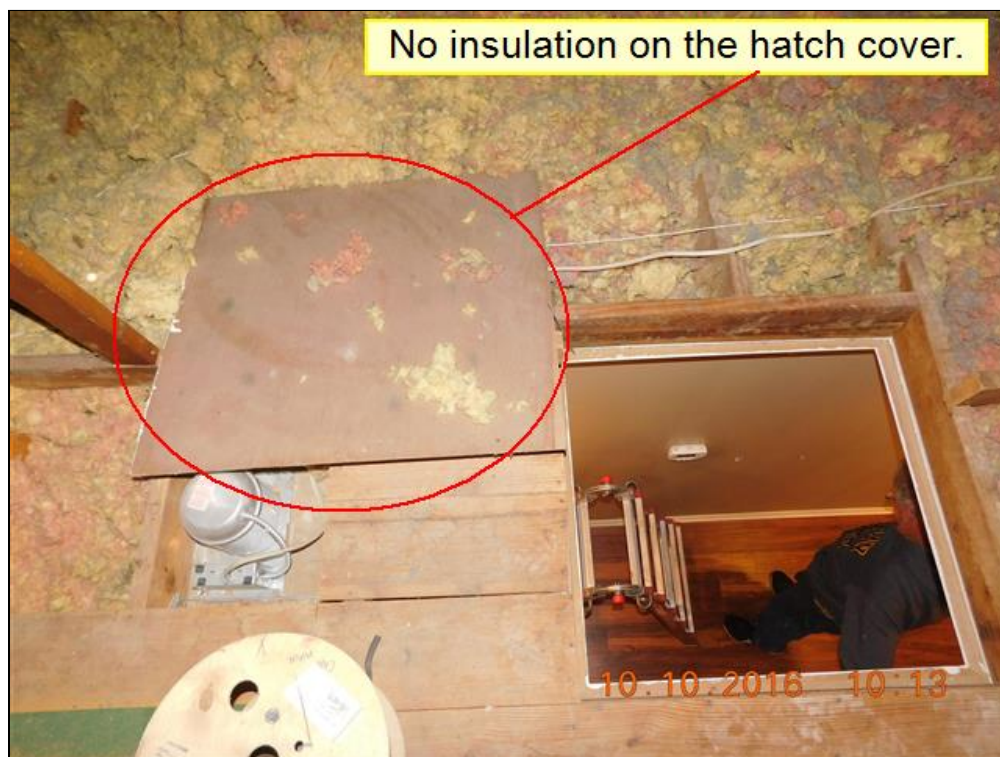
5.1 Item 1(Picture)

5.1 The attic access hatch cover is not air sealed, and doesn't have any insulation on it's backside. Areas like these can be a big ding to the efficiency of the home. You'll want to have the hatch sealed with weather-stripping, and have ridged insulation placed on the back of the sheet goods that cover the hole. I've written a how-to guide on this subject you can read here: <http://abihomeservices.com/insulating-your-attic-access-hole/>

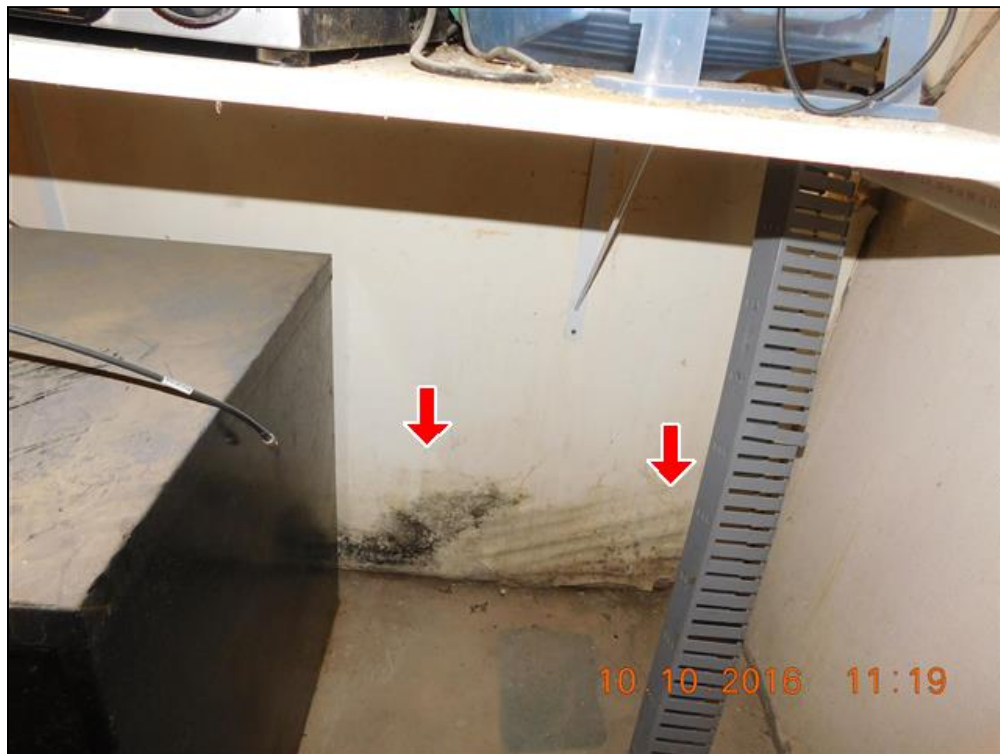
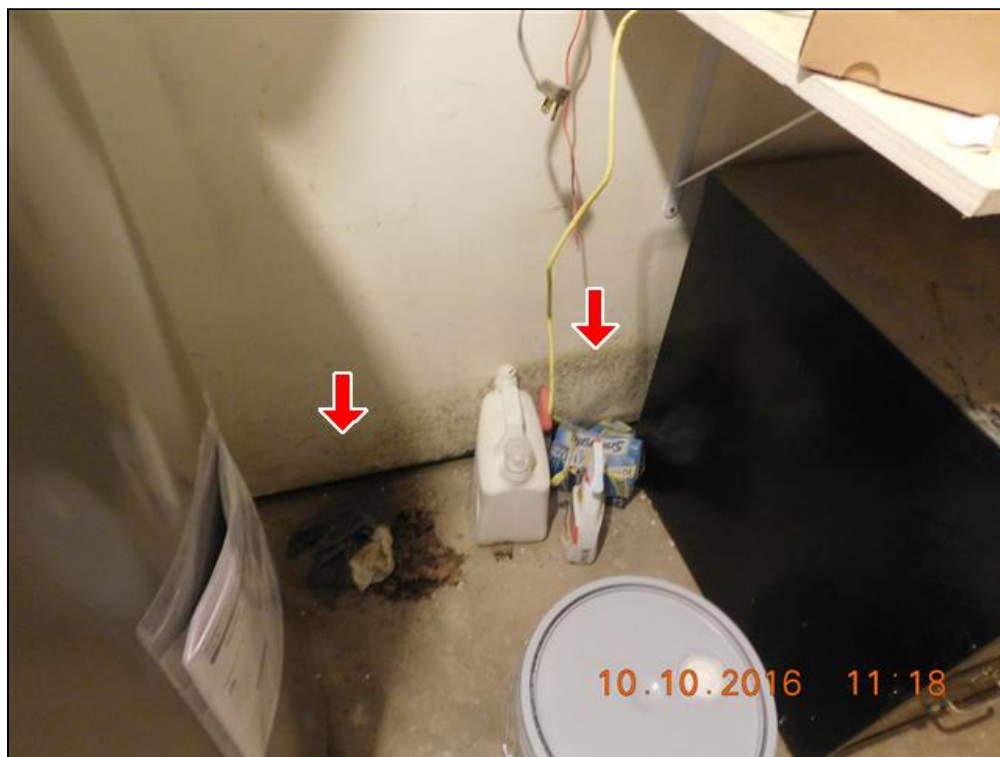
5.2 (1) There is a section of drywall in the basement that has mold on it behind the desk and water heater. It's all dry today, so likely old damage. Have the damaged drywall removed and repaired as needed.

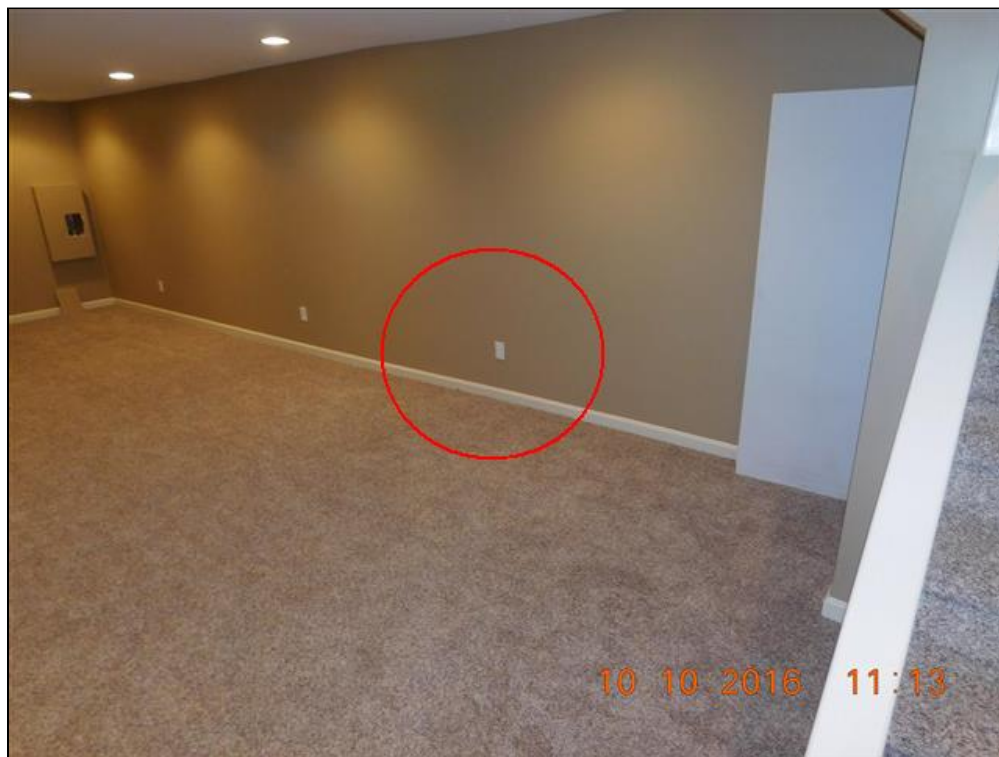
5.2 (2) There is a section of bubbling drywall/paint in the basement (below the fireplace). This could be from water running down the wall from the leak upstairs, or it could be a totally different source of water. You'll need to dig into this deeper to find the issue and repair as needed.

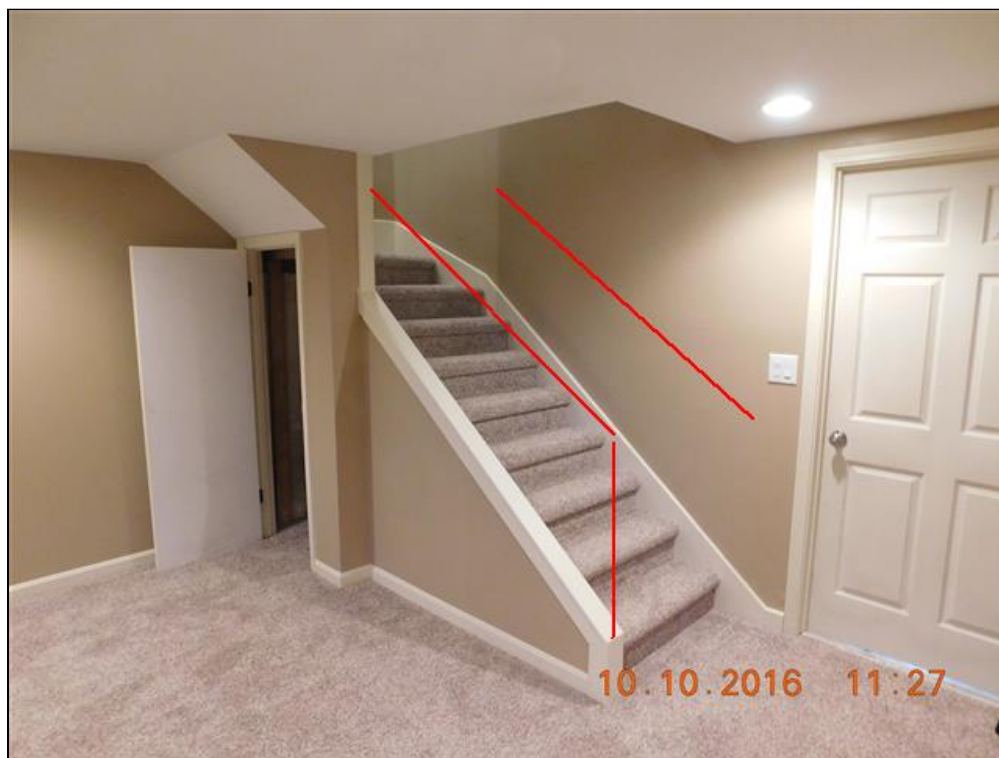
5.4 Item 1(Picture)

5.4 (1) The steps leading into the basement are missing the handrail & guardrail. Have them installed for safety.
