Home Inspection Report

Property Address:
1234 Flipper Lane
Lagrange KY 40031

ABI Home Inspection Service, LLC

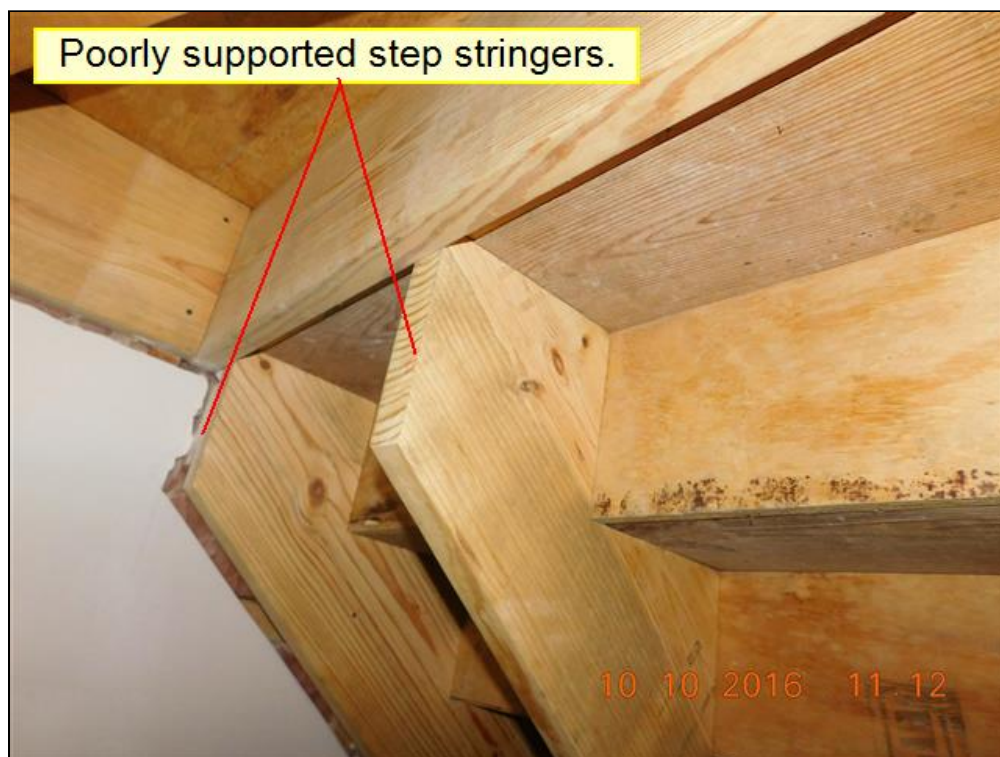
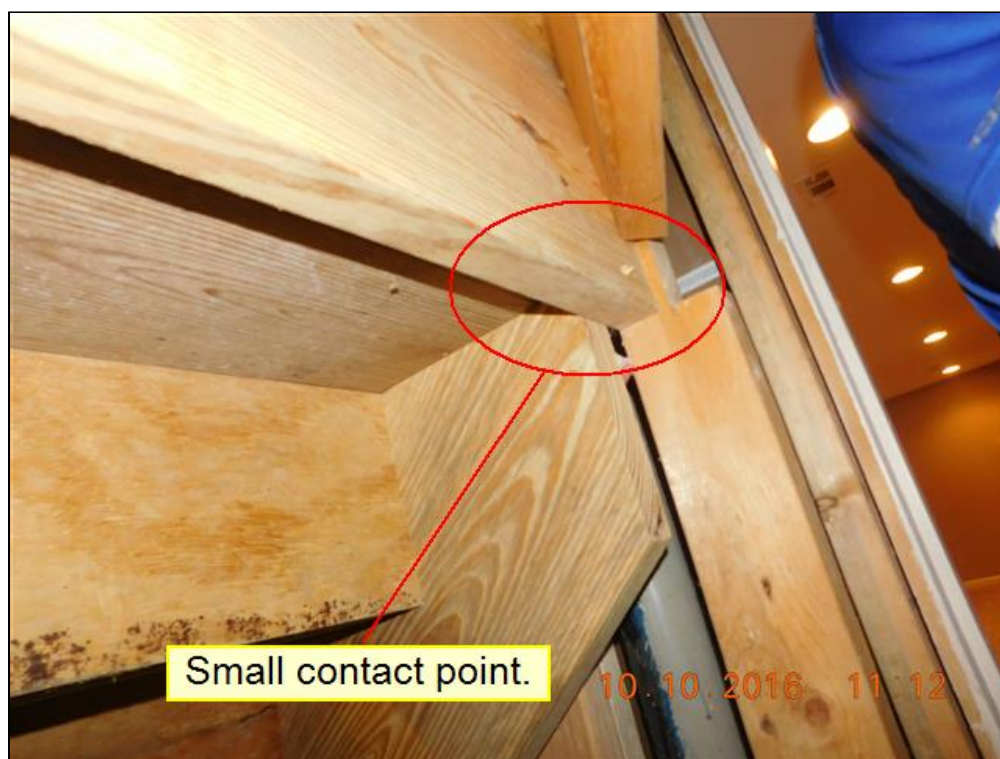
5.4 (2) The steps leading into the basement look to be screwed together with drywall screws (these screws are not rated for use in a structure scenario), and the stringers are barely resting against the platform rim joist. Have a carpenter take a look and repair the steps as needed.

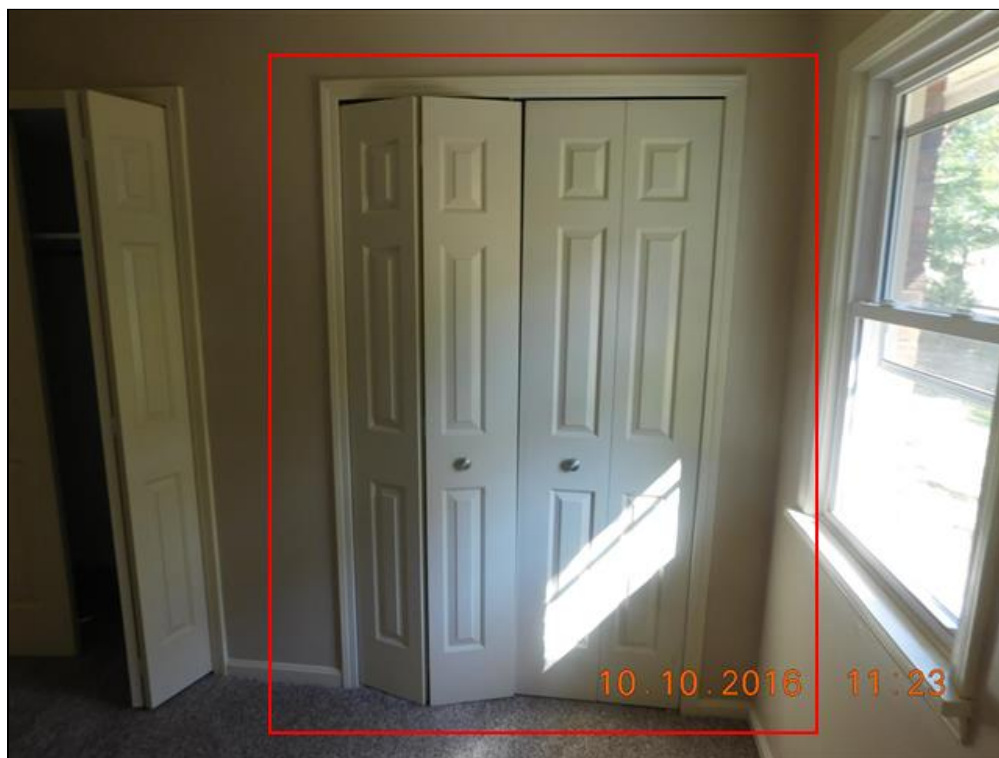
5.6 Item 1(Picture)

5.6 The bi-fold doors in the master bedroom do not close/open smoothly. Repair as needed.

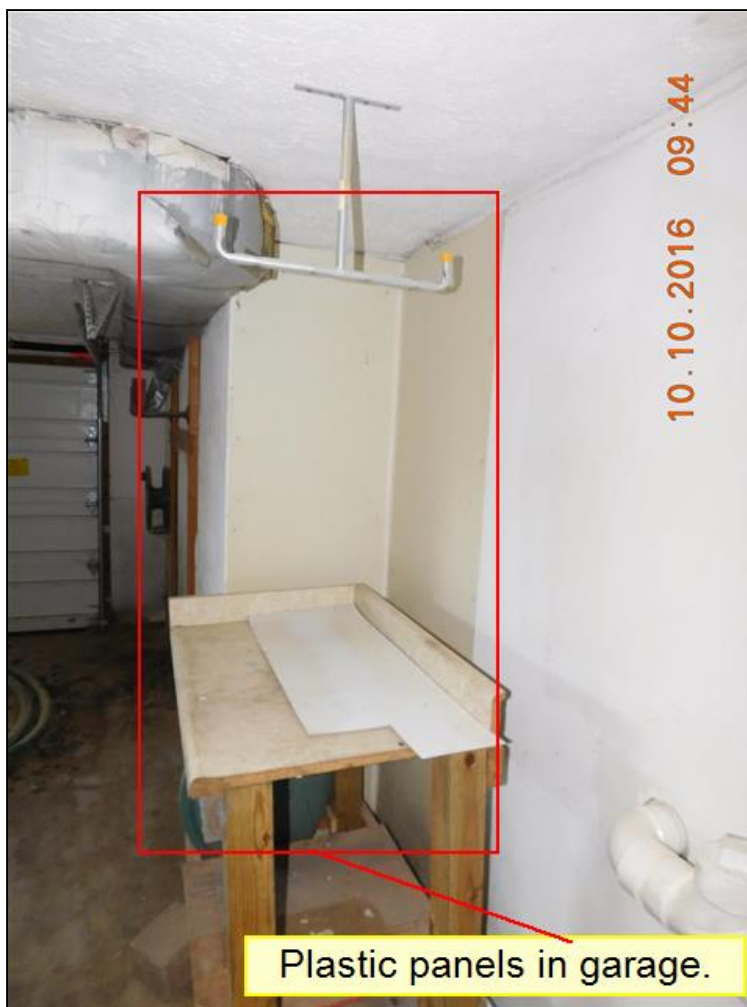
6.1 Item 1(Picture)

6.1 The basement/garage has a water proofing job installed around some walls. Most of the time the companies that install these "systems" do offer a transferrable warranty to the new owner. You'll want to speak with the seller about who did the work, and what you will need to do to make sure you can carry on your warranty with them.

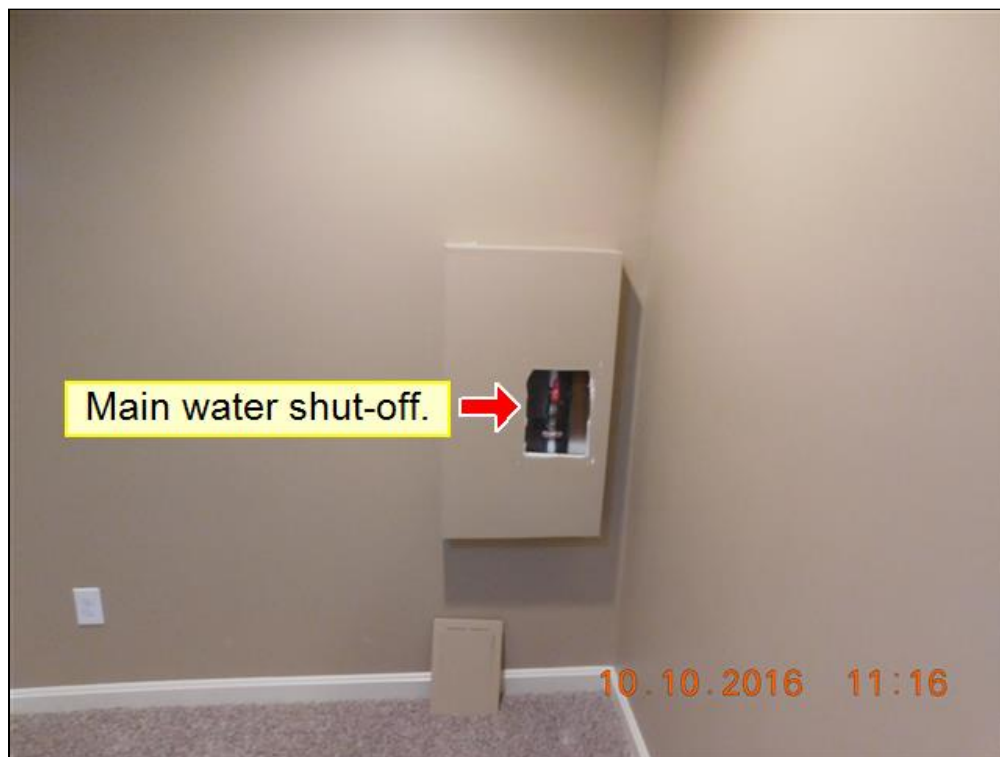
7.3 Item 1(Picture)

7.3 The main water shutoff is located on the far wall in the basement.

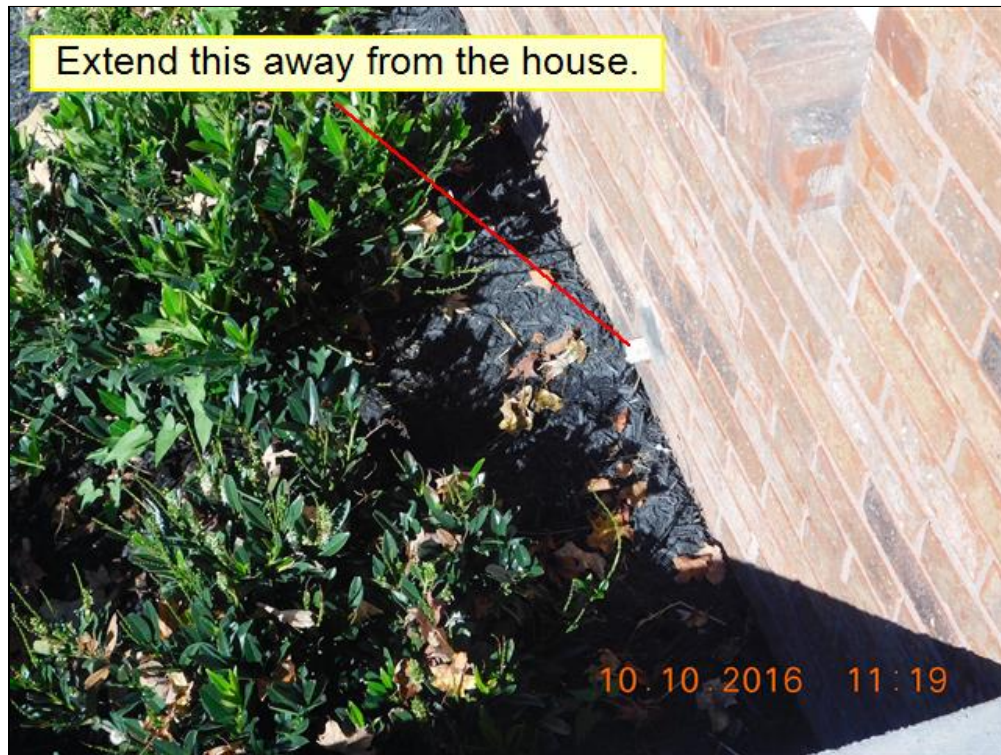
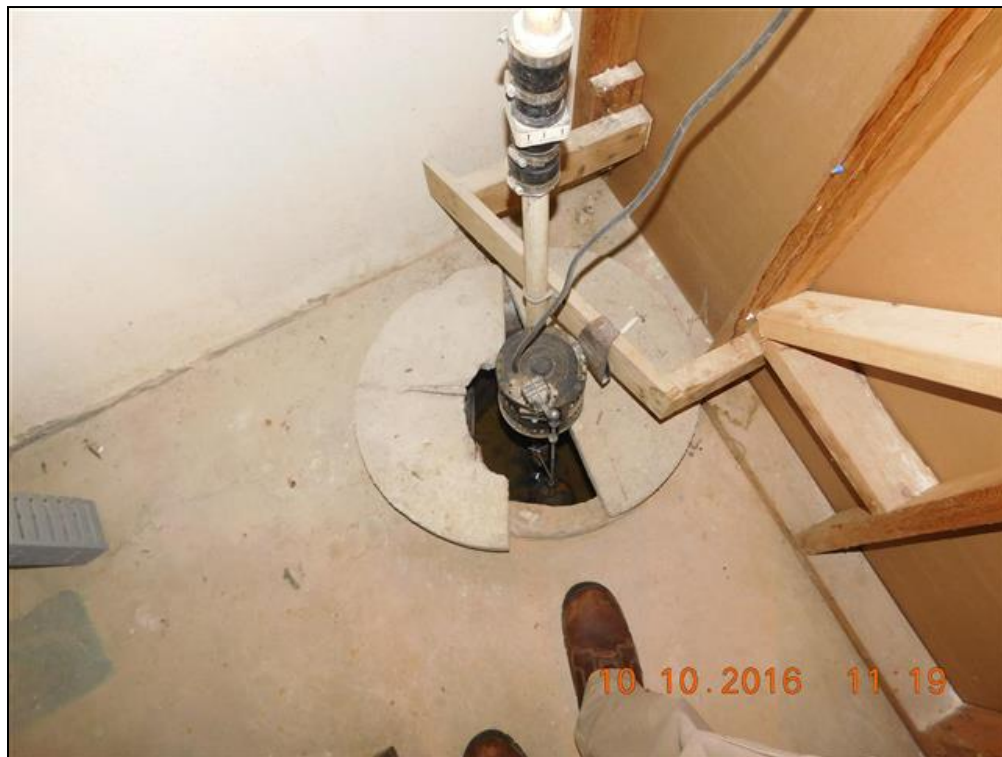
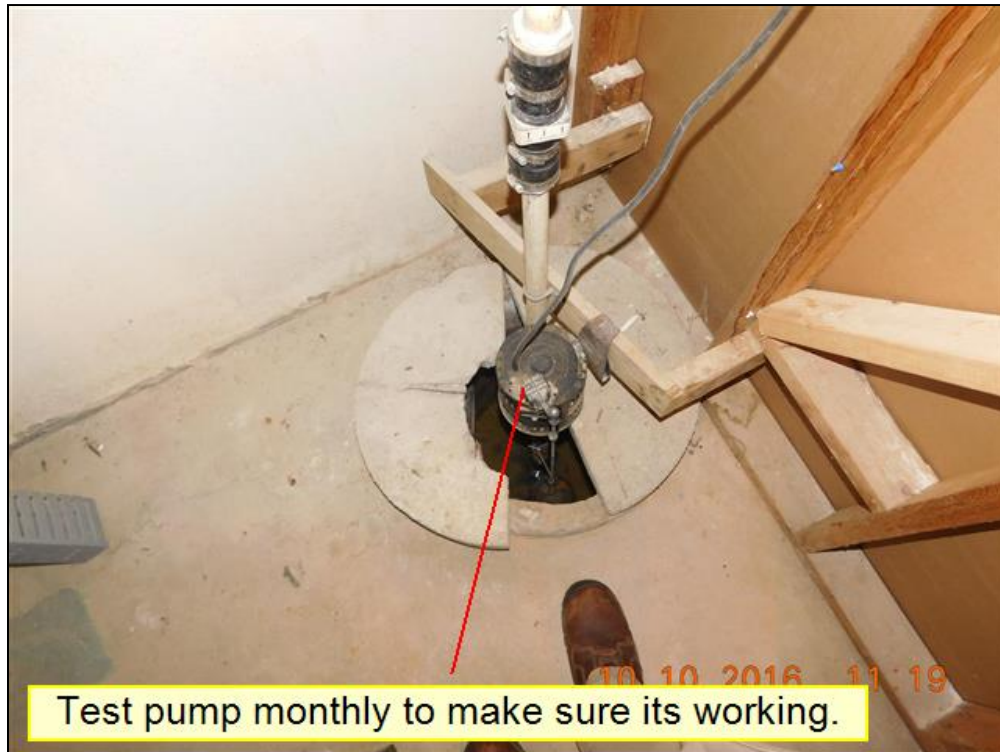
7.4 (1) The discharge line for the sump pump is terminating at the foundation of the home. You need to have this extended away from the house as much as possible. Sump pumps that discharge near the house can cause water intrusion in the basement. *NOTE - It would also be a good idea to increase the size of the pipe to 1 1/2 inch. The smaller pipe could freeze closed in the winter.*

You'll want to also consider adding a water powered backup system. If the power where to ever go out, the back-up system will empty the basin, and may prevent your basement from flooding during hard rain. (FYI)

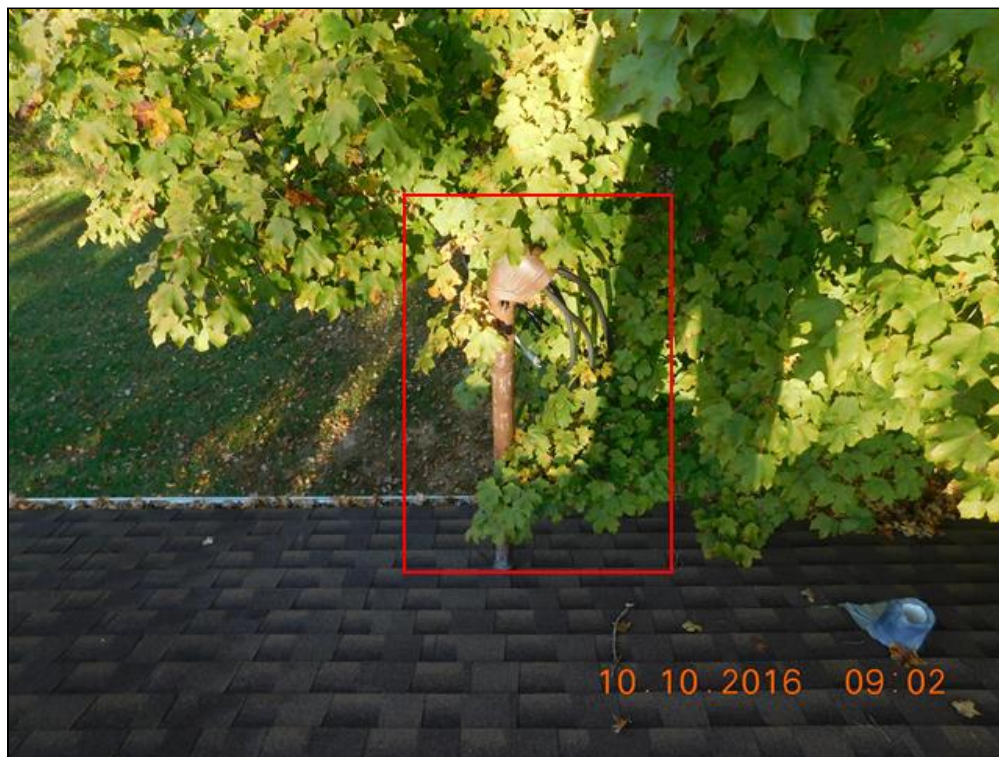
8.0 Item 1(Picture)

8.0 The tree limbs around the riser on the roof need to be trimmed back away from the power lines.

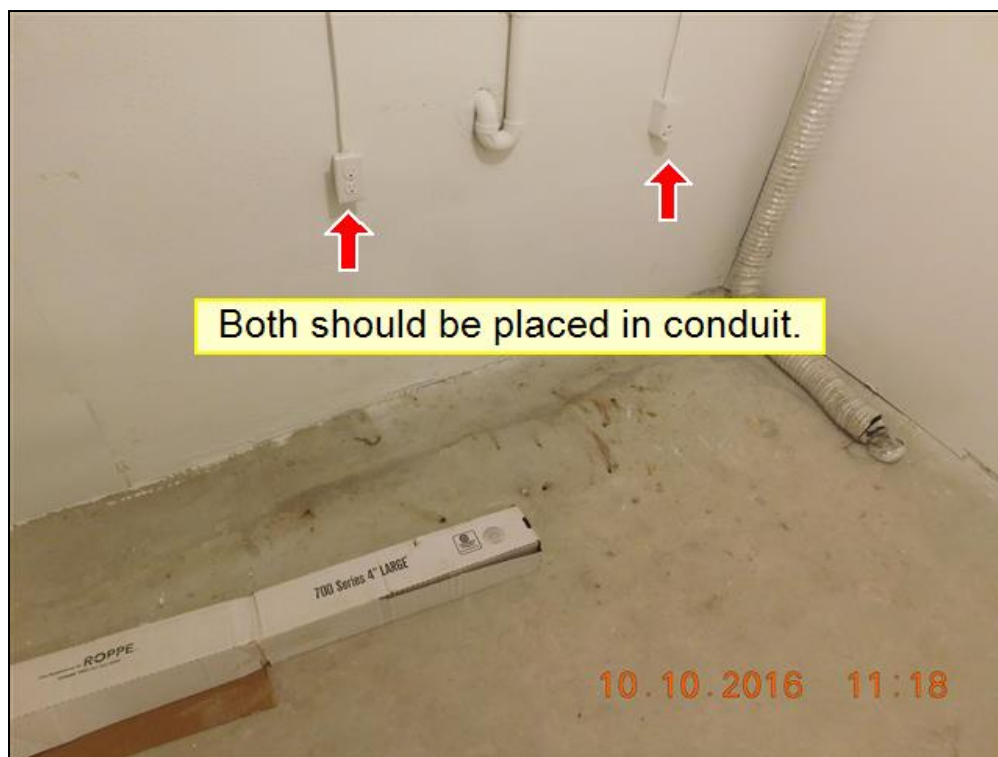
8.3 Item 1(Picture)

8.3 (1) The exposed romex lines in the laundry room should be placed in the proper conduit for safety.

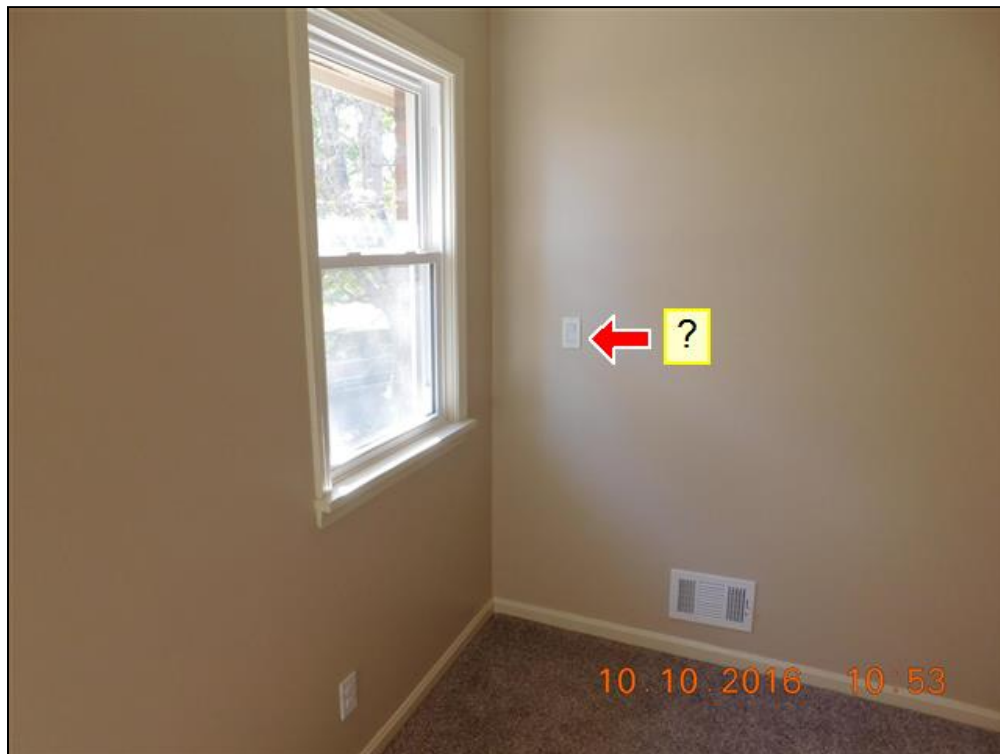
8.4 Item 1(Picture)

8.4 (1) There is a wall switch in the master bedroom that I could not figure out what its for. Ask the sellers if they know what this is used for.

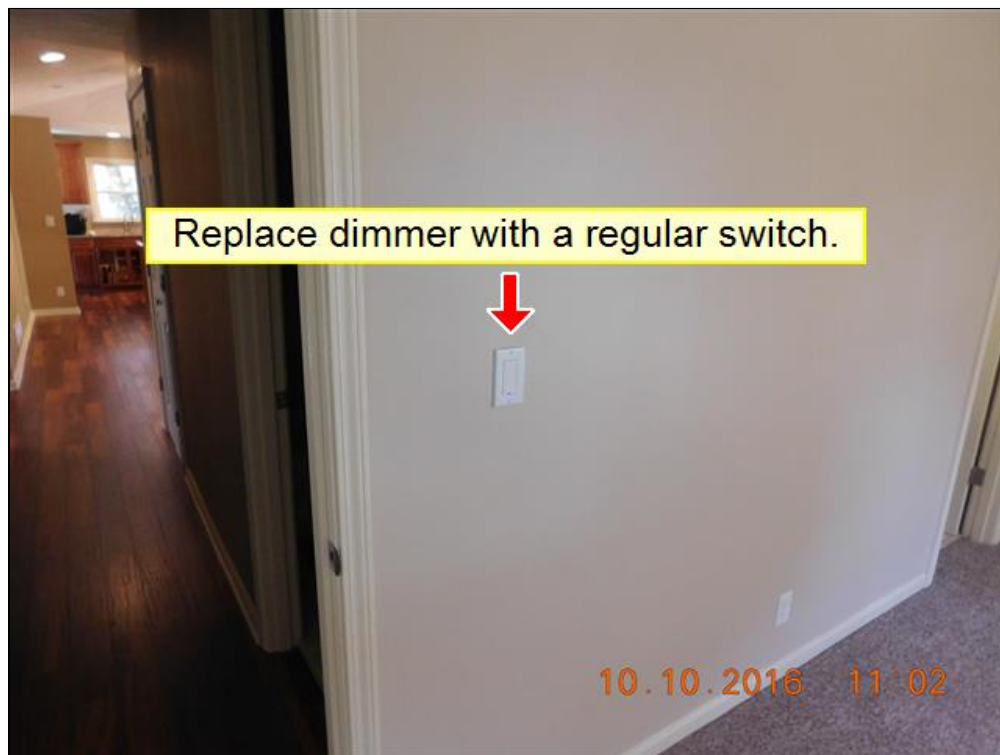
8.4 Item 2(Picture)

8.4 (2) The dimmer switch in the back bedroom is not rated to be connected to a ceiling fan. Most dimmers (for lights) simply cut back the amount of voltage something receives. Ceiling fans don't work that way. When they wired to a switch like this it can cause the fan to burn up/possible fire risk. You can buy special dimmers made just for fans with a light kit. Have this dimmer removed just to be on the safe side.

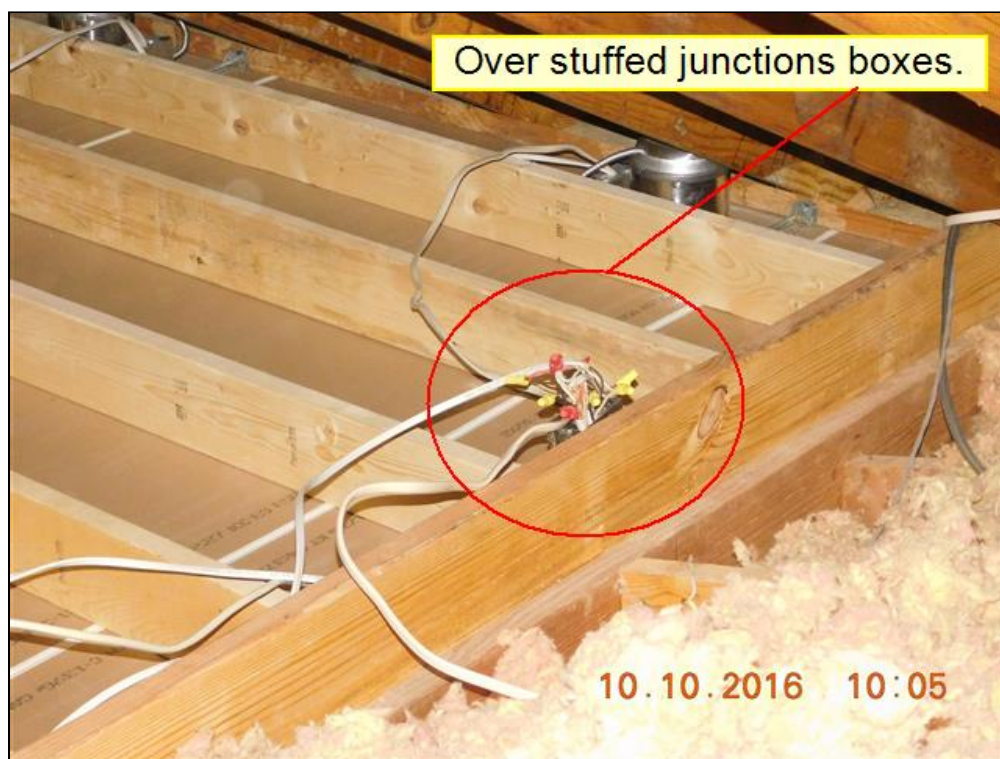
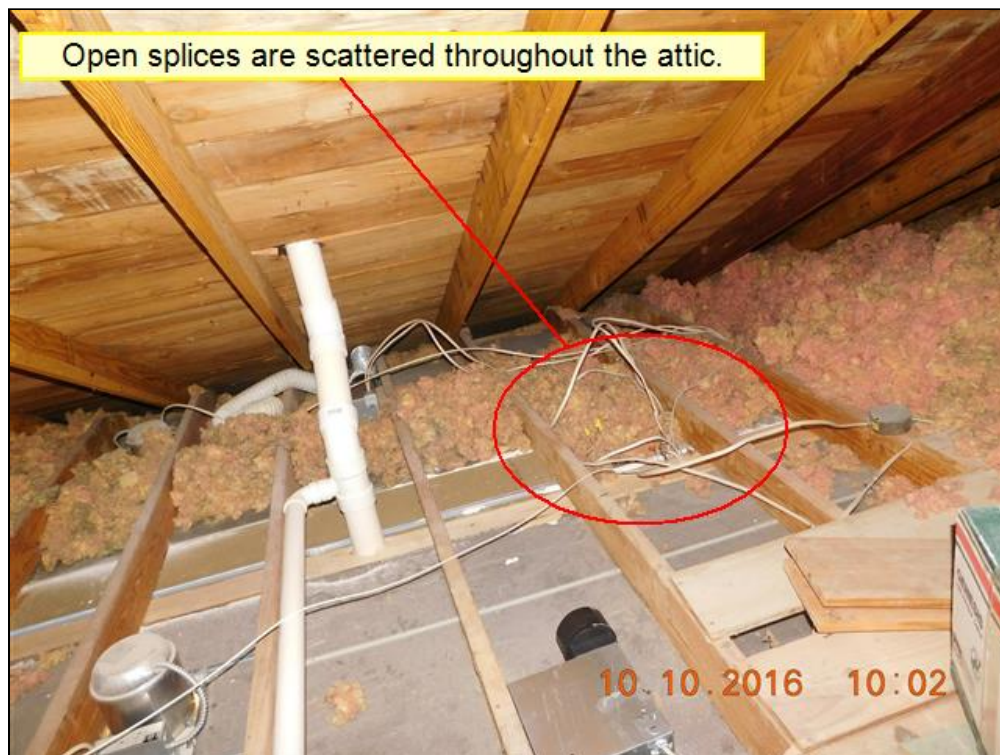
8.4 (3) The wiring that is visible in the attic does not appear to have been installed by a licensed electrician. It's messy, strung about, and could pose a fire risk. I noticed the following while in the attic:

You'll want to have a licensed electrician go through the attic and correct as needed. *Understand there could be more issues like these under the insulation we can't see, or even behind the drywall.-FYI*

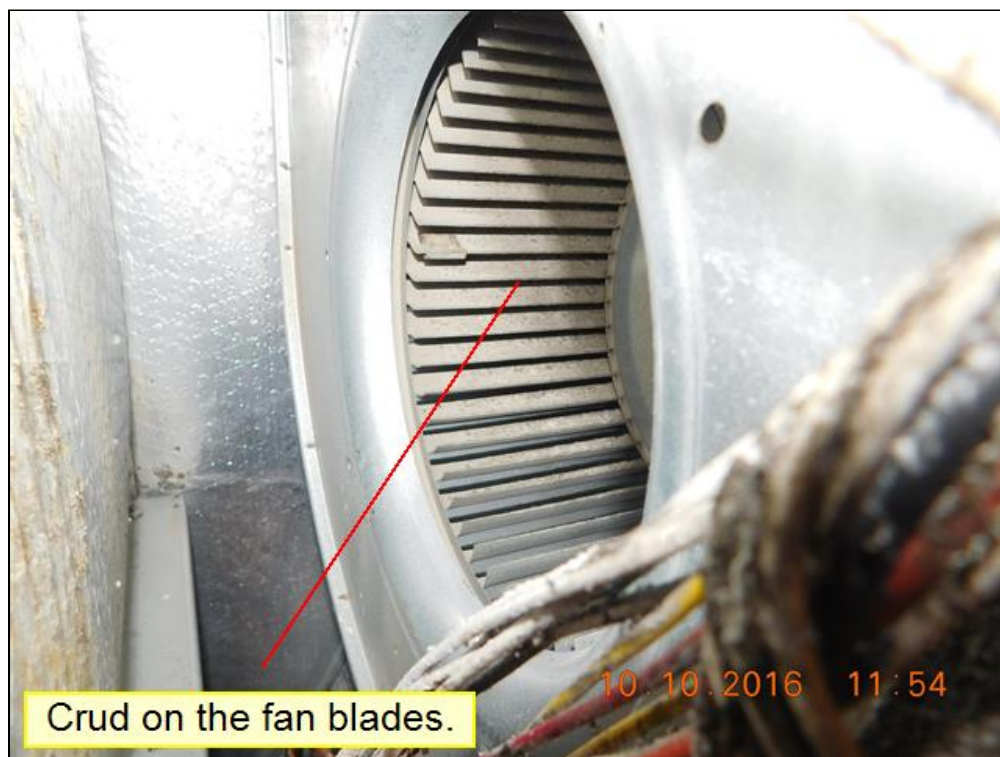
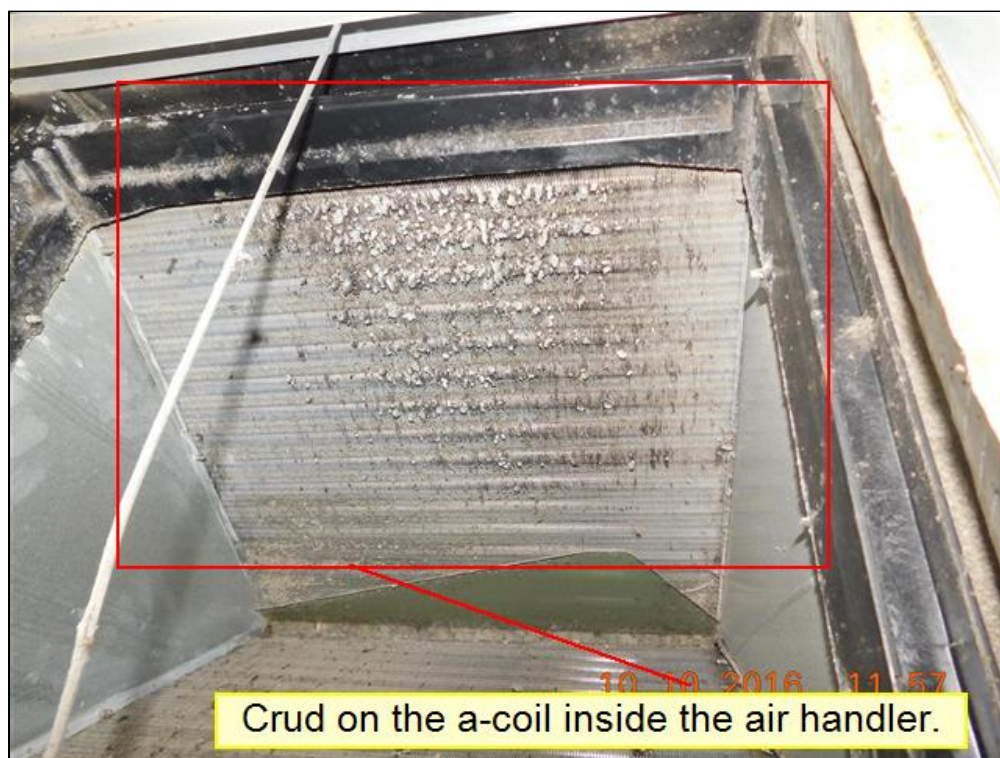
9.0 (2) The air handler is very dirty on the inside and needs to be professionally cleaned. You'll want to have an HVAC tech perform a clean and tune on the unit. It appears it hasn't been professionally maintained for quite some time.

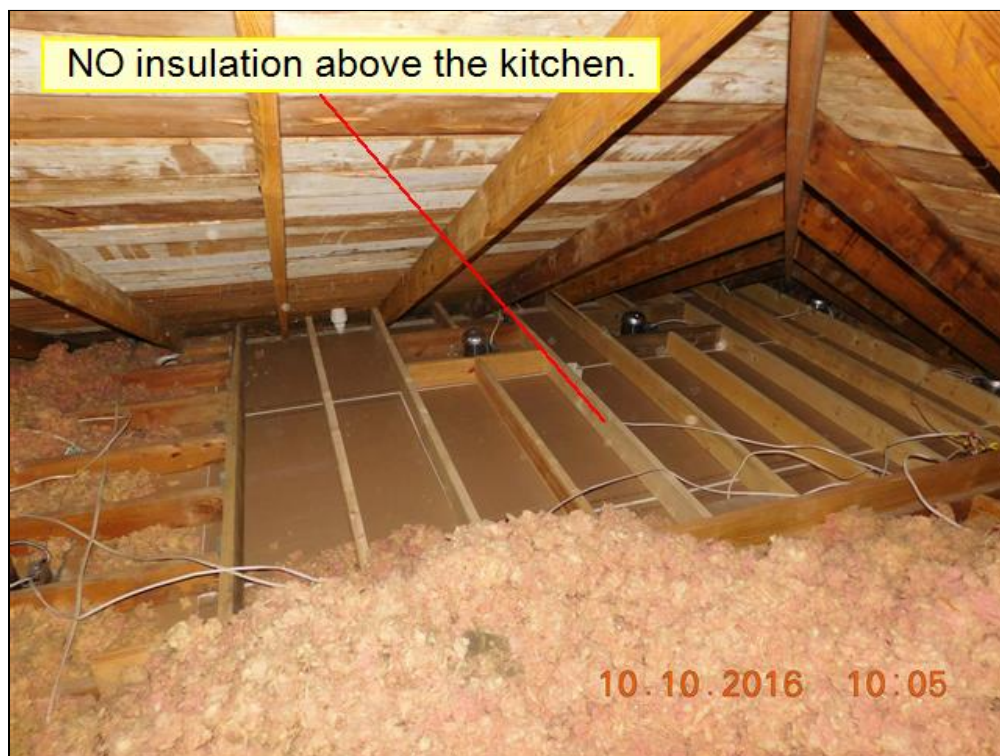
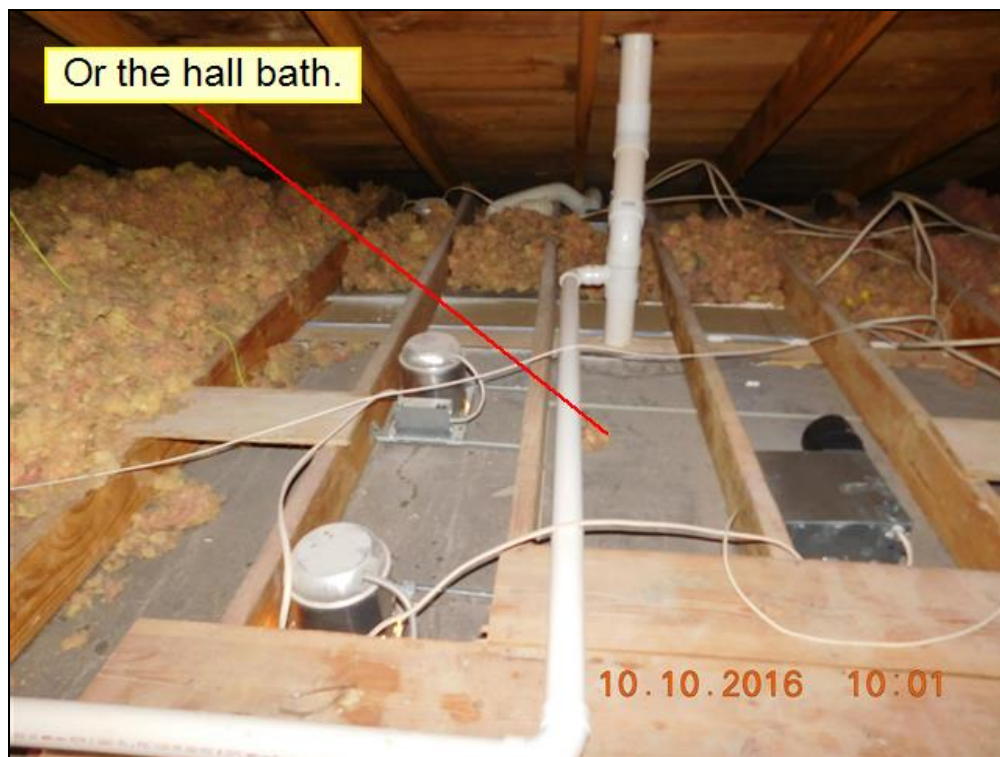
10.0 About half of the attic has NO insulation at all, the other half only has a small amount. You'll want to have the attic insulated to today's standards which is about an R38 to R60 in our area.

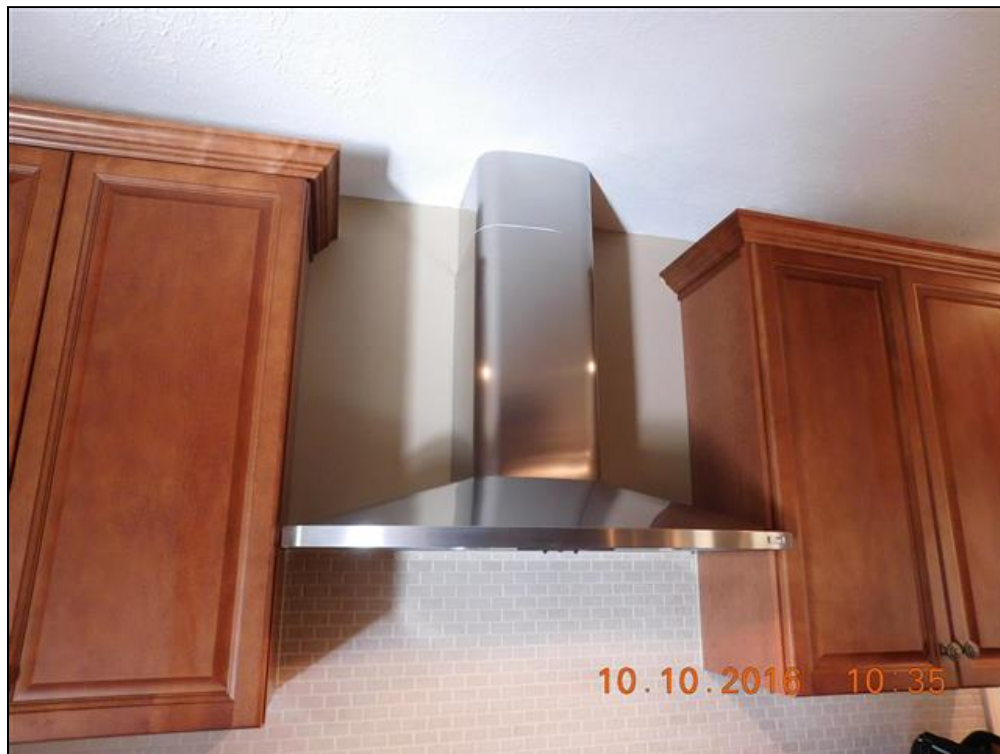
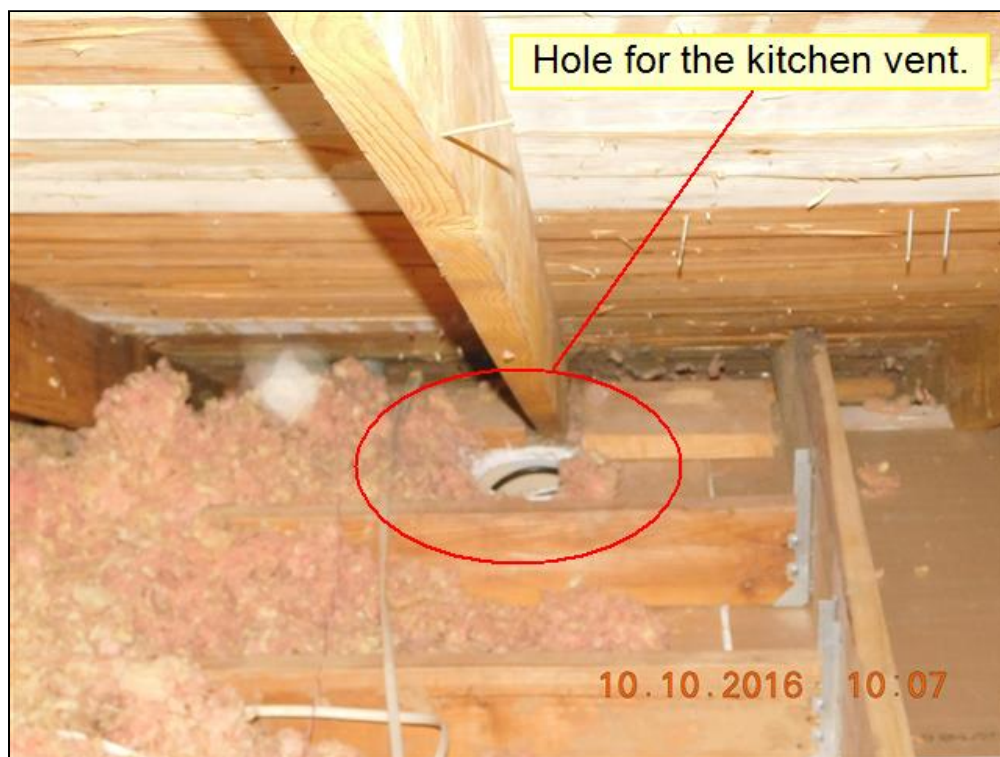
10.2 The vent hood for the kitchen is not plumbed to the outside, but is only venting into the attic. Have the unit extended to the outside, you don't want all that grease collecting in the attic.
