Home Inspection Report

Property Address:
1548 Flipped House Ln.
Louisville KY 40229

ABI Home Inspection Service, LLC

Date: 6/3/2016	Time:	Report ID:
Property: 1548 Flipped House Ln. Louisville KY 40229	Customer: Mr. First Time Home Buyer	Real Estate Professional:

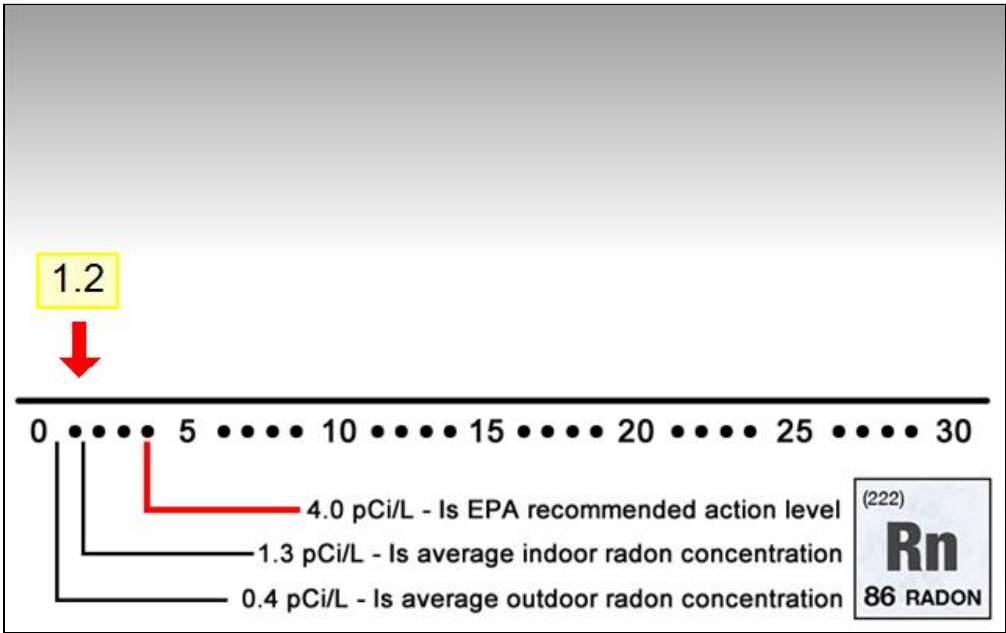
1.0 Item 1(Picture)

1.0 The home was tested for Radon gas using a Sun Nuclear 1027 continuous monitoring system. **The overall average of pCi/l (pico Curies per Liter) was 1.2.** The EPA recommends mitigation (removal system) for all homes with a level of 4.0pCi/l or more.

With numbers this low, it's doubtful you'll ever have elevated Radon gas levels, but if you do large amounts of air sealing and home weatherization, you will seal up the house, and those numbers will rise. -FYI

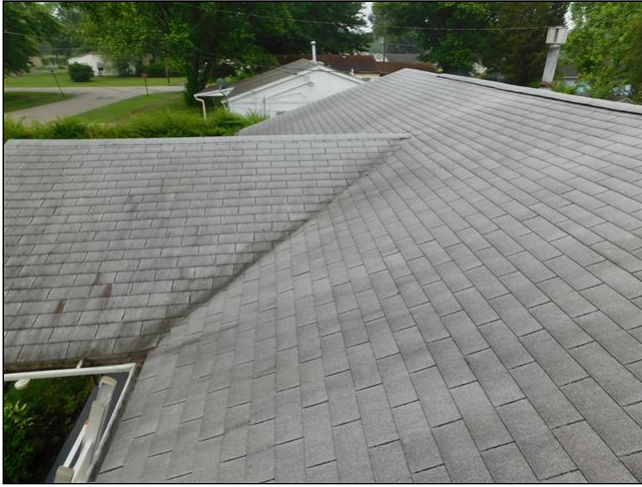
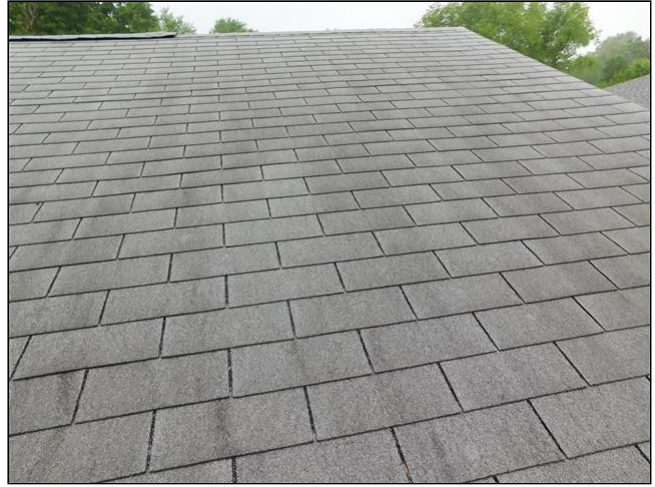
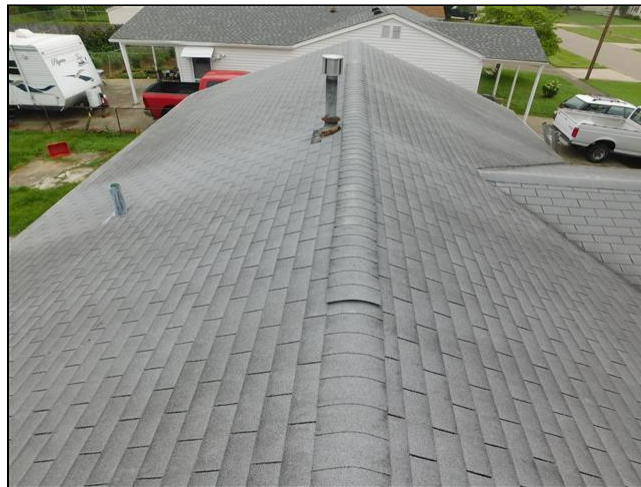
2.0 Item 1(Picture)

2.0 The roof is not in bad condition, but I am starting to see faint cracks start to form in the shingle tabs. This happens as the roof begins to dry out from age. I would guess the roof is about 10 yrs old (give or take a year or two). If this is accurate, you should get another 5 or so years out of the roof. Most 3 tab roofs last around 15rs. -FYI

1. The roof is not in bad condition, but I am starting to see faint cracks start to form in the shingle tabs. This happens as the roof begins to dry out from age. I would guess the roof is about 10 yrs old (give or take a year or two). If this is accurate, you should get another 5 or so years out of the roof. Most 3 tab roofs last around 15rs. -FYI

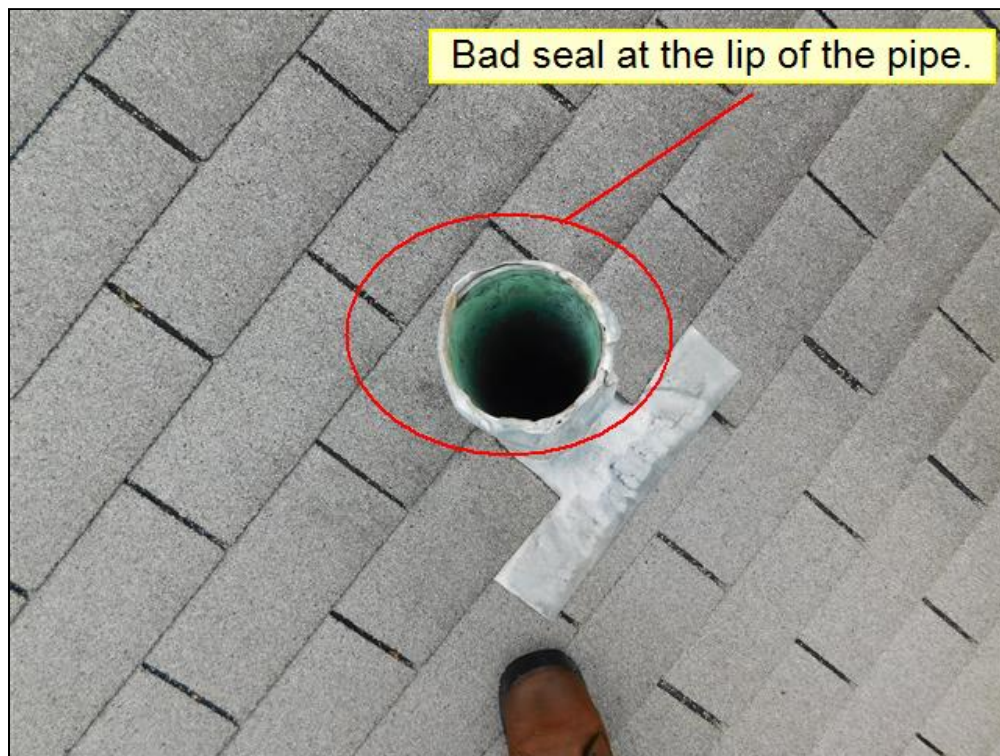
2.1 Item 1(Picture)

2.1 The lead plumbing boot on the roof is damaged and may leak. Have the boots replaced to prevent any water damage in the attic or ceiling area around the pipe. A roofer is best qualified for the job.

2. The lead plumbing boot on the roof is damaged and may leak. Have the boots replaced to prevent any water damage in the attic or ceiling area around the pipe. A roofer is best qualified for the job.

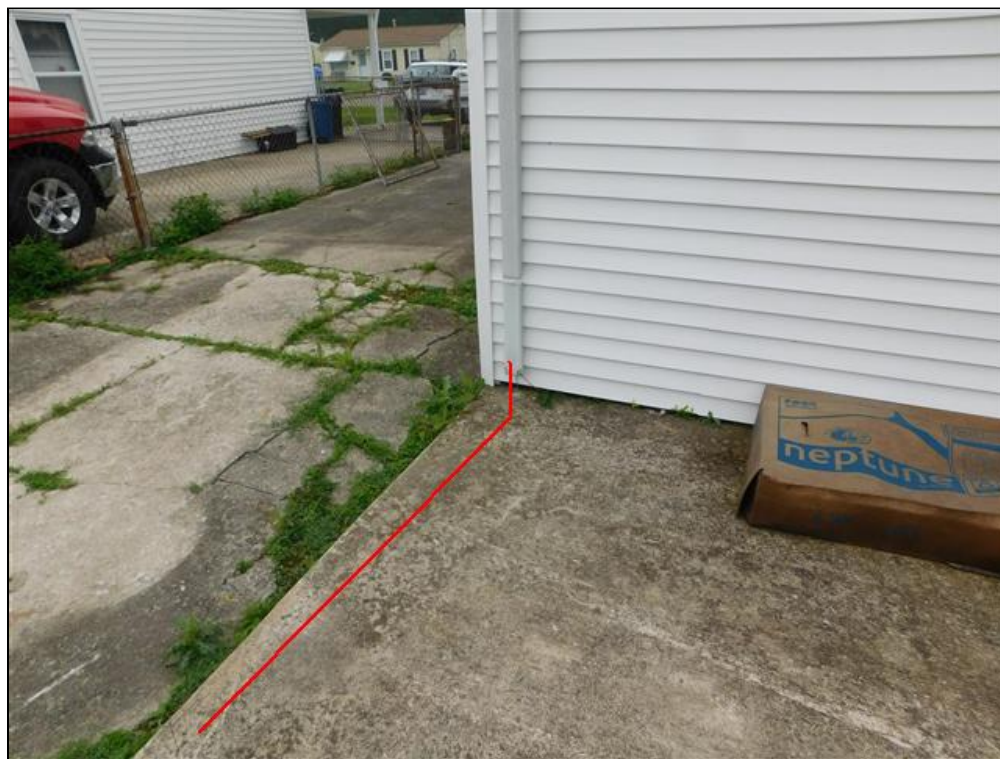
2.2 Item 1(Picture)

2.2 (1) The downspouts around the home need to have extensions added to them. They are discharging water near the homes foundation, which can cause moisture issues around the house. You want to get water away from the foundation at least 5 feet.

3. (1) The downspouts around the home need to have extensions added to them. They are discharging water near the homes foundation, which can cause moisture issues around the house. You want to get water away from the foundation at least 5 feet.

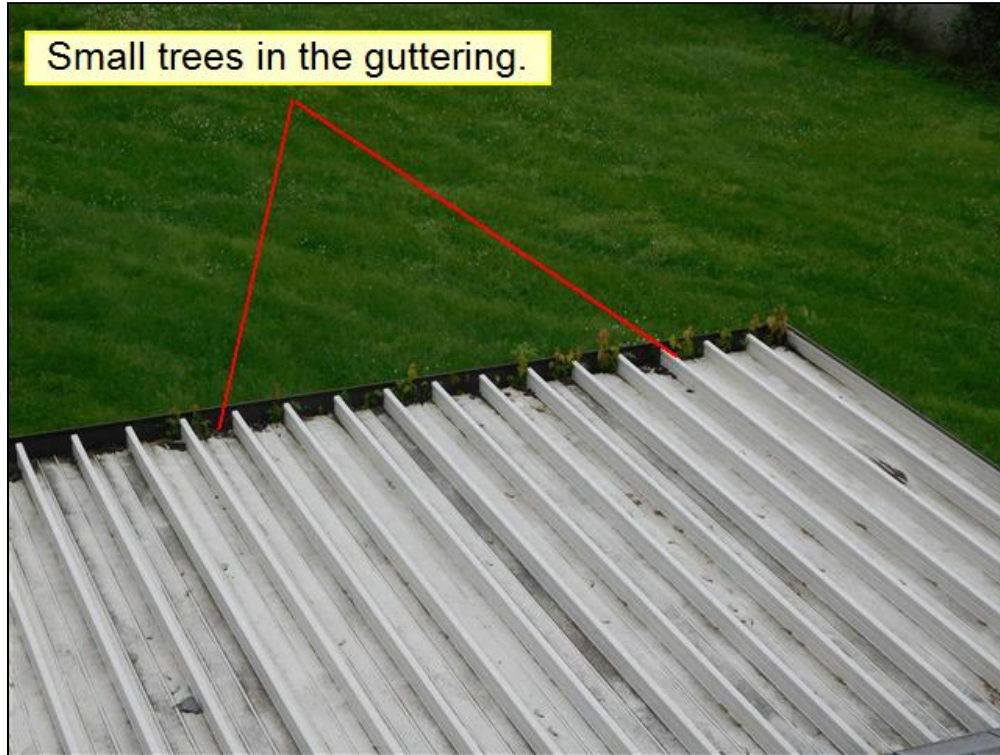
2.2 Item 2(Picture)

2.2 (2) The back gutter is full of debris and need to be cleaned out to allow the roof water to flow properly. This also needs a new downspout placed at the outer post.

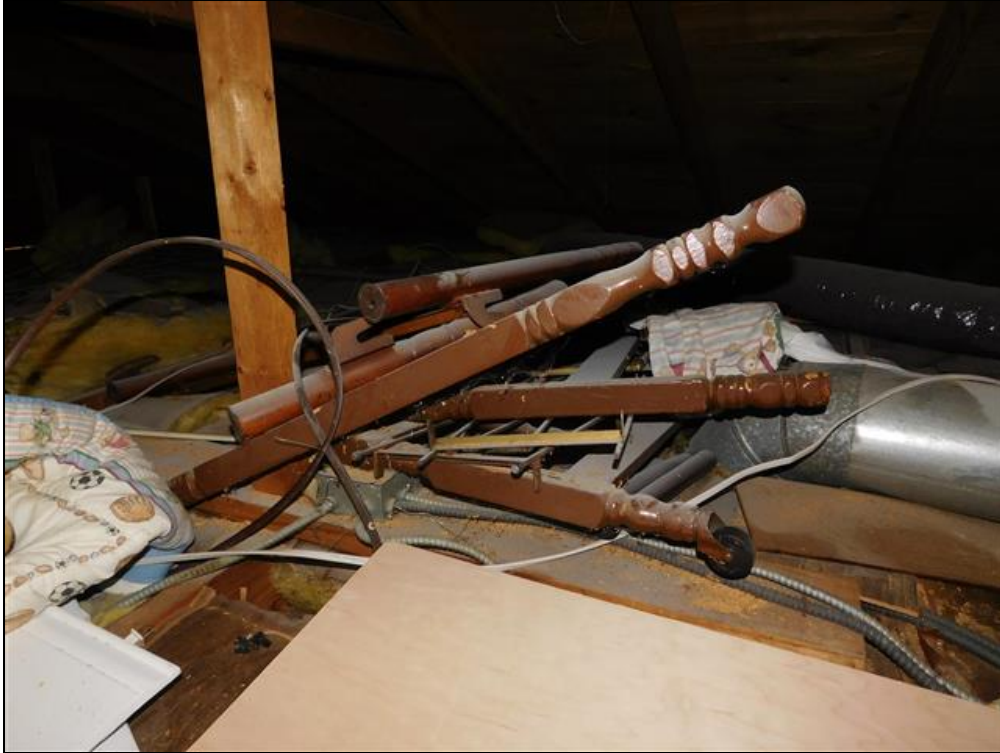
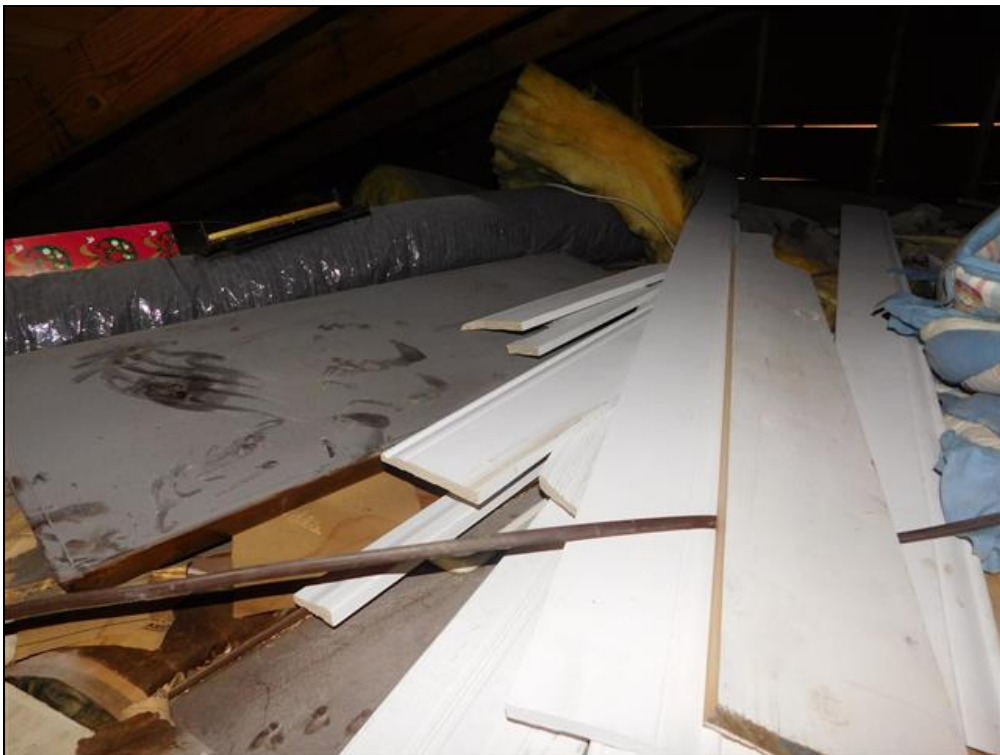
5.5 Item 1(Picture)

5.5 There is a lot of debris in the attic that prevented me from being able to crawl through it. You'll want to have all of this removed so you can see what is going on in the attic.

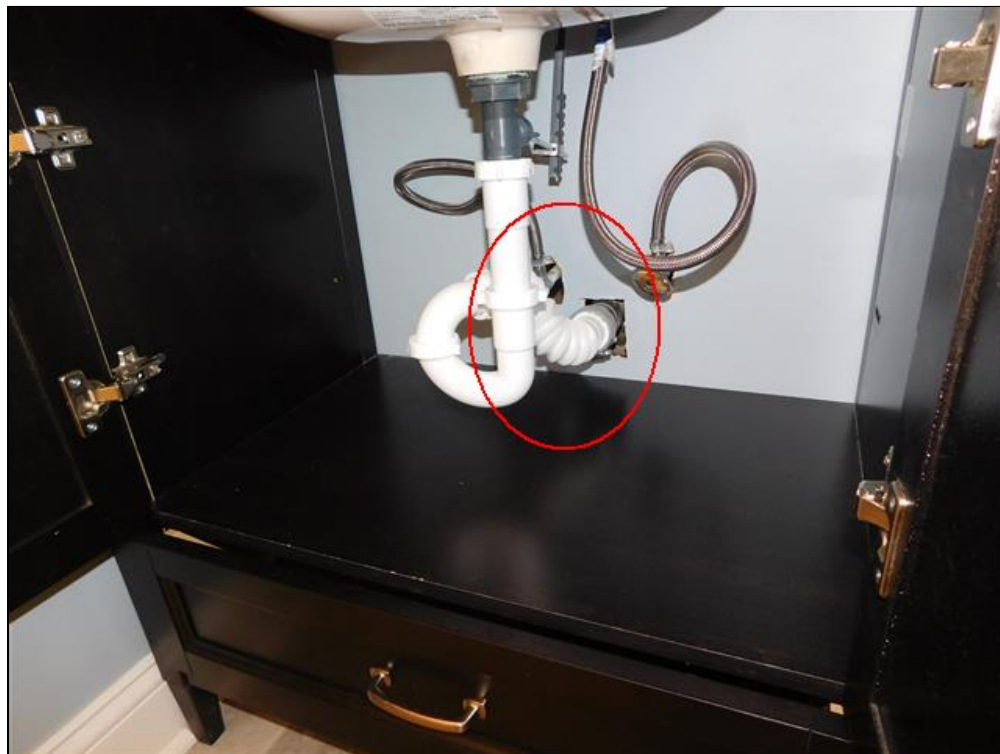
6.0 Item 1(Picture)

6.0 The flexible drain lines that is installed may cause the sinks to drain slowly, or clog easily. I recommend you have the drains replaced with rigid PVC pipe. (FYI)

6. The flexible drain lines that is installed may cause the sinks to drain slowly, or clog easily. I recommend you have the drains replaced with rigid PVC pipe. (FYI)

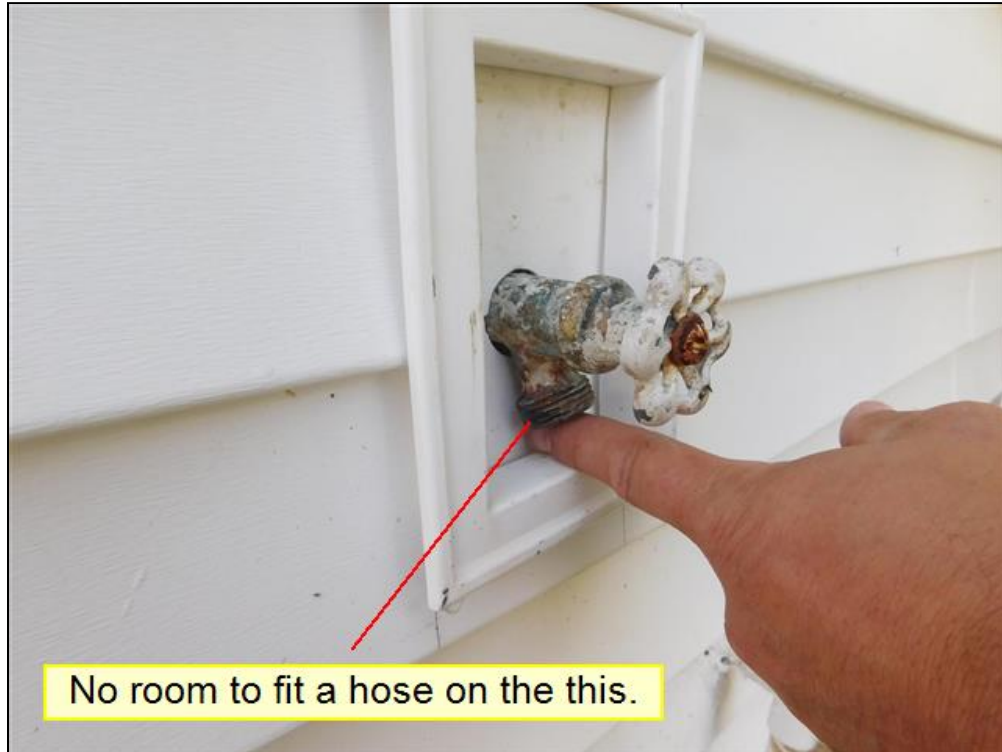
6.1 Item 1(Picture)

6.1 The back wall hose bib has been trimmed out too tightly a with the siding and you can't get anything threaded onto it. Replace as needed so its sticking out from the wall further.

7. The back wall hose bib has been trimmed out too tightly a with the siding and you can't get anything threaded onto it. Replace as needed so its sticking out from the wall further.

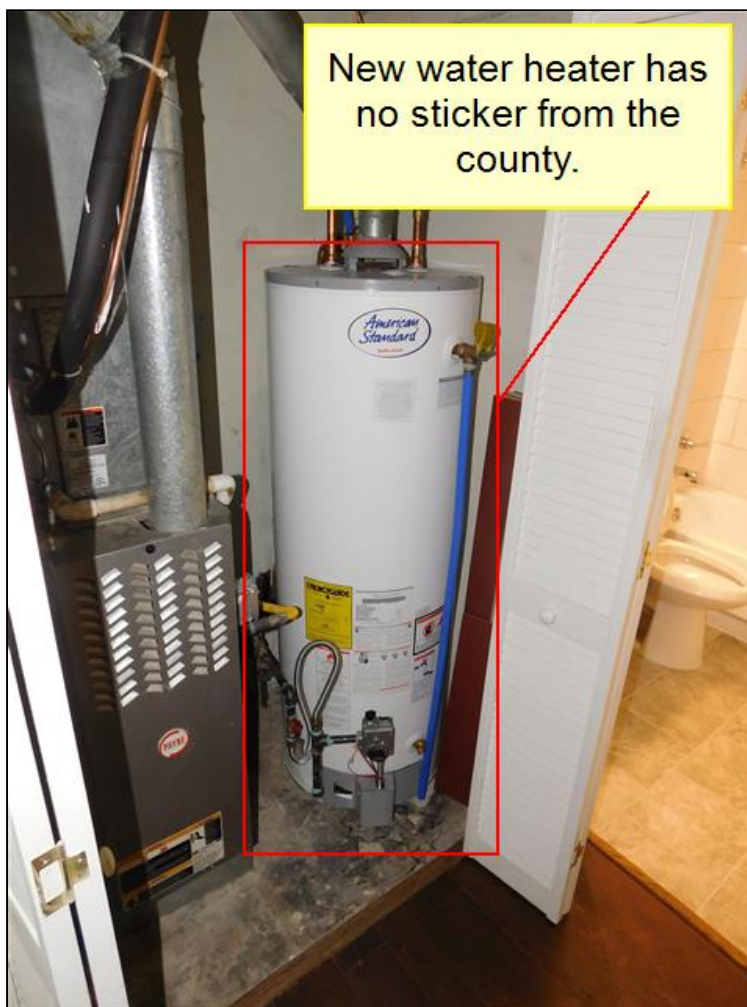
6.2 Item 1(Picture)

6.2 I could not find the "passed" green sticker on the unit from the city inspectors. This likely means the unit was not inspected by the city. You'll want to have the unit inspected and passed by the city inspectors, so there are no questions about why it was never inspected when you decide to re-sell the place.

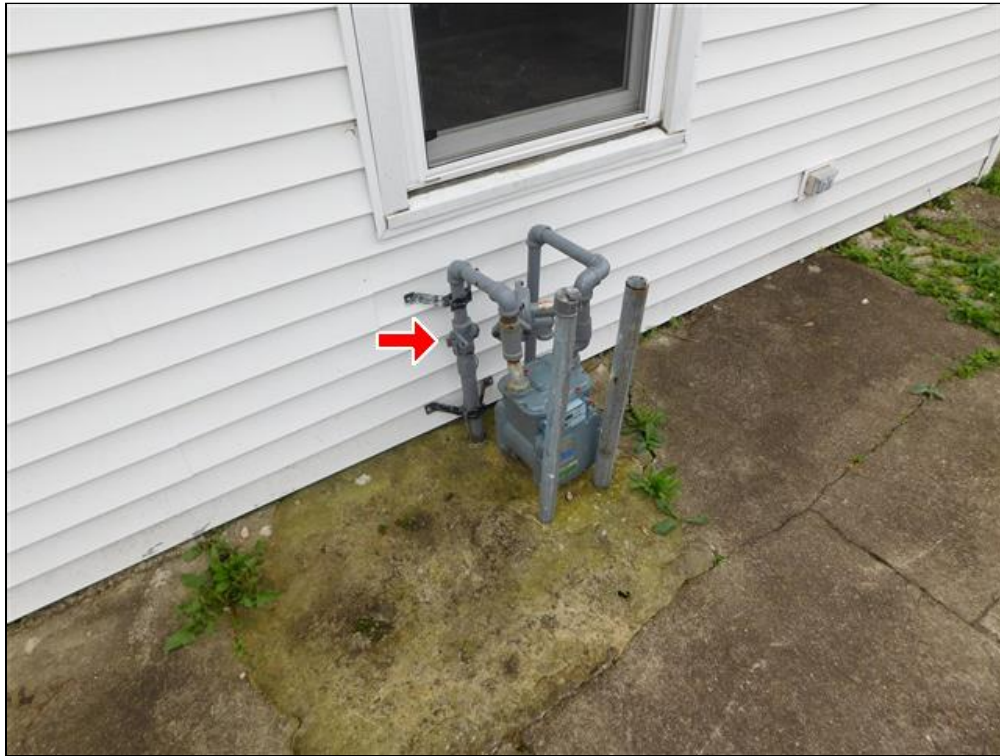
6.4 Item 1(Picture)

6.4 The main fuel shut off is at gas meter outside.

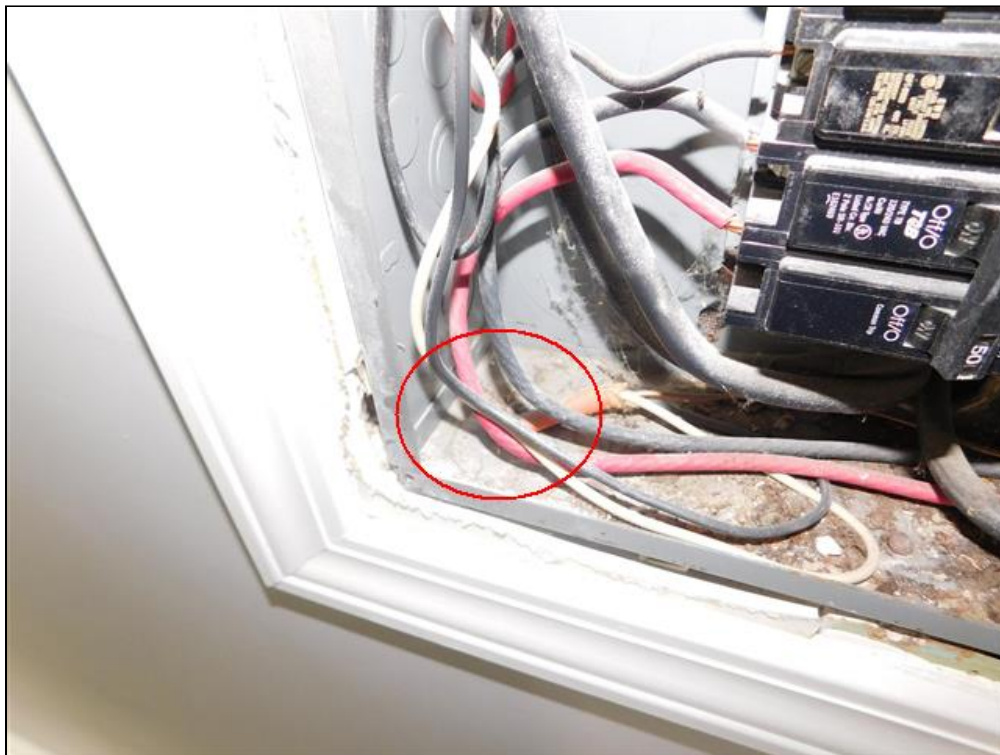
7.3 Item 1(Picture)

7.3 (1) There are wires that are passing through the electrical panel without the proper insulating bushing installed. These keep the wires from being damaged on the sharp metal of the panel wall. Have an electrician install the clamps where needed.

8. (1) There are wires that are passing through the electrical panel without the proper insulating bushing installed. These keep the wires from being damaged on the sharp metal of the panel wall. Have an electrician install the clamps where needed.
9. (2) The outlet in the back wall (middle front bedroom) has no power. Have an electrician repair as needed.

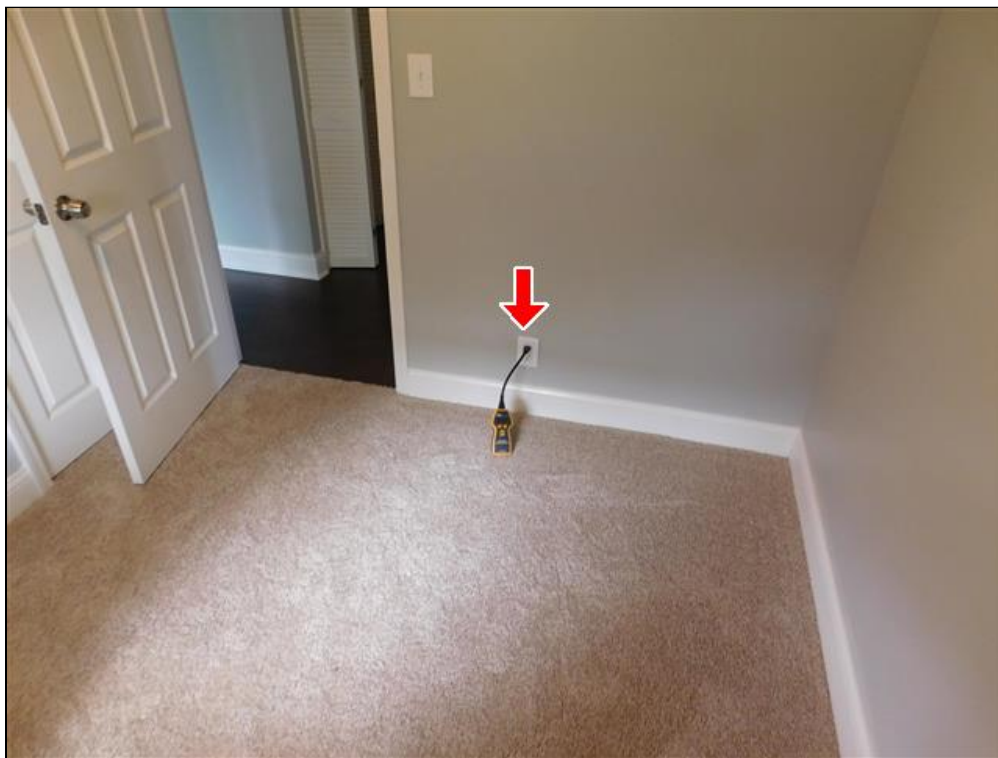
7.3 Item 3(Picture)

7.3 (2) The outlet in the back wall (middle front bedroom) has no power. Have an electrician repair as needed.

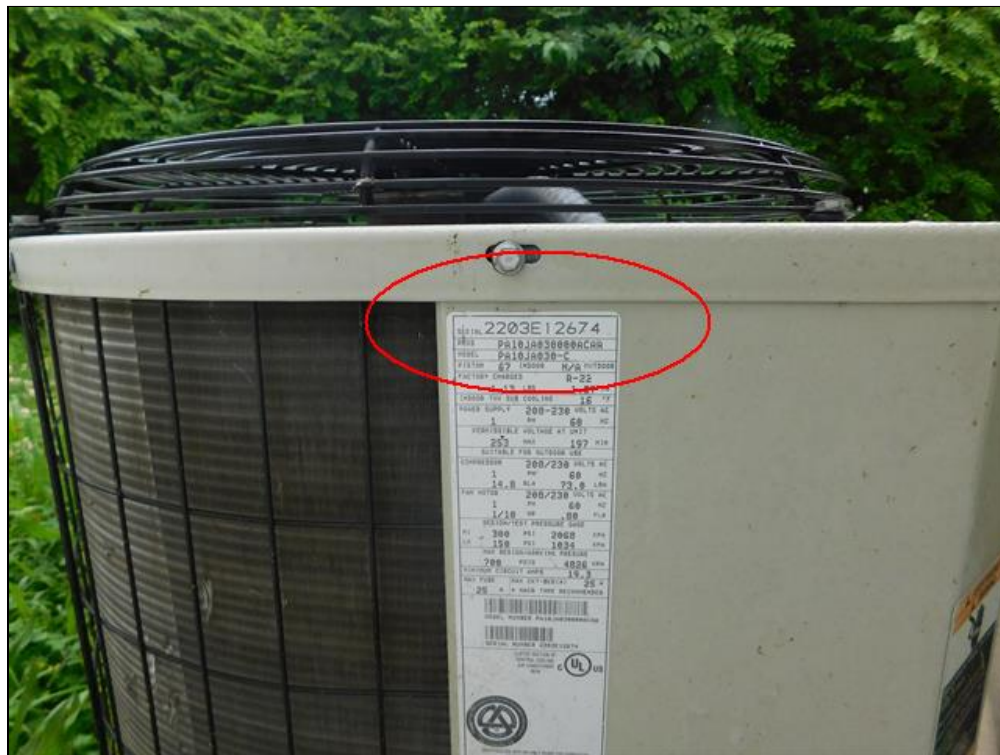
8.5 Item 1(Picture)

8.5 The split temp of the A/C unit is a bit low. Normally 15-18 degrees is optimal for cooling, this home has about a 10 degree split temp (difference in temperature between supply & return runs). This can be caused by a number of problems such as refrigerant leak/low charge, poor airflow/clogged evaporator coil, etc... You'll want to have an HVAC tech take a look at the unit and make sure it's running at peak performance.

12. The split temp of the A/C unit is a bit low. Normally 15-18 degrees is optimal for cooling, this home has about a 10 degree spilt temp (difference in temperature between supply & return runs). This can be caused by a number of problems such as refrigerant leak/low charge, poor airflow/clogged evaporator coil, etc... You'll want to have an HVAC tech take a look at the unit and make sure it's running at peak performance.

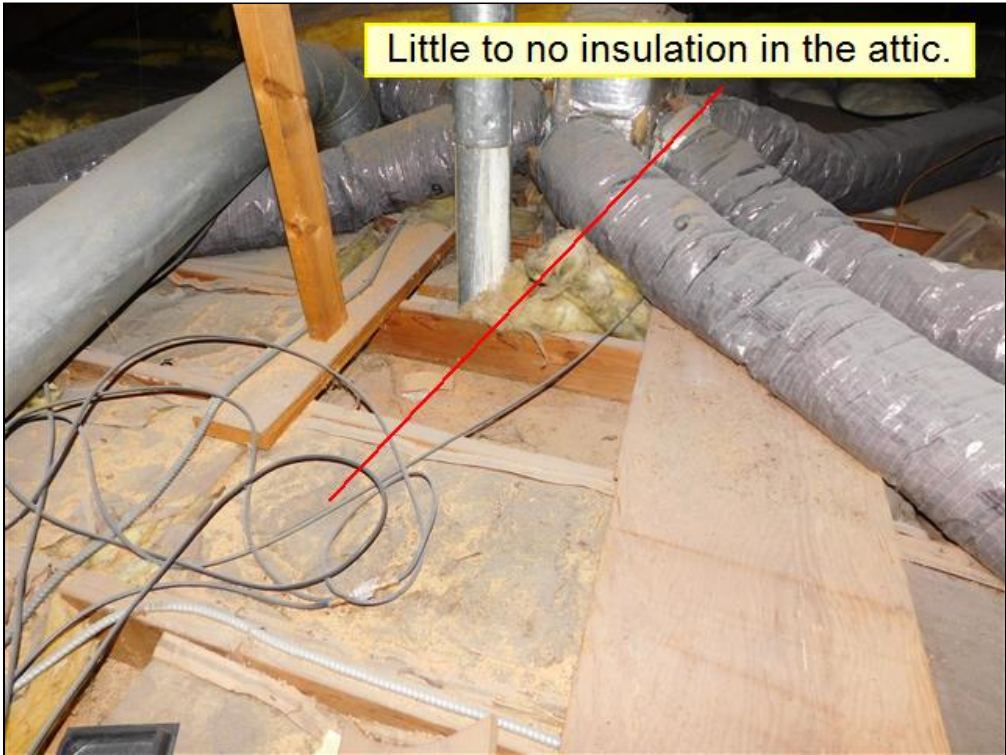
9.0 Item 1(Picture)

9.0 The insulation in the attic appears to be original and it has lost most of it's fluffiness. Insulation is effective because of its *loft*- the airspace in between the glass fibers helps slow down the transfer of hot air. When you compress it (or it settles over time),that air space goes away. You would greatly benefit from adding new insulation, both in comfort and energy savings. Most homes have less than a 12 month ROI on a newly insulated attic. A target level of **R-38 to R-60** is recommend for this area in the attic.

13. The insulation in the attic appears to be original and it has lost most of it's fluffiness. Insulation is effective because of its *loft*- the airspace in between the glass fibers helps slow down the transfer of hot air. When you compress it (or it settles over time), that air space goes away. You would greatly benefit from adding new insulation, both in comfort and energy savings. Most homes have less than a 12 month ROI on a newly insulated attic. A target level of **R-38 to R-60** is recommend for this area in the attic.

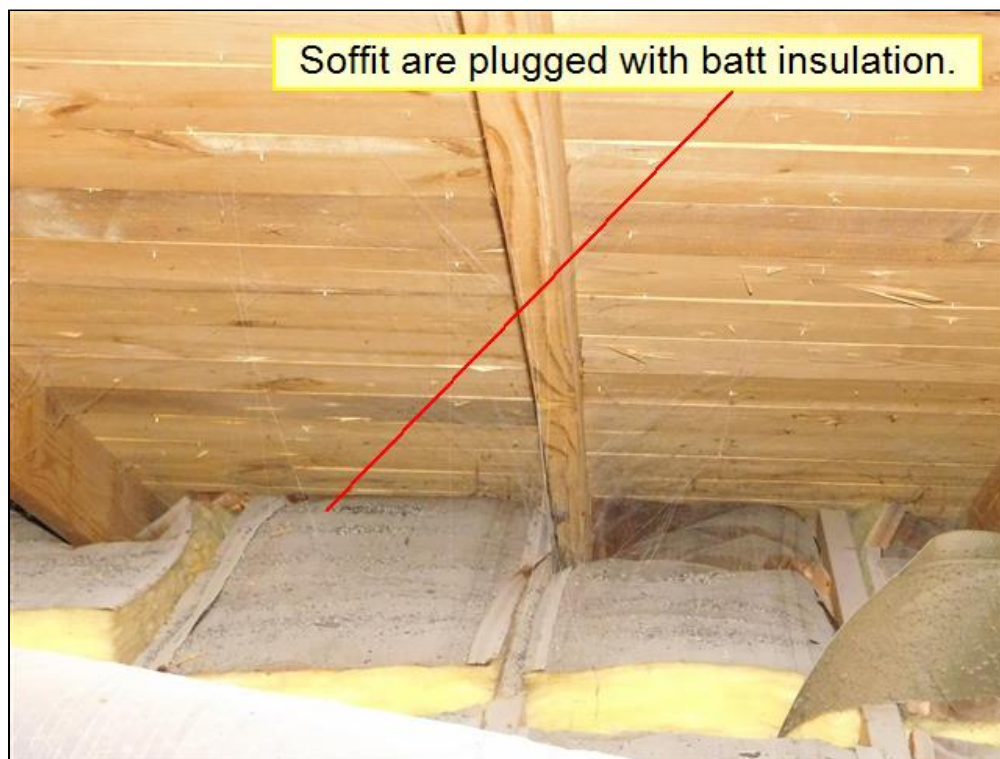
9.1 Item 1(Picture)

9.1 The batt insulation in the attic has been stuffed into the soffits. The vents that are in the soffits are now blocked and can't allow the fresh air to get into the attic to help vent out and moisture. Have the insulation pulled back so the soffit vents can work as intended.

14. The batt insulation in the attic has been stuffed into the soffits. The vents that are in the soffits are now blocked and can't allow the fresh air to get into the attic to help vent out and moisture. Have the insulation pulled back so the soffit vents can work as intended.

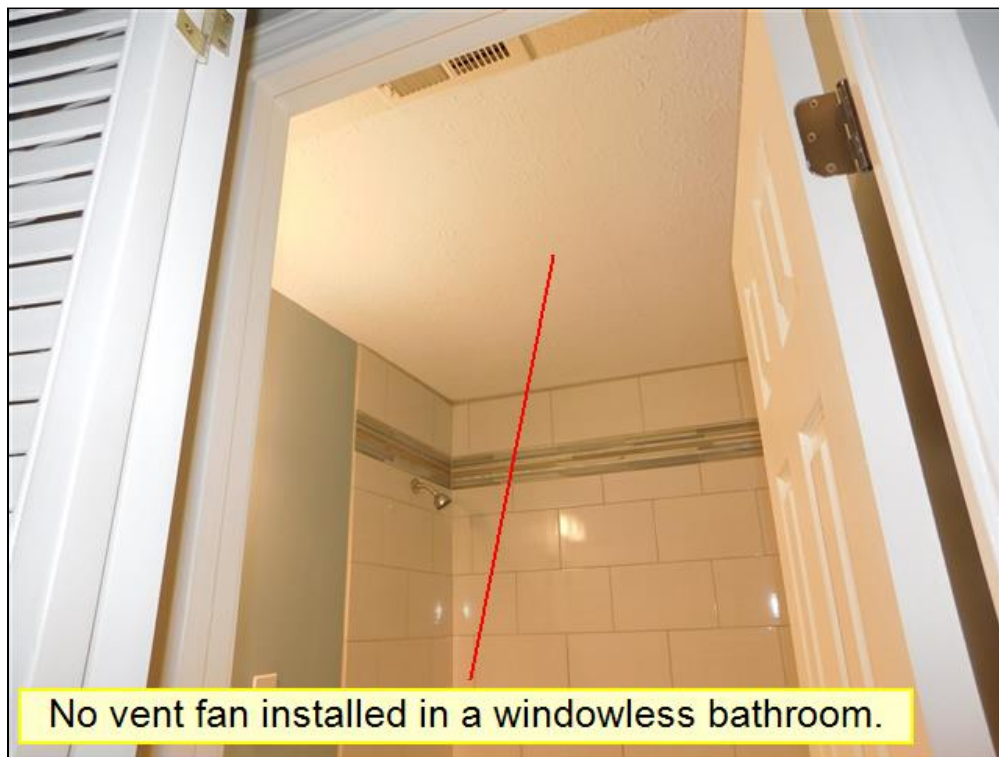
9.2 Item 1(Picture)

9.2 The bathroom does not have any form of ventilation. Bathrooms cause an extreme amount of moisture to build up inside a small room and this can cause mold to grow, and paint to fail. Have a vent fan installed to remove this moisture, and make certain it's ducted to the outside of the house (not just the attic).

15. The bathroom does not have any form of ventilation. Bathrooms cause an extreme amount of moisture to build up inside a small room and this can cause mold to grow, and paint to fail. Have a vent fan installed to remove this moisture, and make certain it's ducted to the outside of the house (not just the attic).
